# Point Hudson Condition Assessment Port Townsend, WA

**TITLE PAGE / TABLE OF CONTENTS**  
**PAGE T-1**

WASHINGTON ENGINEERING  
4040 WHEATON WAY, SUITE 202  
BREMERTON, WASHINGTON 98310  
360-405-1420

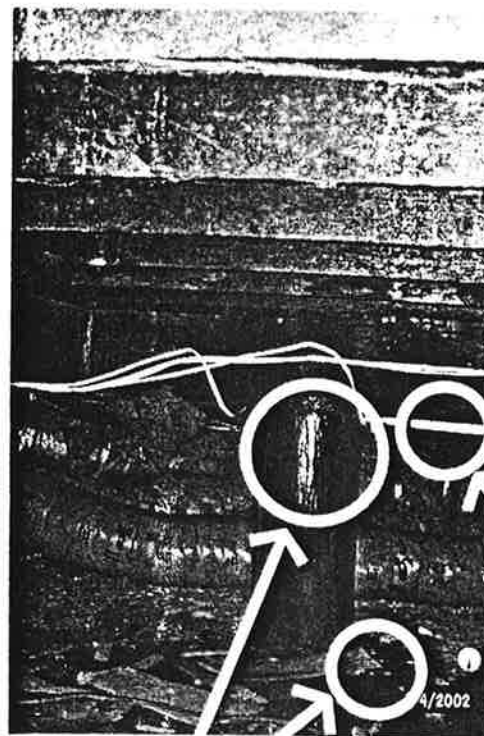
1.1

- Dripping creosote at piling.
- Dripping creosote at floor joists and diagonal sub-flooring.
- Steam pipe insulation [non-friable asbestos].

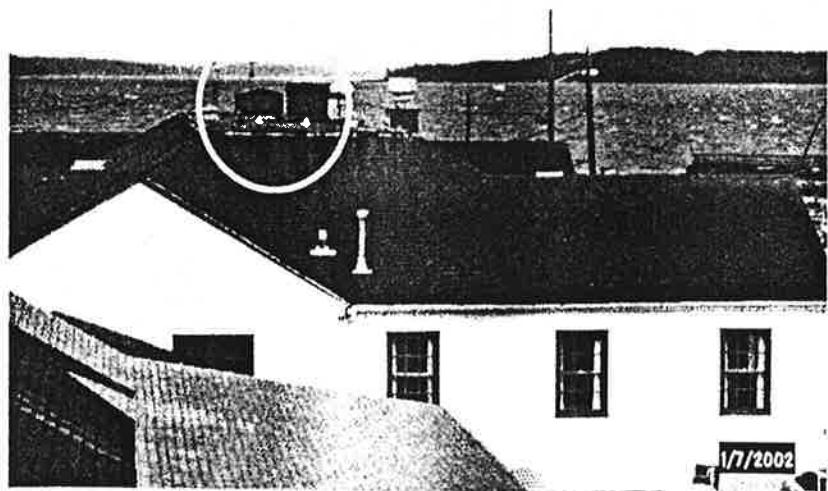
3.3

- Roof ridge repair including placing galvanized sheet under existing ridge shingles.
- Repair of shingles to include application of roofing adhesive over existing shingles.
- Built up roof weathering to expose fiberglass roofing felts.
- Flat roof over main building

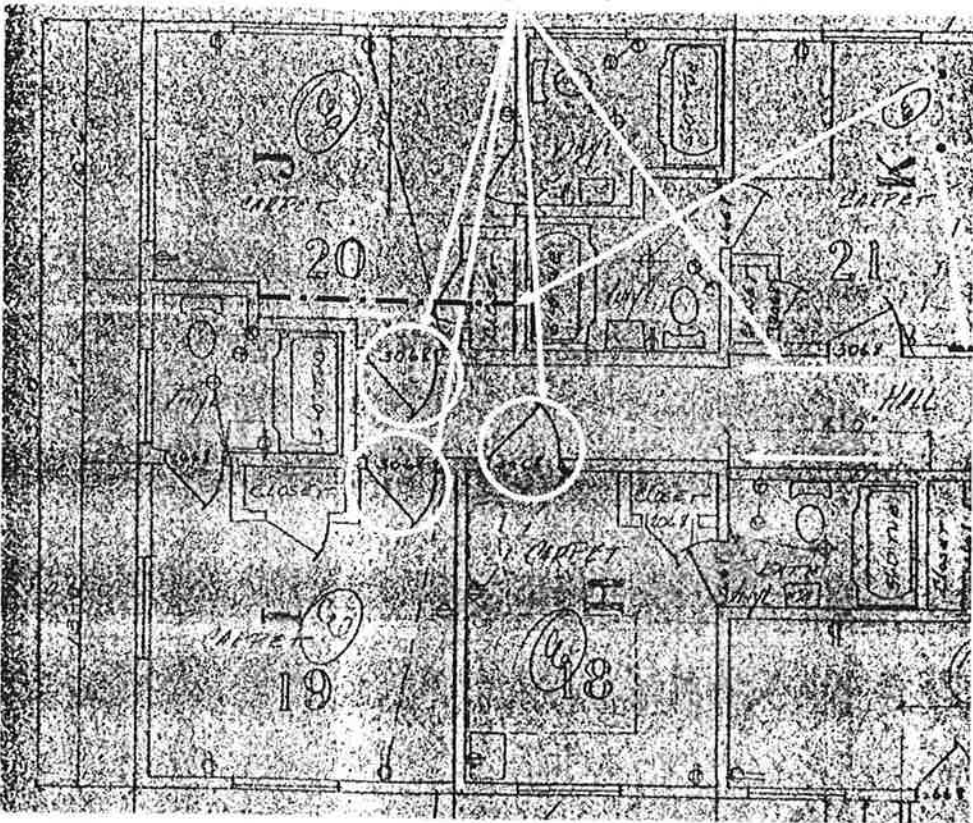
5.1 North West corridor, Motel building, bottom floor

Examples of non-rated, hollow core doors, and sub-standard corridor, and goofy door swings. Corridor was diminished in width to construct toilets (for no apparent space planning reason).

Header location. Installed to support bearing capacity of the corridor walls. Bearing line of original design that lines up with piling and structure line below floor.

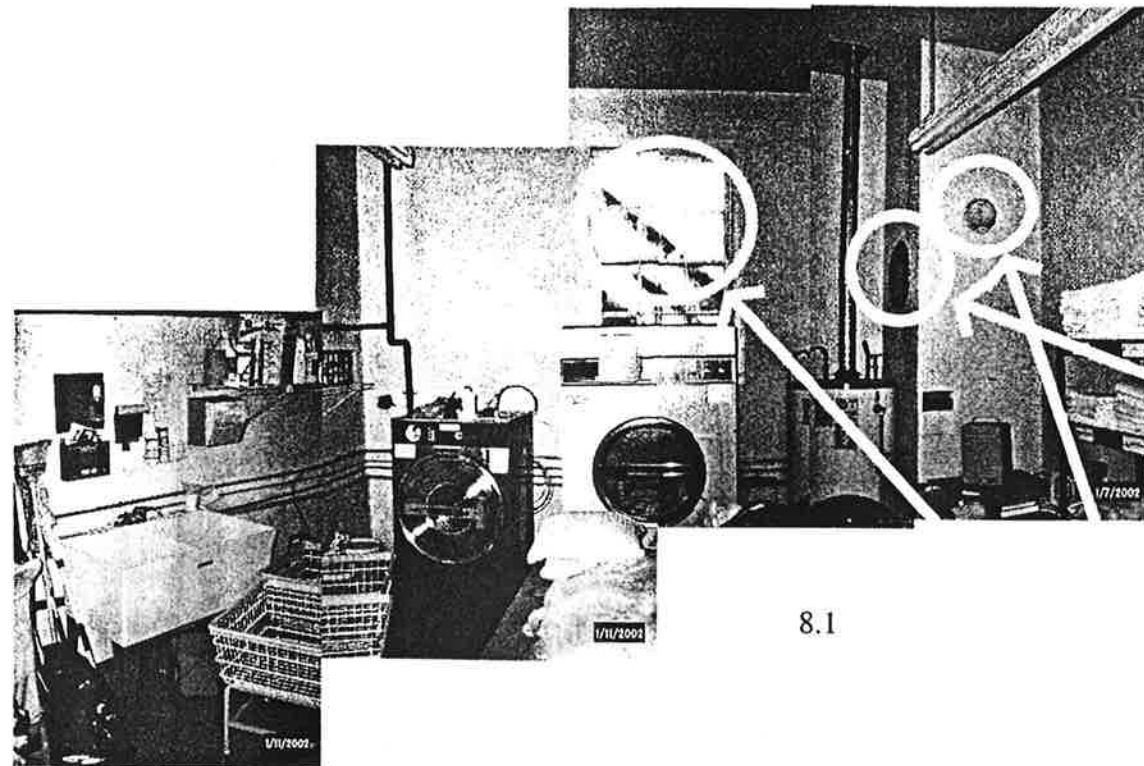
8.1

- Decommissioned masonry flu
- Barometric damper operating during high wind conditions
- Combustion air supplied by window

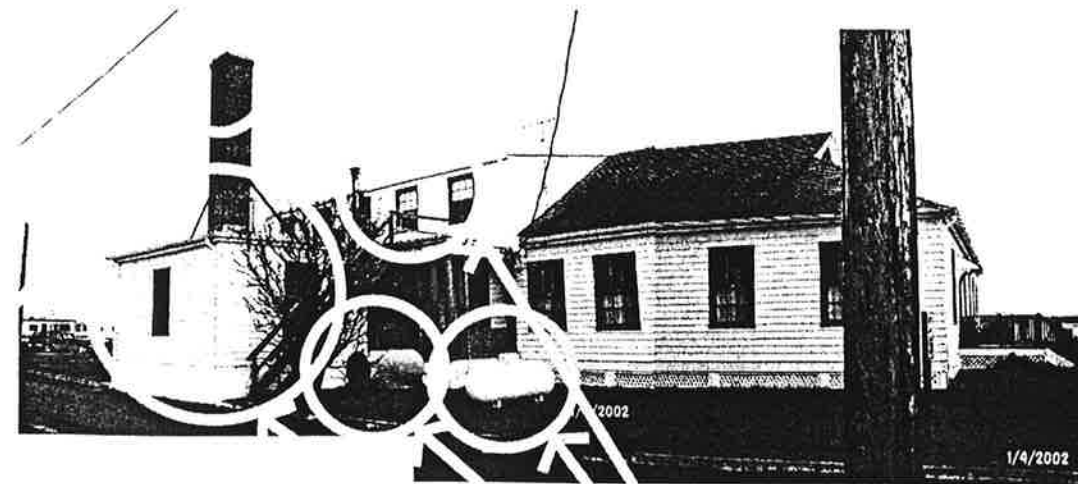
8.2

- Hazardous exit from second floor
- Propane Tank [Laundry]
- Fuel Oil Tank [Motel]
- Laundry Building

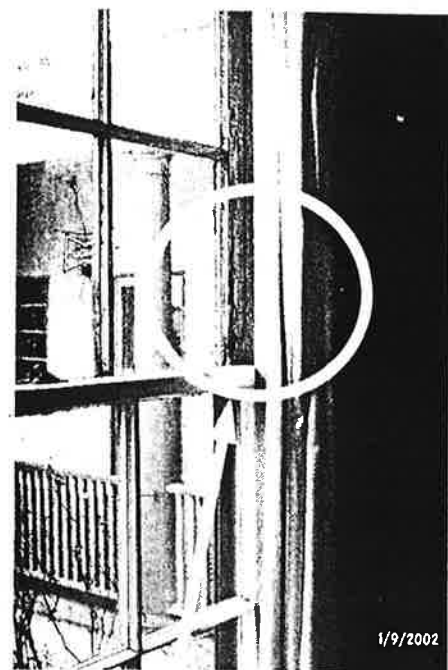
9.1 Window mullion deterioration due to moisture

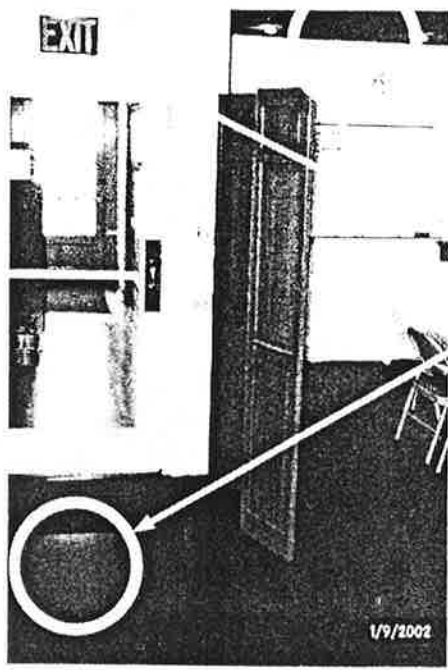
South-west wing of Main Building 9.2

- Cork applied to ceiling for sound control
  - Non-illuminated exit sign
  - 'Hardwood' flooring
- Discontinuous and fractured flooring

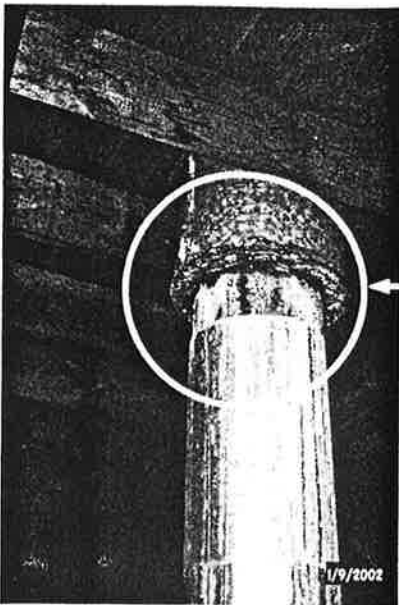
10.3

Failing vent stack

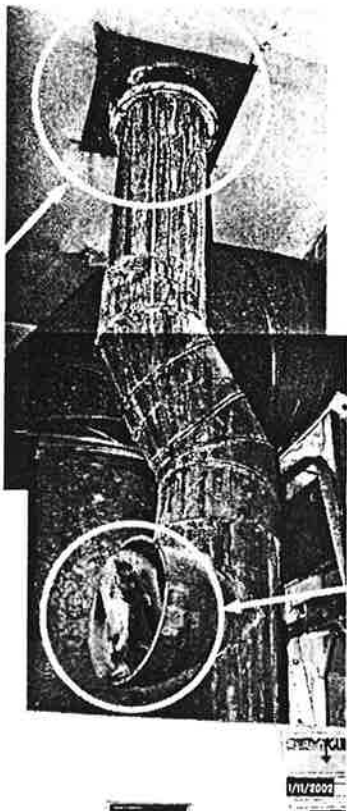
10.5

Barometric valve corroded open  
Forced air, oil fired heating plant

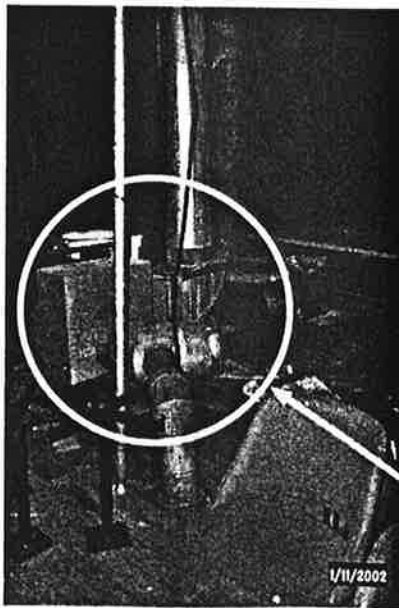
10.4

Decommissioned air handing equipment

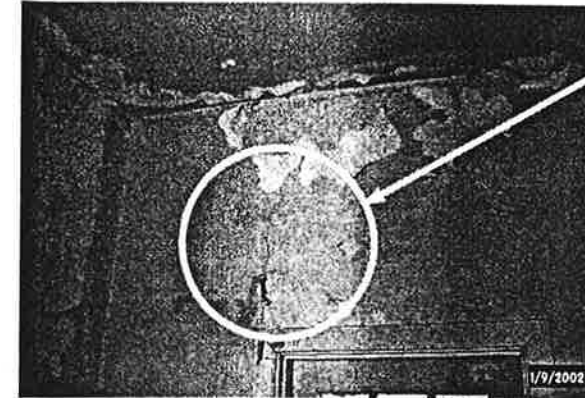
12.3

- Moisture migration through paint.
- Kitchen ventilation point.

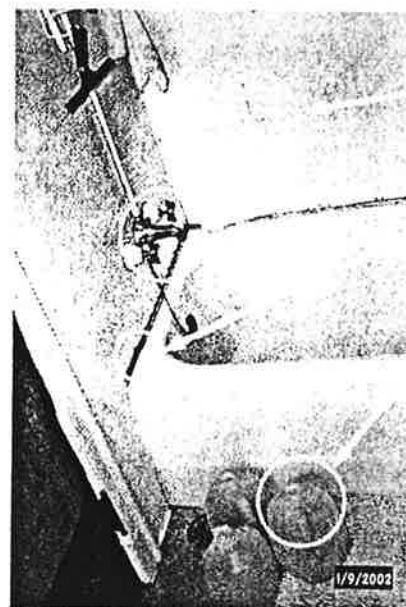
13.1

- Original hardboard shower enclosure
- Original hardware
- Mildew [fungus] growth at enclosure edge
- Dehumidifier condensate
- Copper roof, conflict with adjacent tree

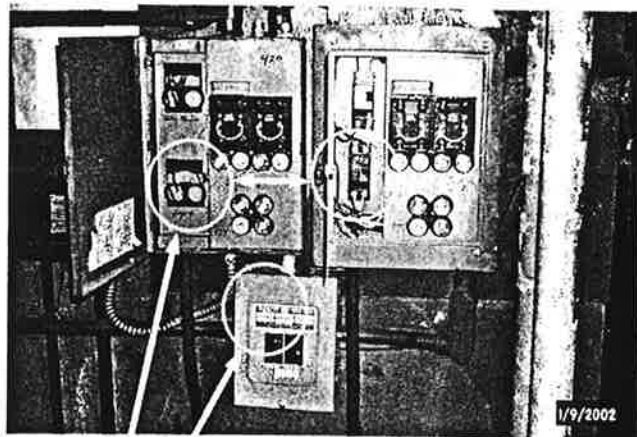
13.4

- Modern disconnect connected to distribution system.
- Old fused panels modified to accept breakers. This is likely a violation of the electrical code, and could be an insurance issue due to voiding UL listing of panel.
- Encrusted barometric damper
- Deteriorating combustion exhaust flue.
- Standing water from boilers
- Boiler pop-off valve releasing excess pressure.

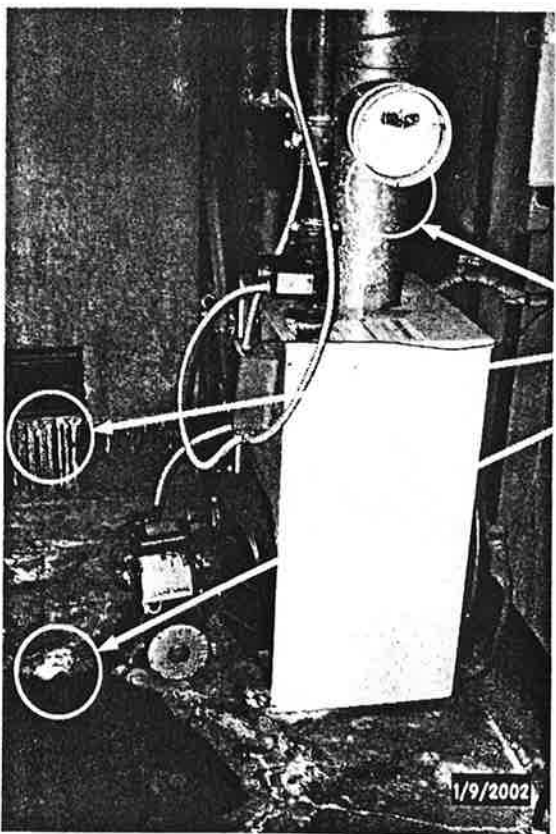
13.6

- Indication of failing flue
- Standing water

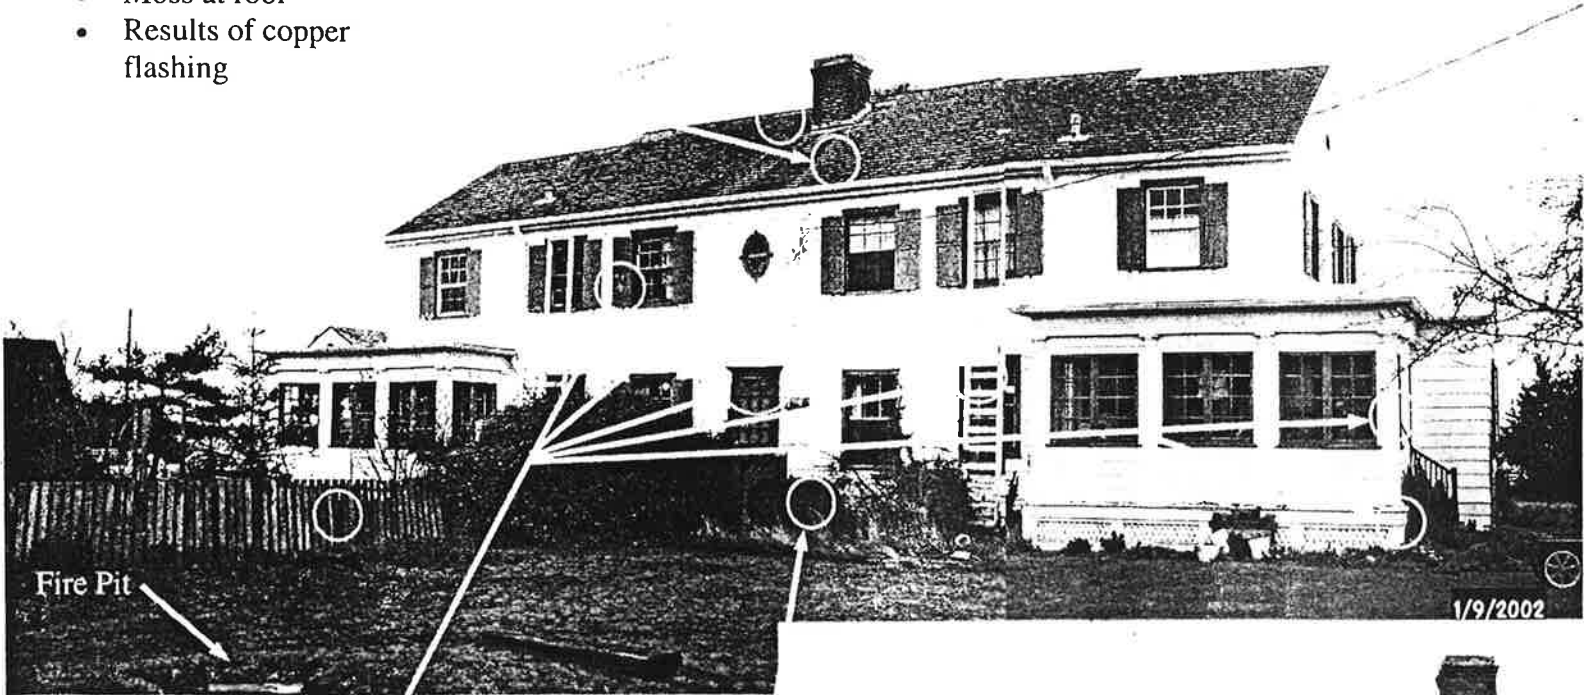
14.1 South Duplex

- Moss at roof
- Results of copper flashing

- Devices showing signs of deterioration.
- Fuel oil tank serving both duplexes.

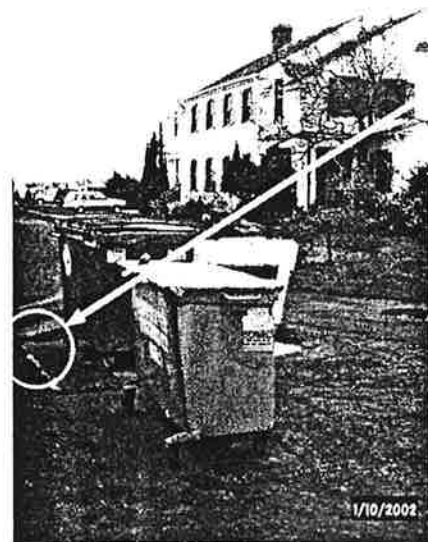
15.1

- Dumpster located on plywood sheet in proximity to sidewalk.
- Paint, and window mullion deterioration.
- Double feed from common fuel tank.

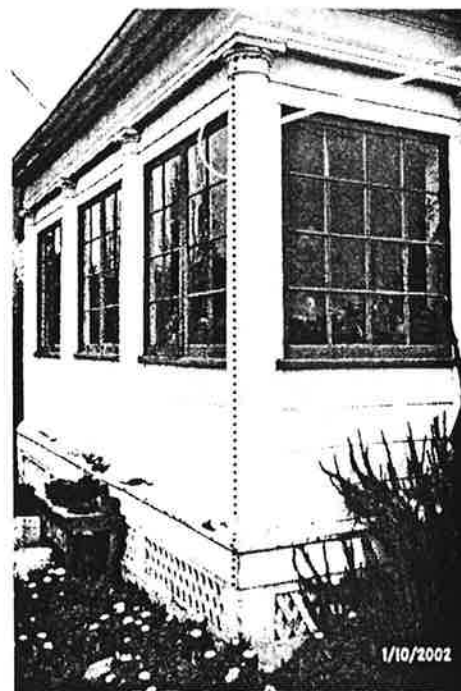
15.7

Approximate location of leak into porch area below.

Lateral crack at exterior ornamental columns.

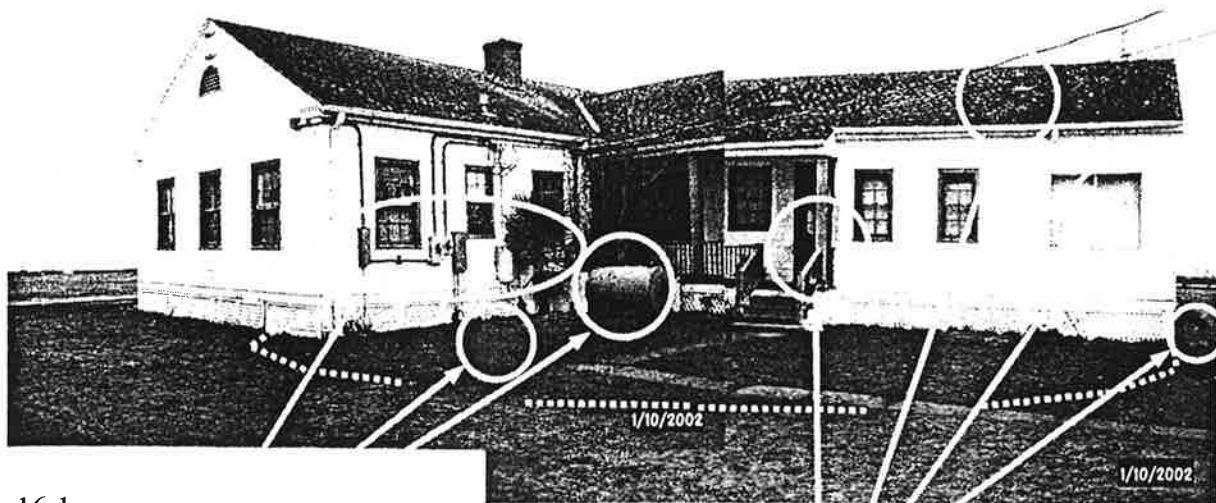
16.1

- Fuel oil tank servicing two buildings
- Saturated ground
- Service entrance and breaker panels located on the exterior of the building.
- Edge of vehicle access
- New aluminum windows
- Moss growing on roofing
- Paint failure

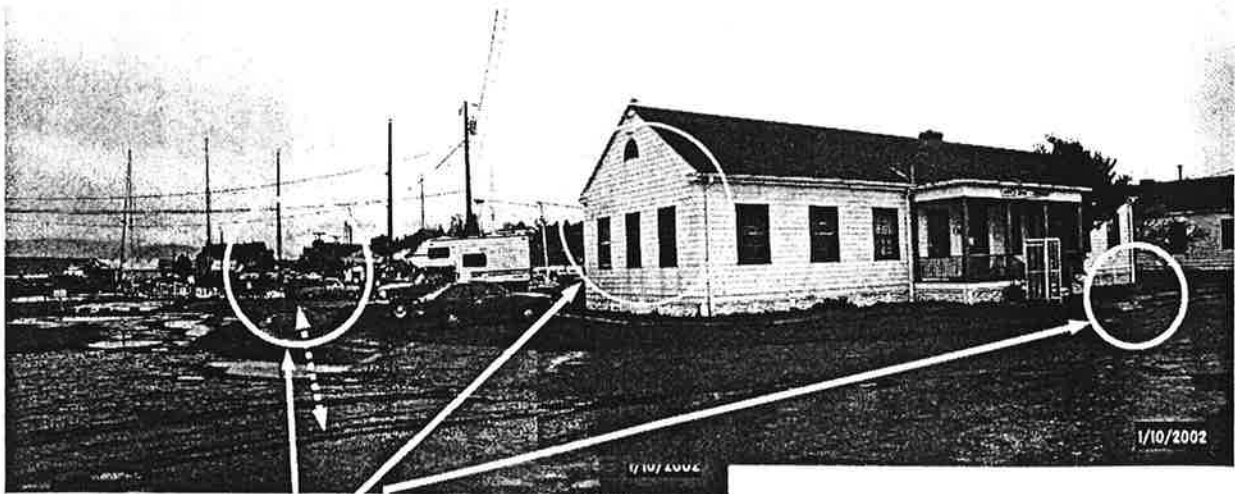
16.4

- End of the sidewalk.
- Surfaces and openings typically showing indications of deterioration on sides of building exposed to the South-west.
- Centerline of Water Street.

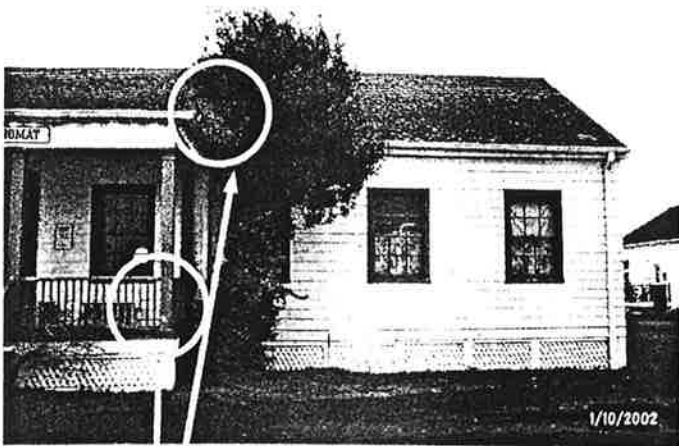
16.2

- Tree/roof conflict
- Paint failure

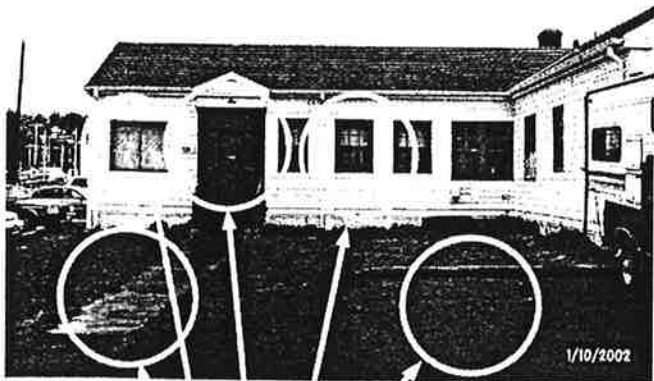
16.3

- Parking
- Original windows typically showing indications of deterioration on sides of building exposed to the South-west.
- Decommissioned entrance exhibiting signs of deterioration.
- Aluminum windows.
- Decommissioned pedestrian access.
- Pedestrian walking in the street as the street is the only pedestrian option at this location.
- Parking on shoulders, lawns conflicting with pedestrian space allocation.
- End of the sidewalk.
- Primary 'public' access.

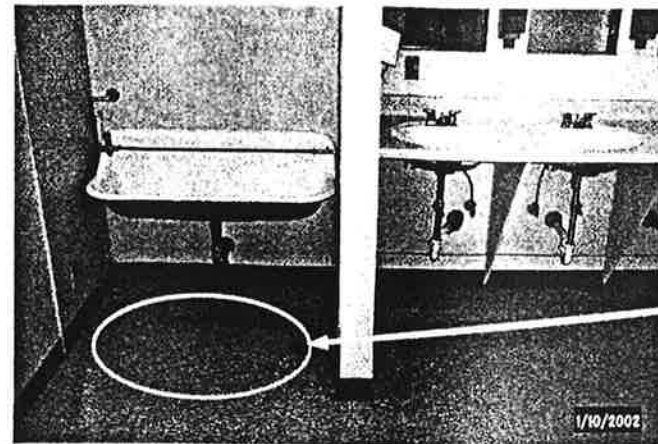
17.1

- 1970's sheet vinyl showing wear in front of urinal.

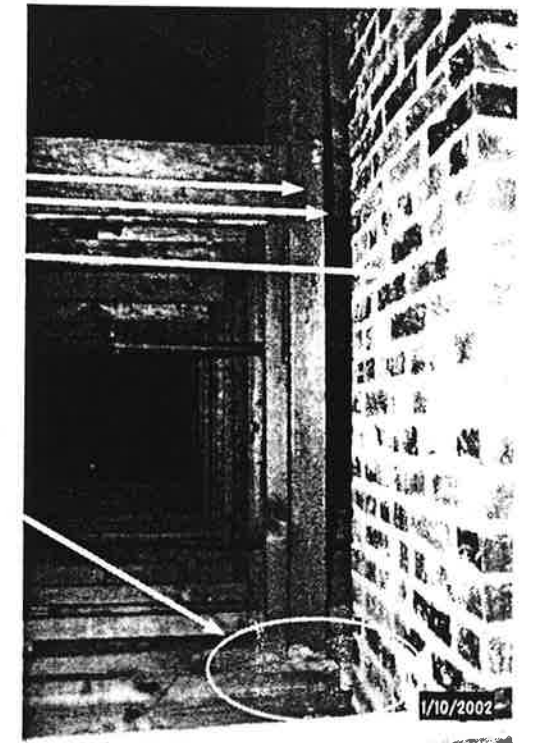
17.4

Paint failure due to moisture migration.

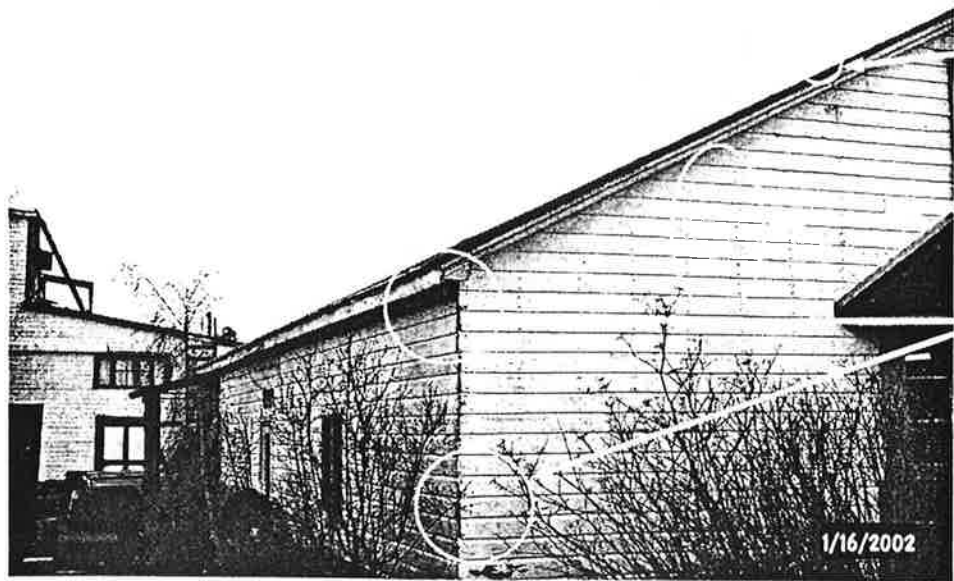
18.1

Roof plane relatively without distortion

Nail heads rusting through paint.

Exposed siding corner

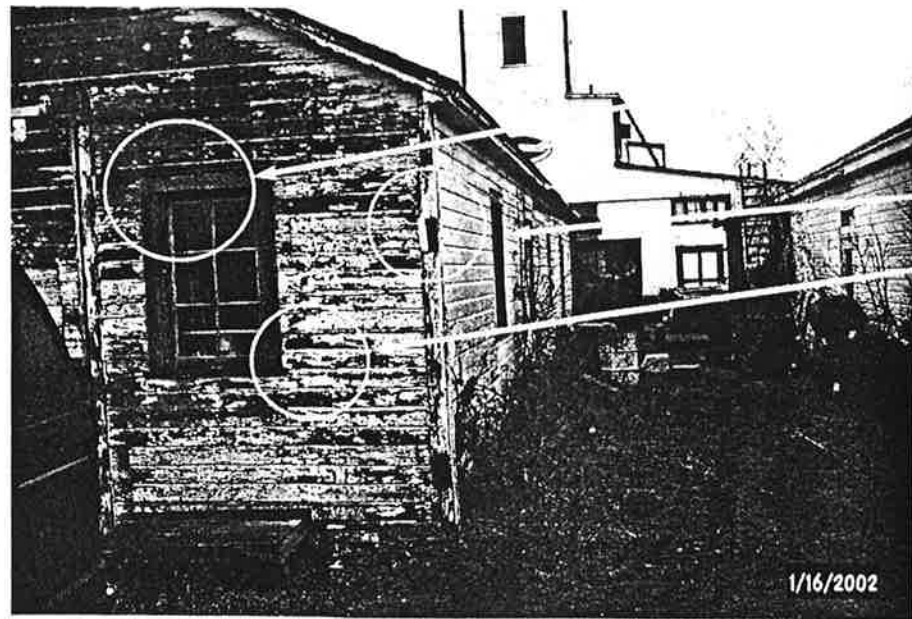
18.2

Window showing signs of advanced deterioration.

Corner trim failure

Siding failure, paint failure.

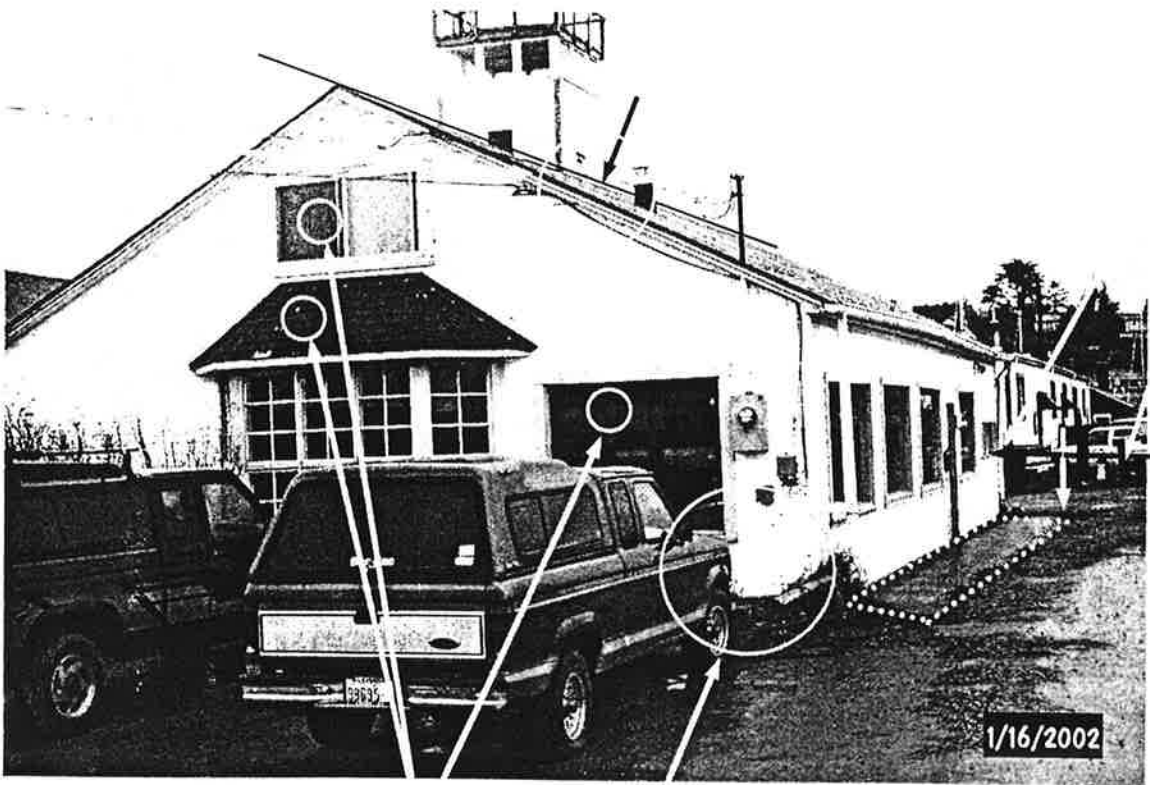
18.3

Location of occasional leak into inside of building

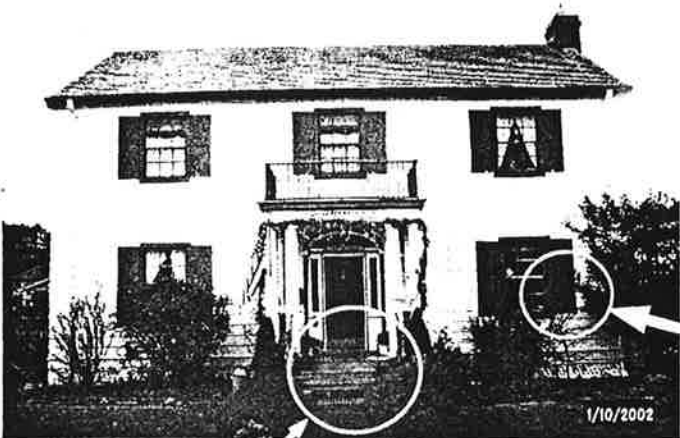
19.1

- Deteriorating painted finish
- Deteriorating shutters
- Original windows typically showing indications of sash and putty deterioration.

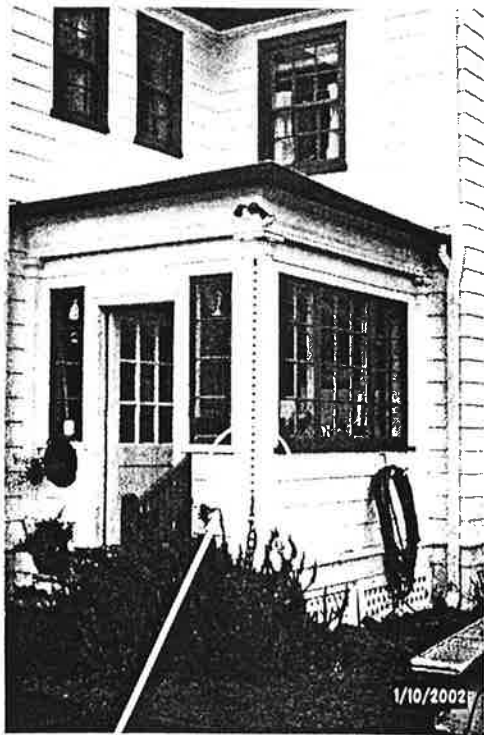
Cracked column 19.5

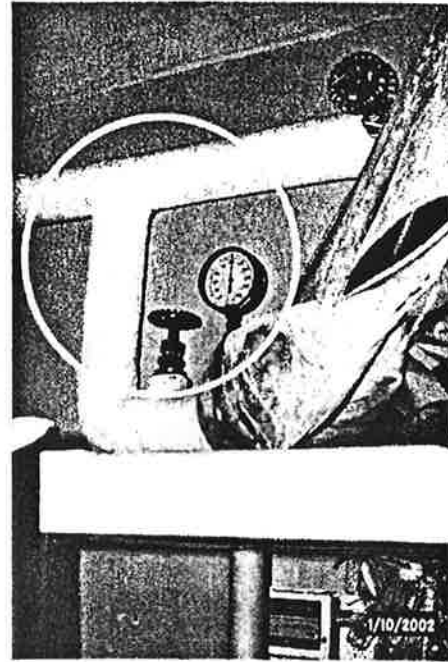
20.1

Existing steam piping adapted for hot water distribution. Asbestos insulation encapsulated to prevent friability.

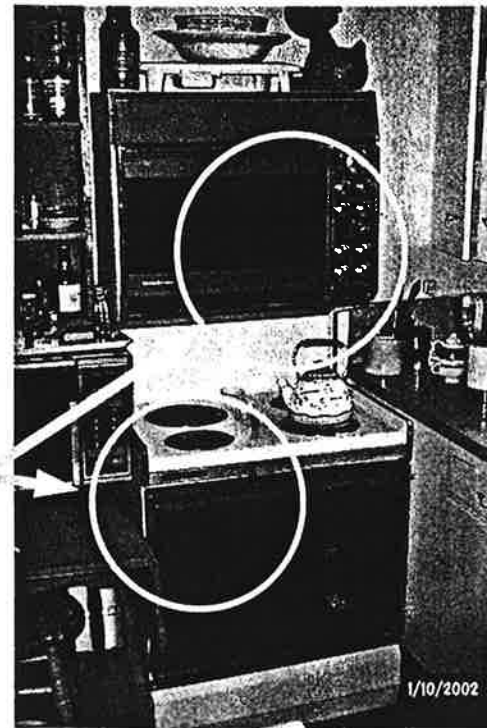
20.3

Aging residential appliance sited by health department due to deteriorating seals.

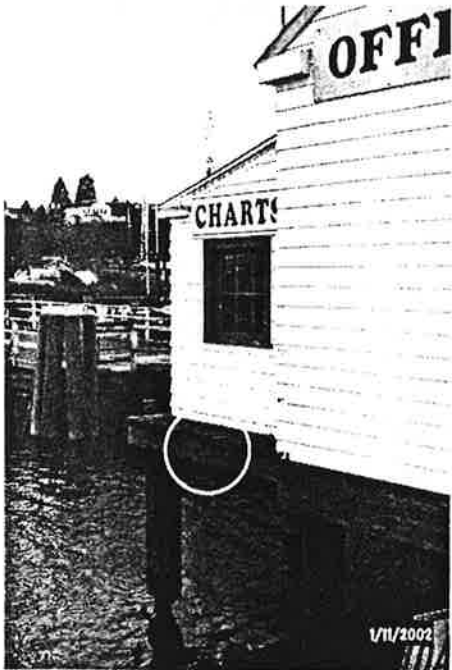
21.6

Creosote treated structure  
Creosote treated piling  
Deteriorating wood deck

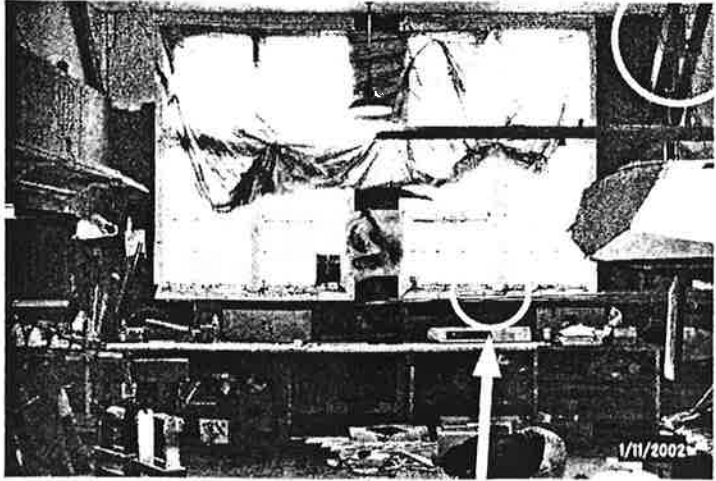
23.2

Water damage at window jamb

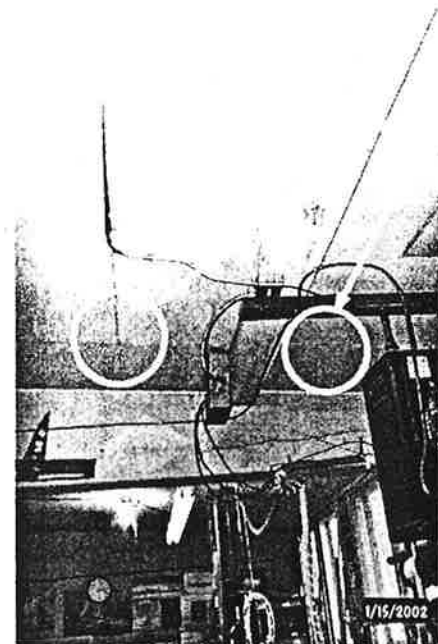
24.1

Potential indication  
of lateral move-  
ment of building

Crack showing on  
one side of beam.

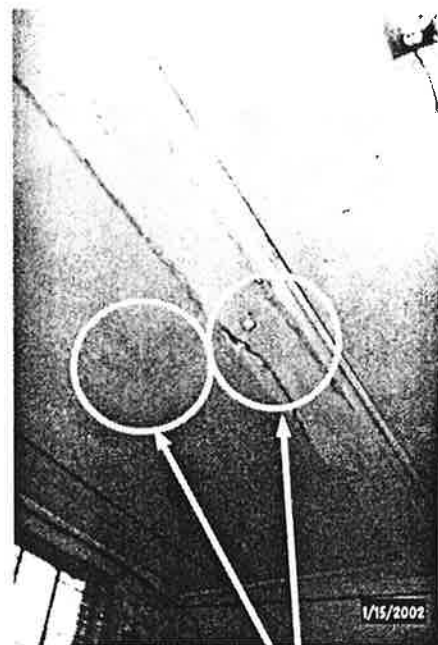
24.2

Water leak in proximity  
to exterior tower

Potential indication of lat-  
eral movement of building

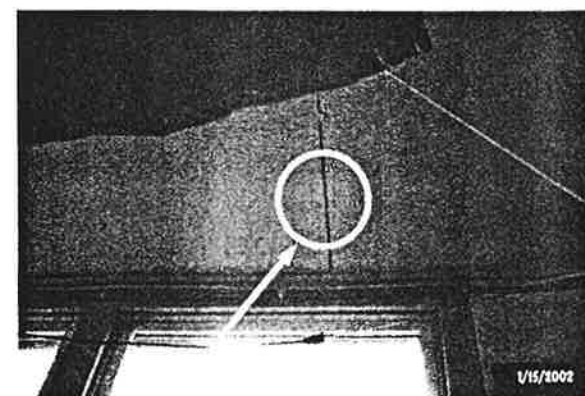
24.5

Torsional movement of  
column

Recent crack activity

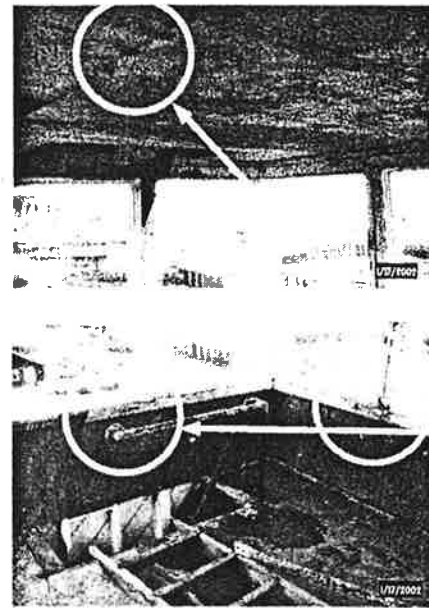
24B.1

Results of water vapor migration back and forth through tower ceiling

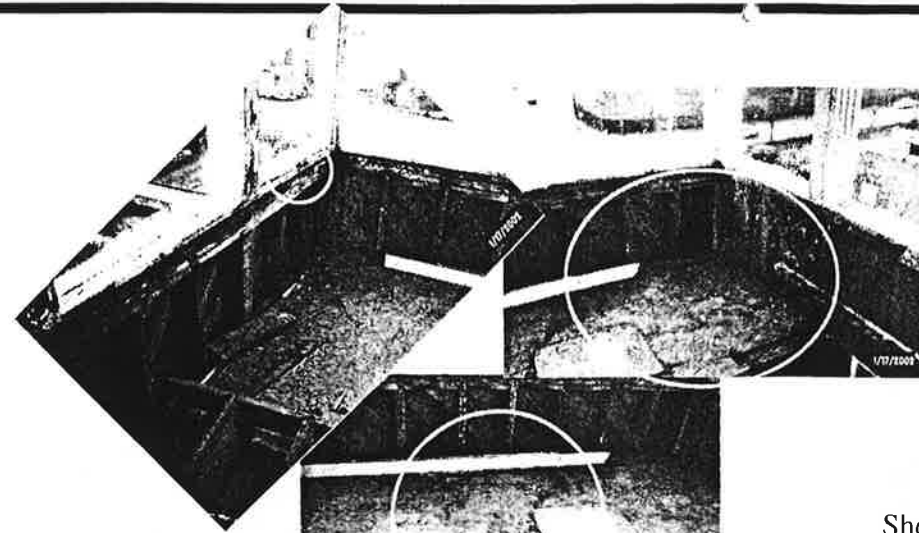
24B.2

Water stain indication at edge of floor

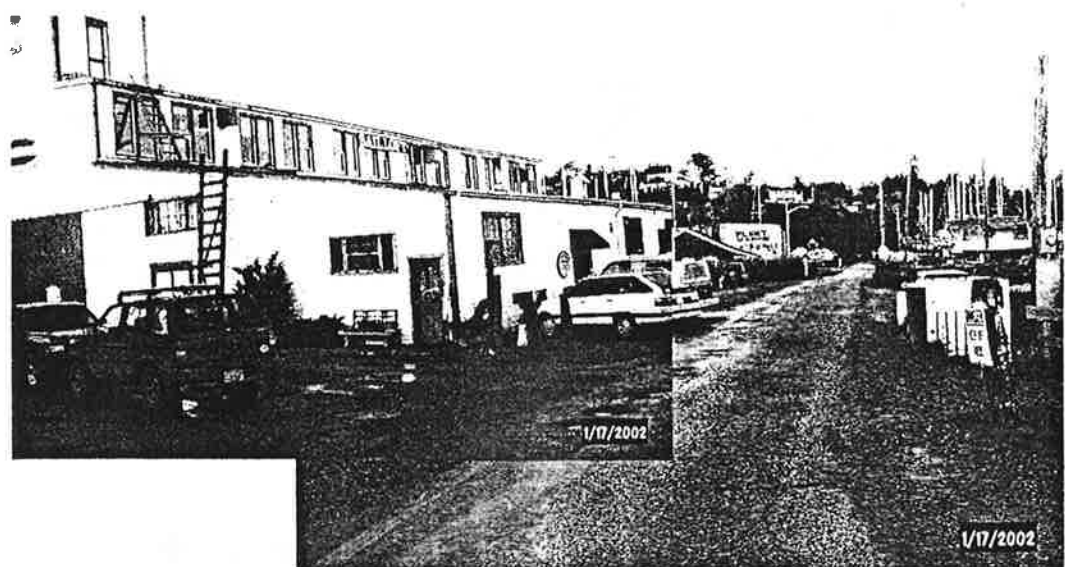
24C.1

Illustration of upward [Column 1] and downward [Column 2] structural displacement

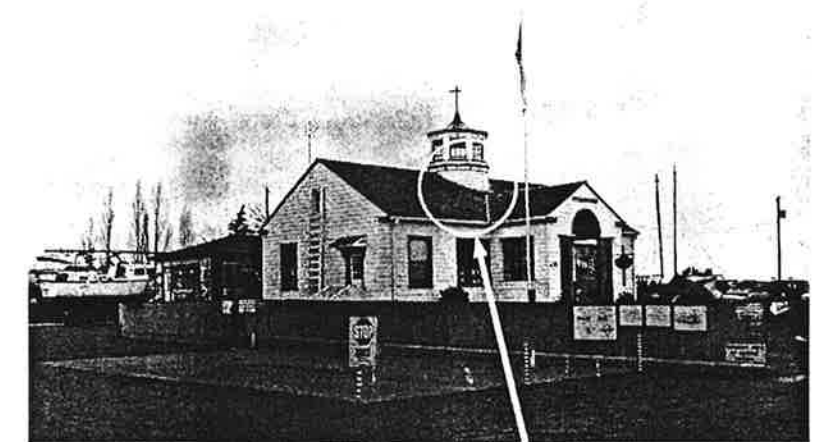
25.12

Probable area tributary for  
roof leak

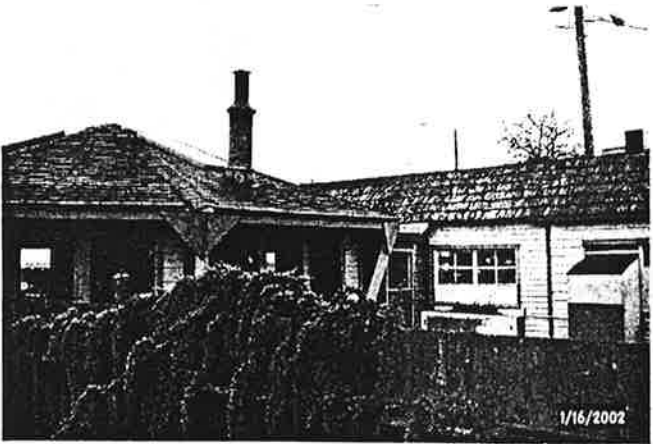
27.7

Potential roof leak area

Site drainage problem:
