PORT OF PORT TOWNSEND

Point Hudson Marina Entrance Breakwater Feasibility Assessment

April 25, 2014

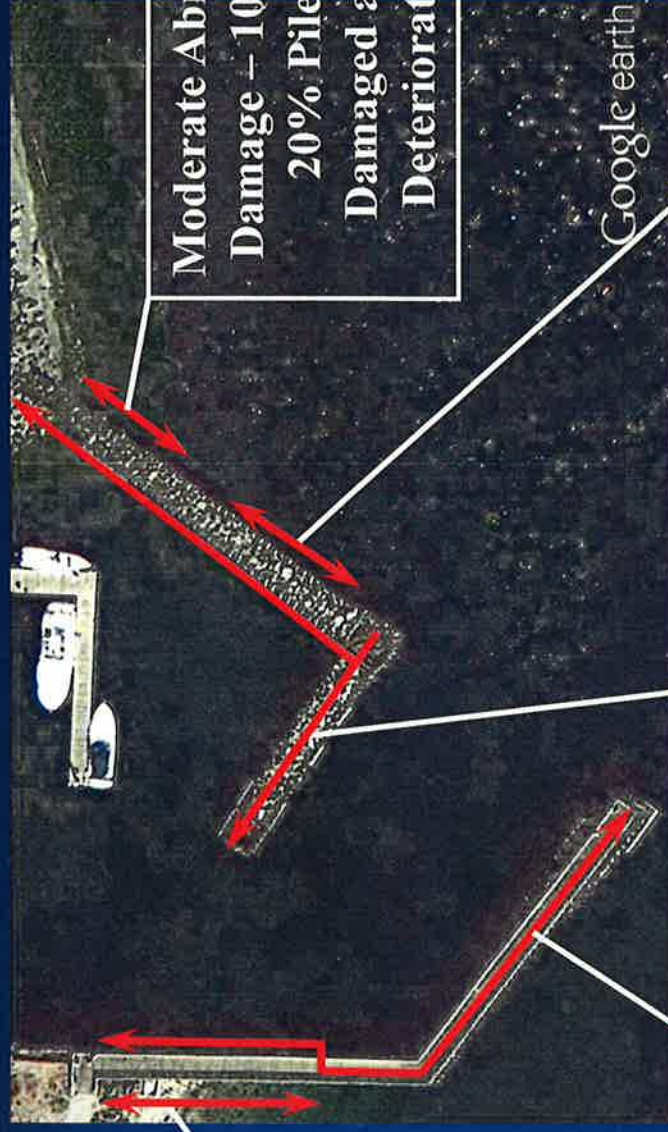
Moderate Abrasion
Damage – 10% to
20% Piles
Damaged and
Deteriorated

Severe Marine
Borer Attack,
20% to 30% Piles
Damaged and
Deteriorated

10% to 20% of Piles
Sounded Somewhat
Hollow, Exposed Side
Worse than Sheltered
Side

Moderate to Severe
Abrasion Damage
20% to 30% Piles
Damaged and
Deteriorated

10% to 20% of Piles
Sounded Somewhat
Hollow, Exposed
Side Worse than
Sheltered Side

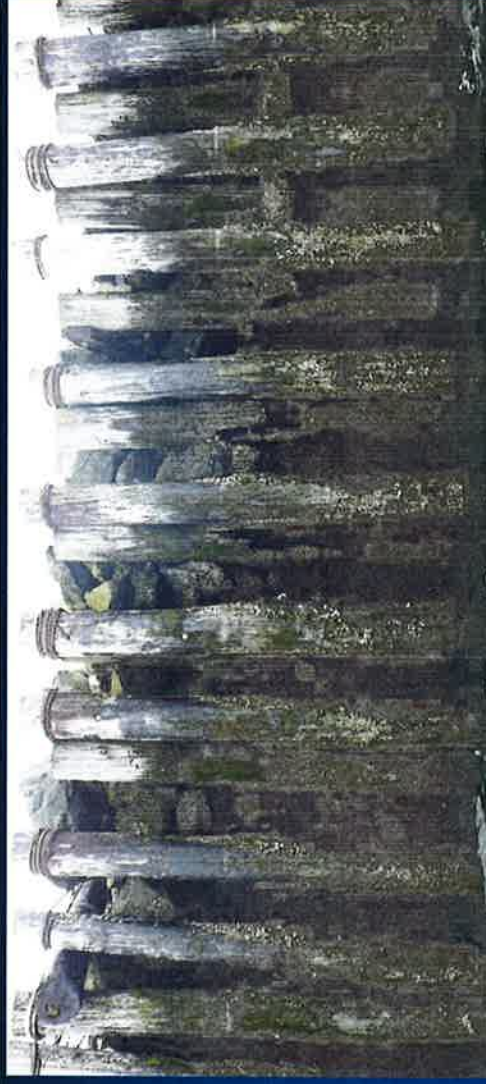
- Varying Levels of Deterioration Depending on Exposure, Damage
- Likely Shallow Embedment – Highly Compacted Sand Layer 0.8ft to 2ft Below Mudline (Landau Biological Assessment/Evaluation, September 2005)
- Piles Beyond Useful Service Life

Piles in Poor Condition

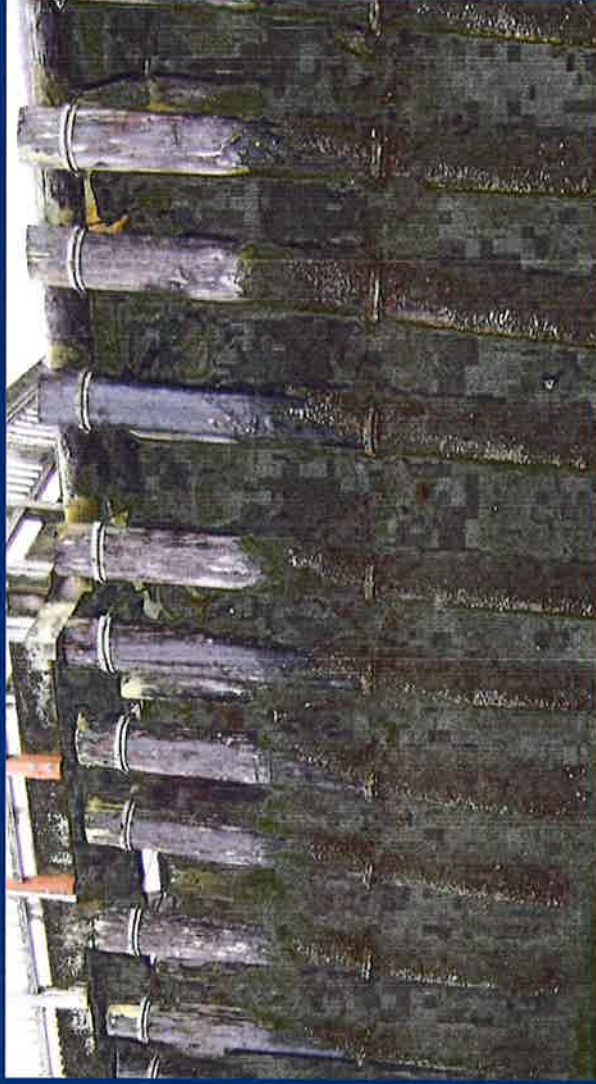
Piles in Fair Condition

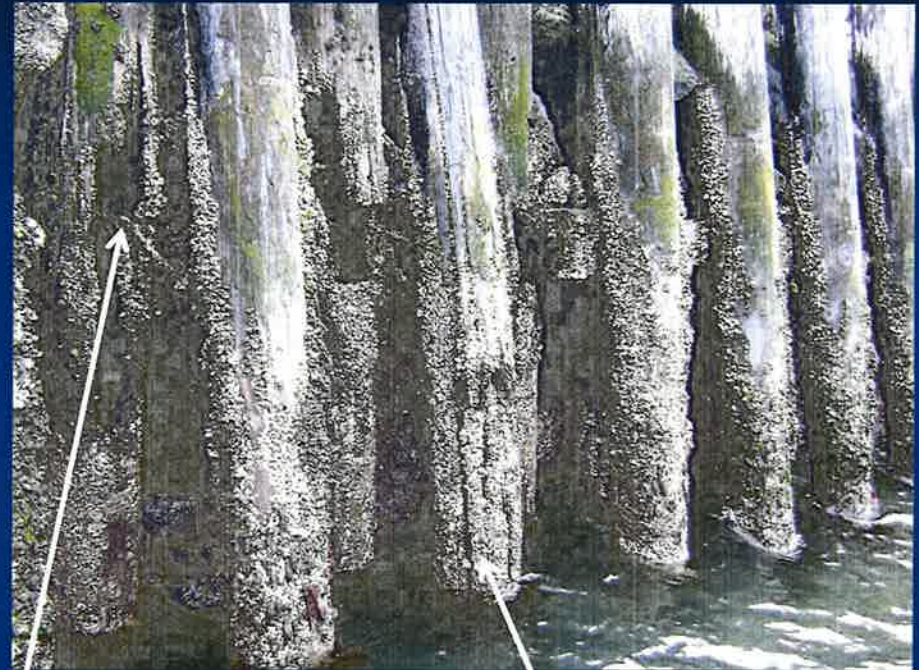
- Marine Borer Attack
- Varying Levels of Deterioration
- Decay Where Creosote Treatment Penetrated by Bolts, Thru Rods

**Inner Pile
(1934) :
Decay at
Penetration**

**Outer Pile
(1969):
Marine
Borer
Attack**

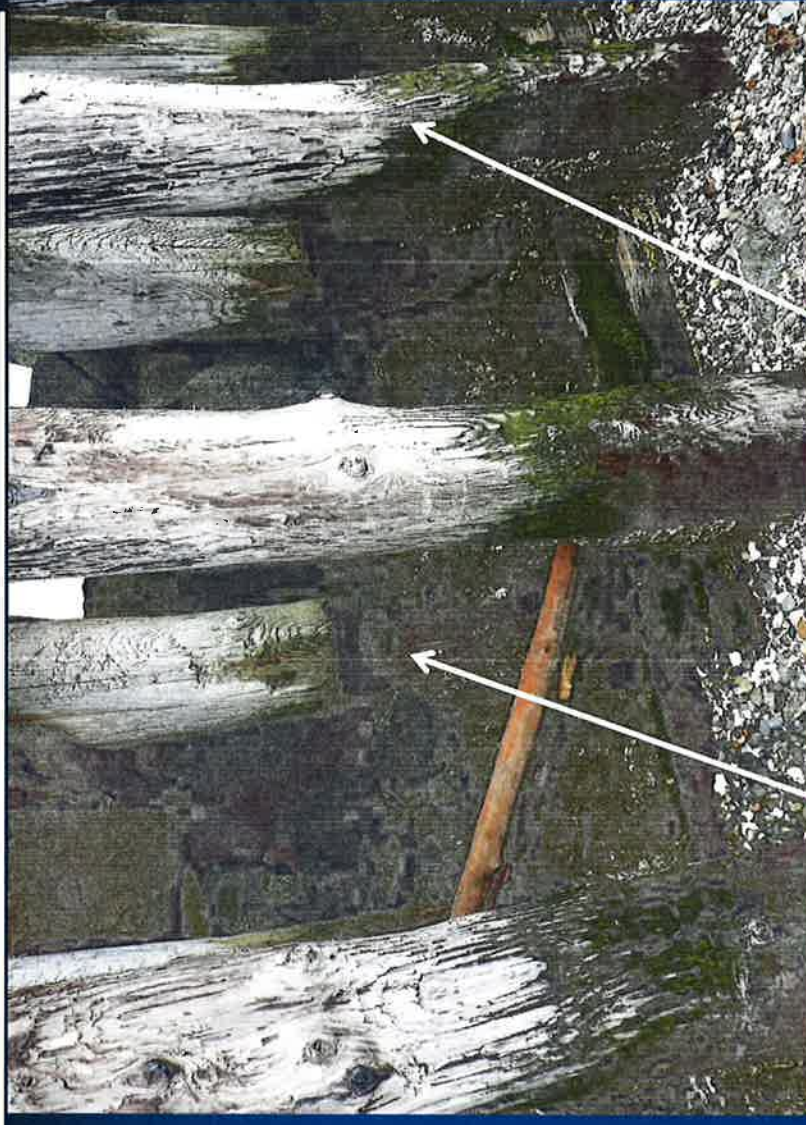
- Abrasion
Penetrated
Creosote
Protective
Treatment,
Subsequent
Decay/Marine
Borer Attack

Inner Pile
(1934)
Abraded &
Decayed

Outer Pile (1969)
Abraded, Decaying
(Hollow Sounding)

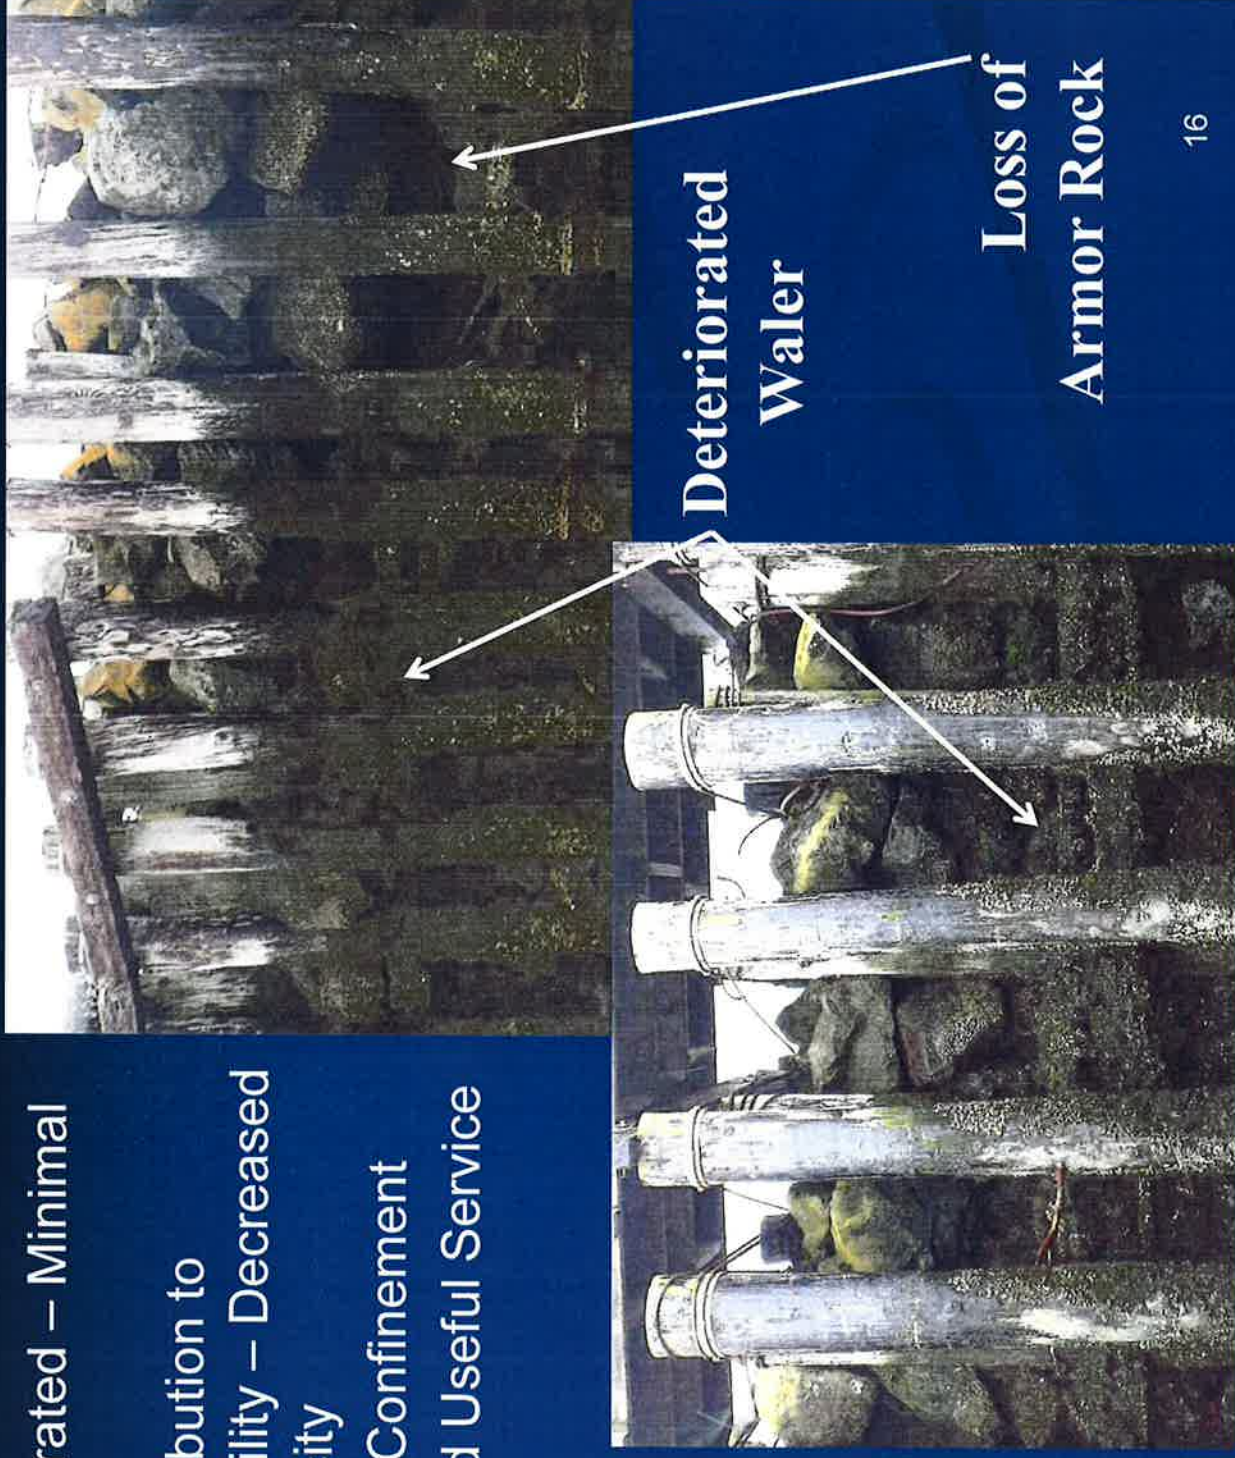
- Highly Deteriorated – Minimal Capacity
- Minimal Contribution to Structure Stability – Decreased System Capacity
- Loss of Stone Confinement
- Walers Beyond Useful Service Life

Deteriorated
Waler

Loss of
Armor Rock

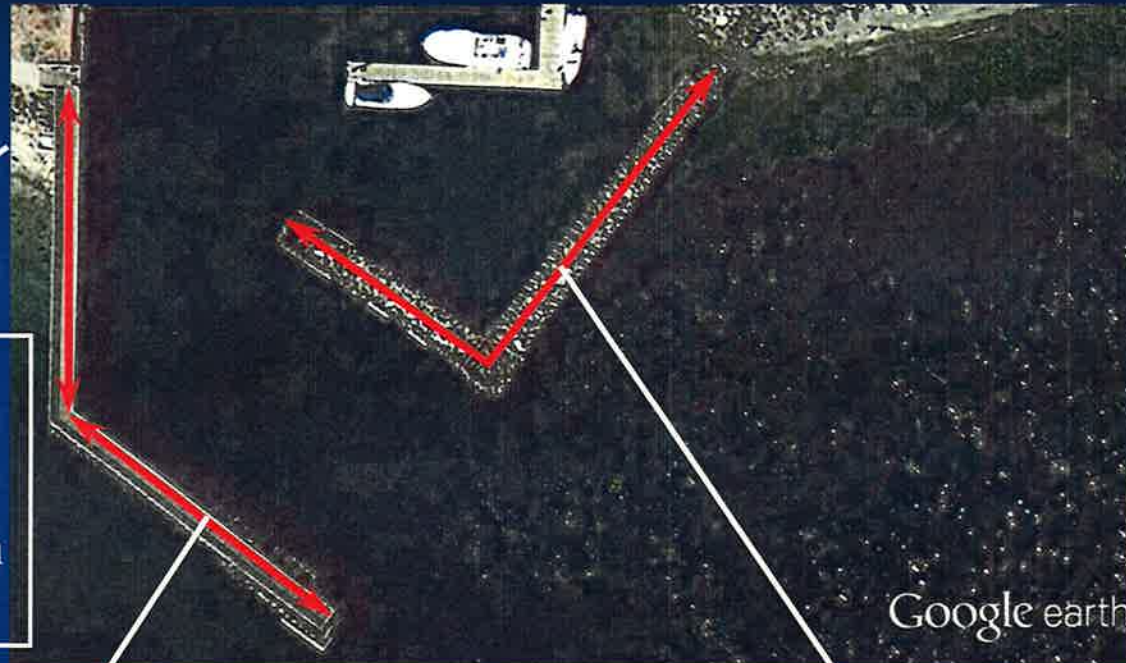
**10% Cables Severed,
Remainder
Deteriorated, Areas
Exposed to Wave Splash
Worst**

**10% to 20% of Cables
Severed, Remainder
Deteriorated, or
Highly Deteriorated**

**5% to 10% of
Cables Severed,
Remainder
Deteriorated**

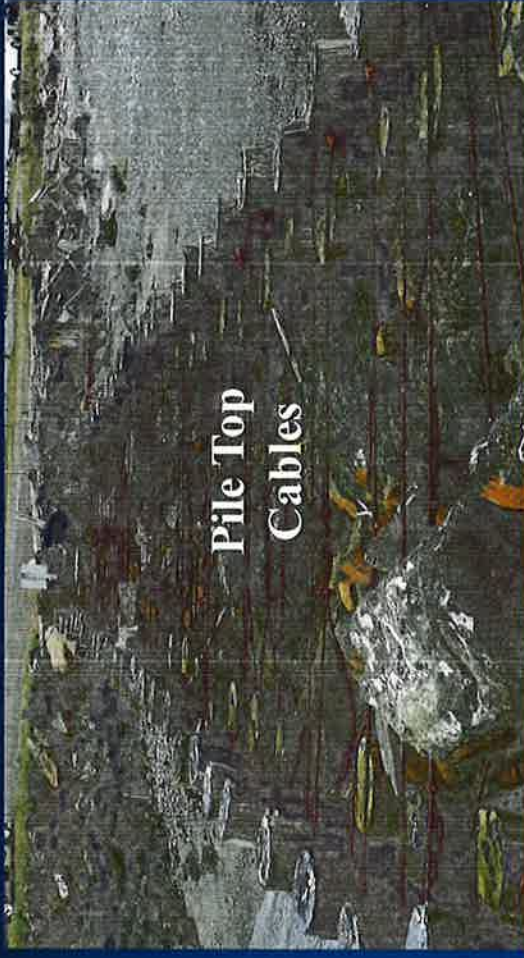
- Pile Top – Cables Wrapped Around Pile Tops to Provided Lateral Support
- Intermediate – Cables Wrapped Between New and Old Piling – 90%+ Missing, Remainder Highly Deteriorated

Pile Top
Cables

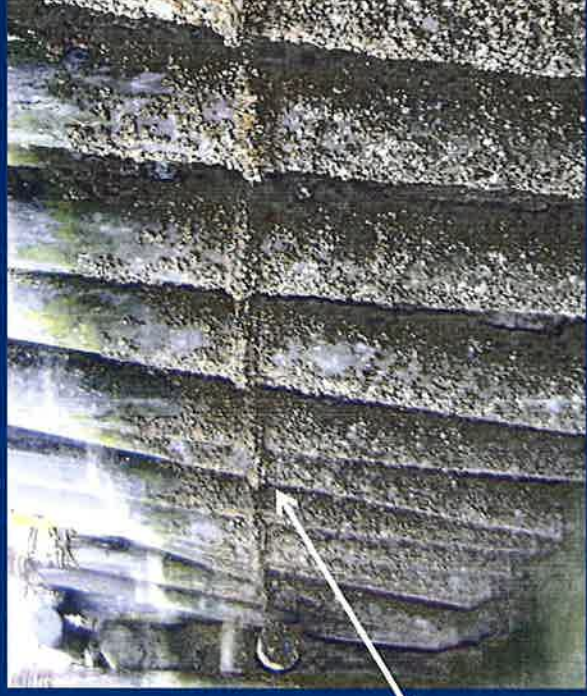
Intermediate Cables

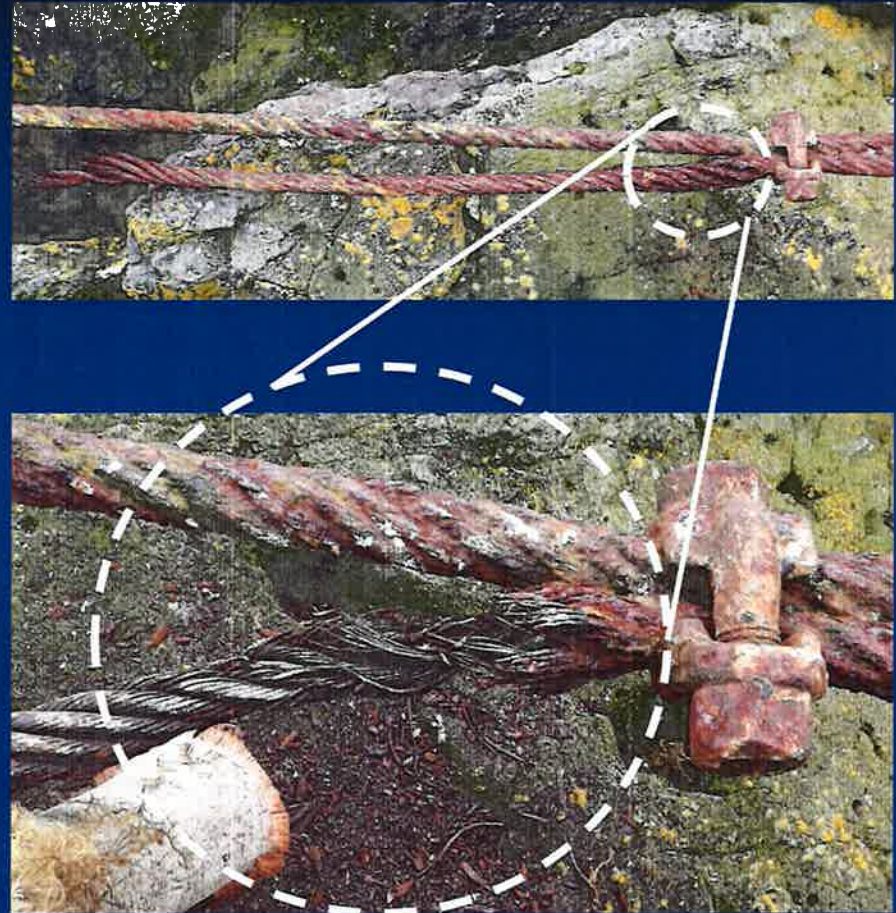
- Level of Deterioration Difficult to Determine Visually
- Caked on Rust
- Cable End Examined, Estimated $<10\%$ Capacity Remaining
- Cable Beyond Useful Service Life

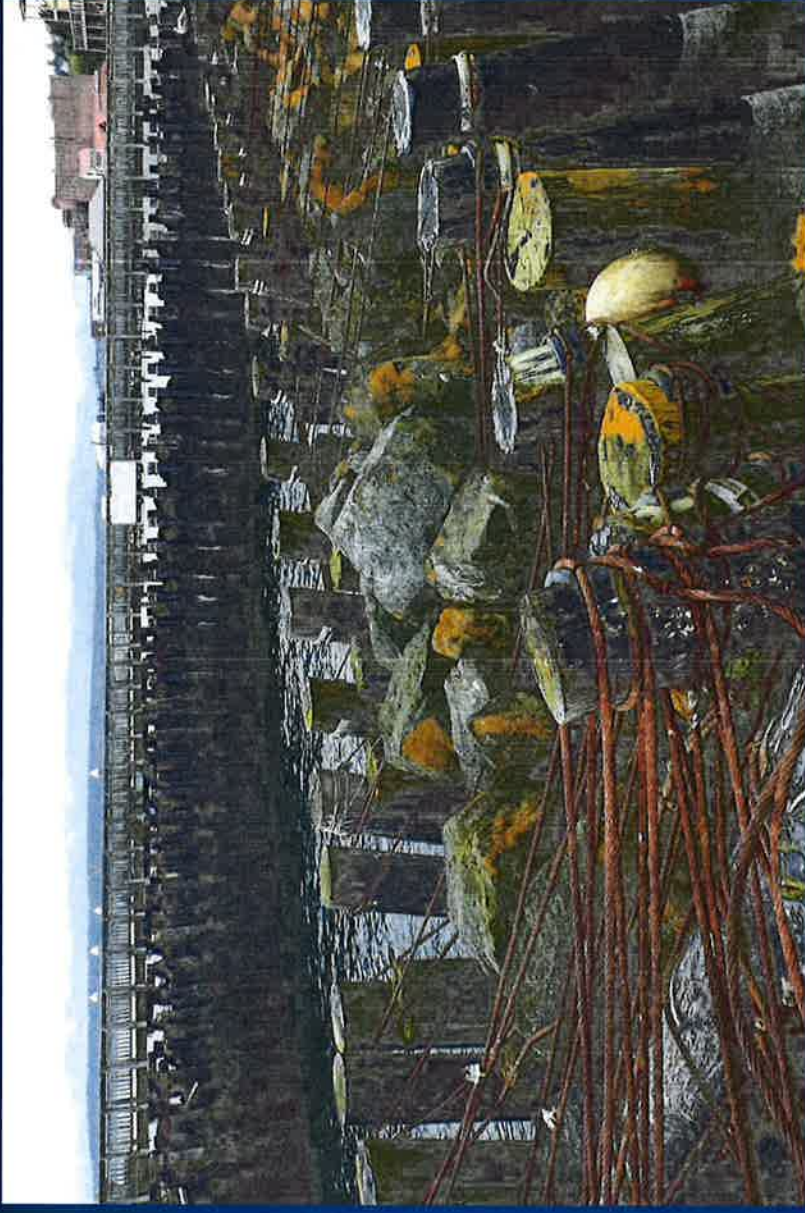
- Supplementary Armor Piled on Cables – Potentially Causing Damage

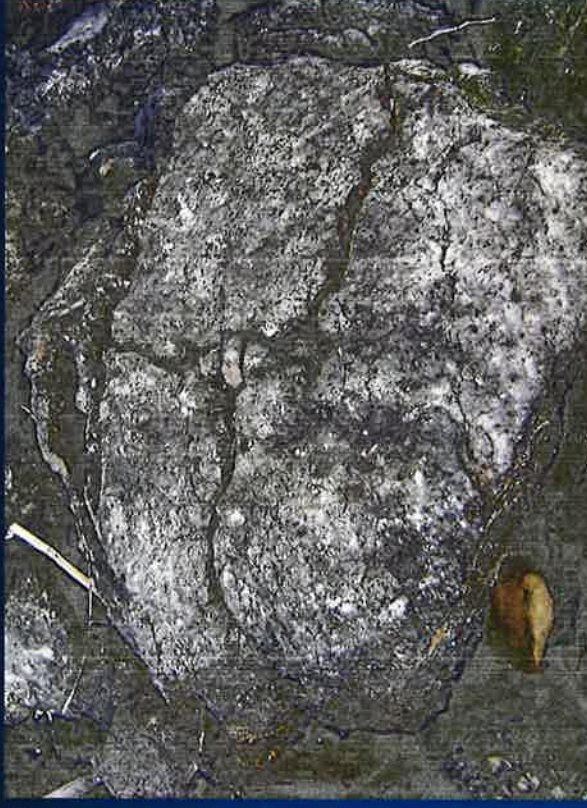
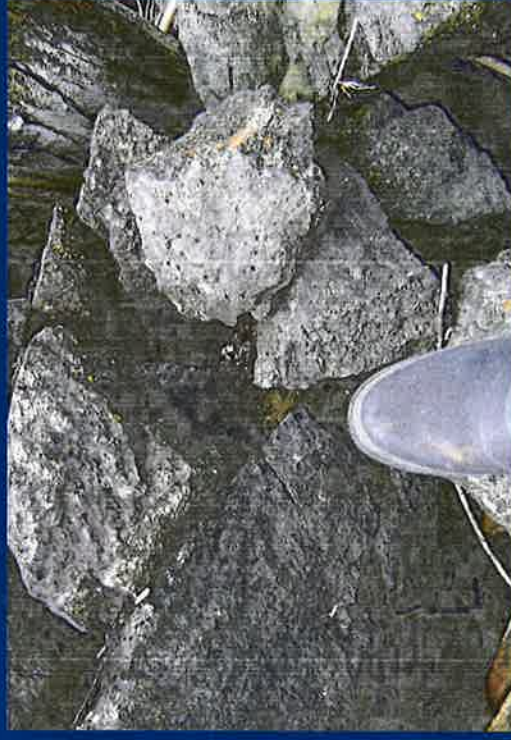
- Appears to be Matts Matts Sourced Marine Basalt – Low Quality Stone
- Highly Fractured
- >50% of Stone in Deteriorated to Highly Deteriorated State

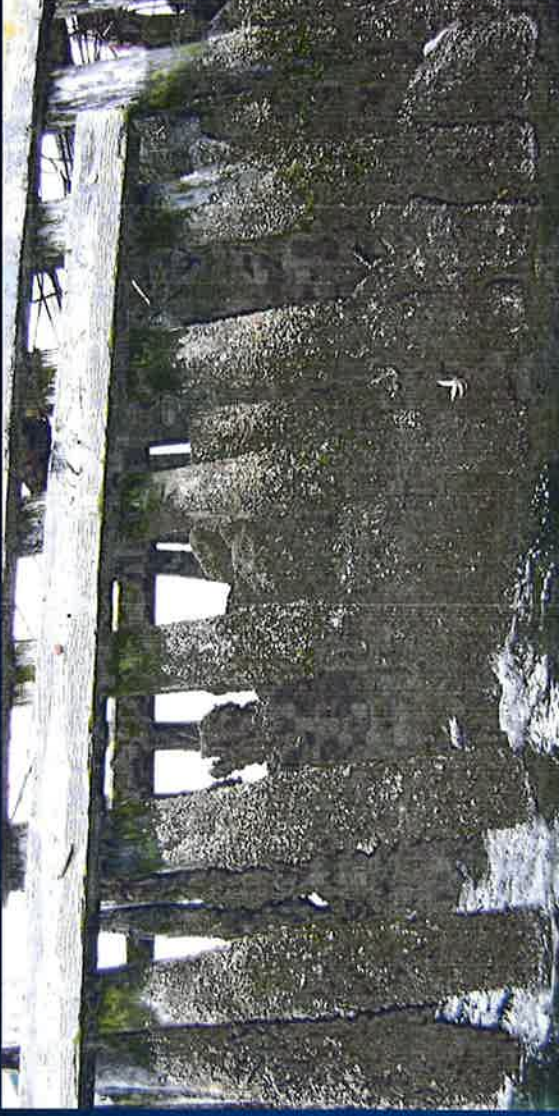
- Armor Rock Spalls to 12" x 12" x 8" Pieces, Which are Being Pulled From Between Piles by Wave Action
- Loss of Water Results in Decreased Confinement of Armor Rock

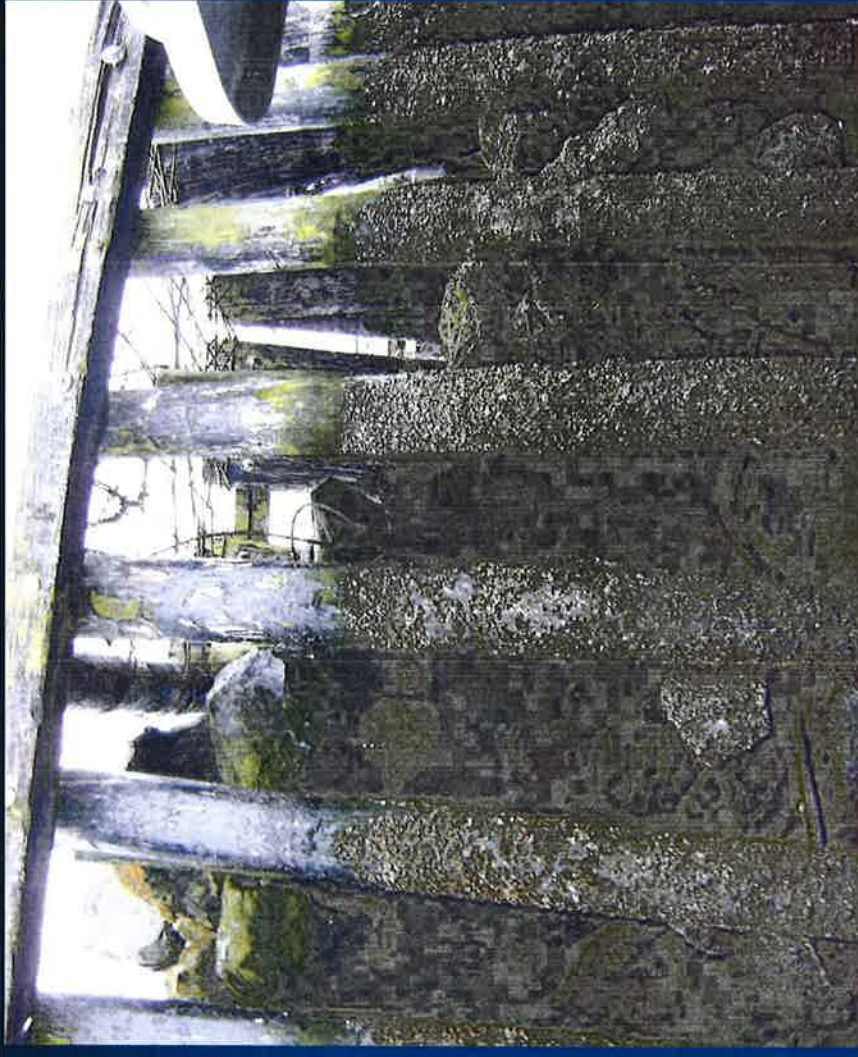
- Substantial Armor Rock Loss at Breakwater Ends – Approx. 6' Height of Material Lost
- 10% to 15% Voids in Face Stone in Contact With Vert. Pile
- Armor Rock Beyond Useful Service Life

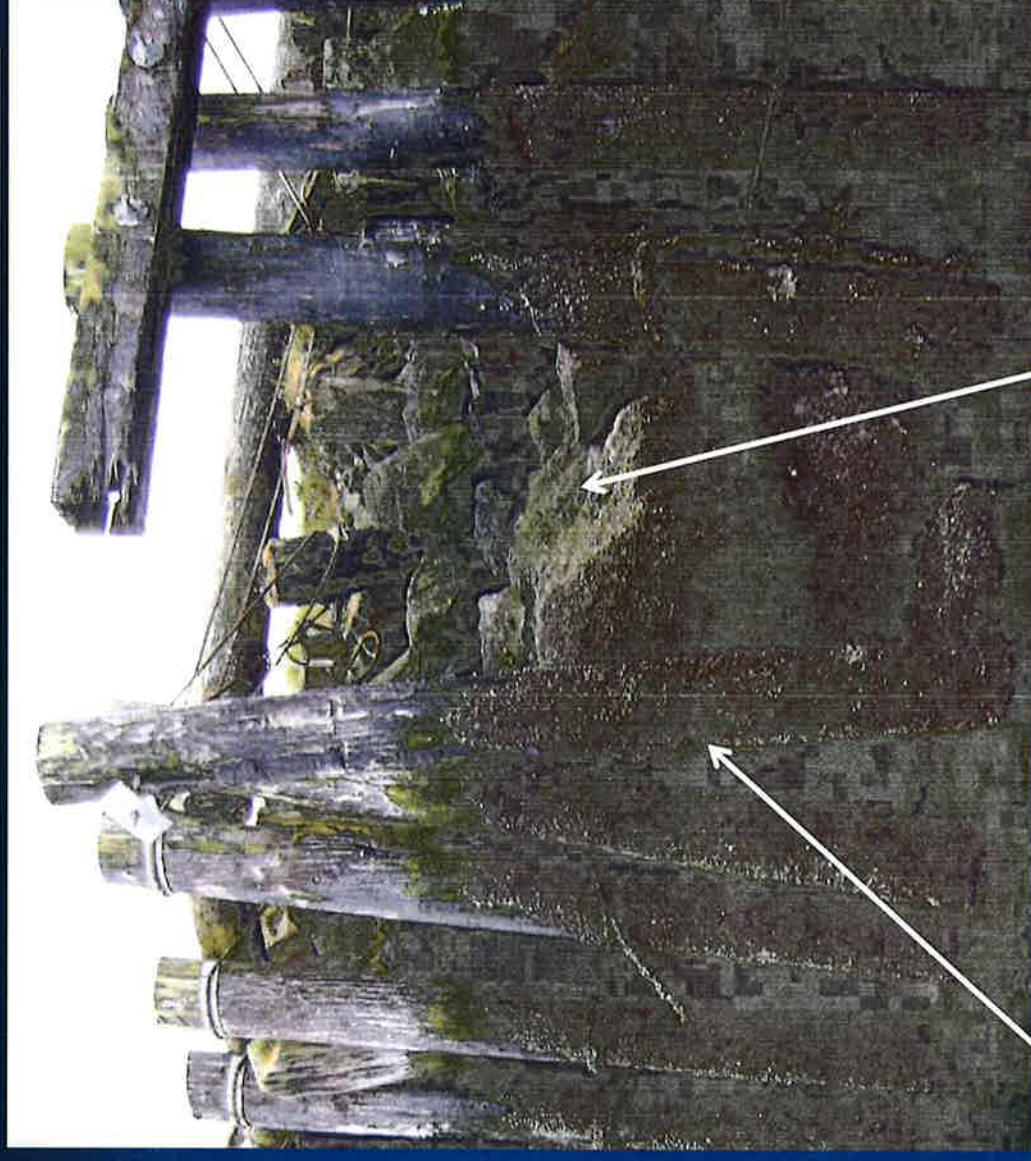
- Barge Impact Shows Consequences of Lost Pile: Armor Rock Falling Through Hole Created by Pile Failure

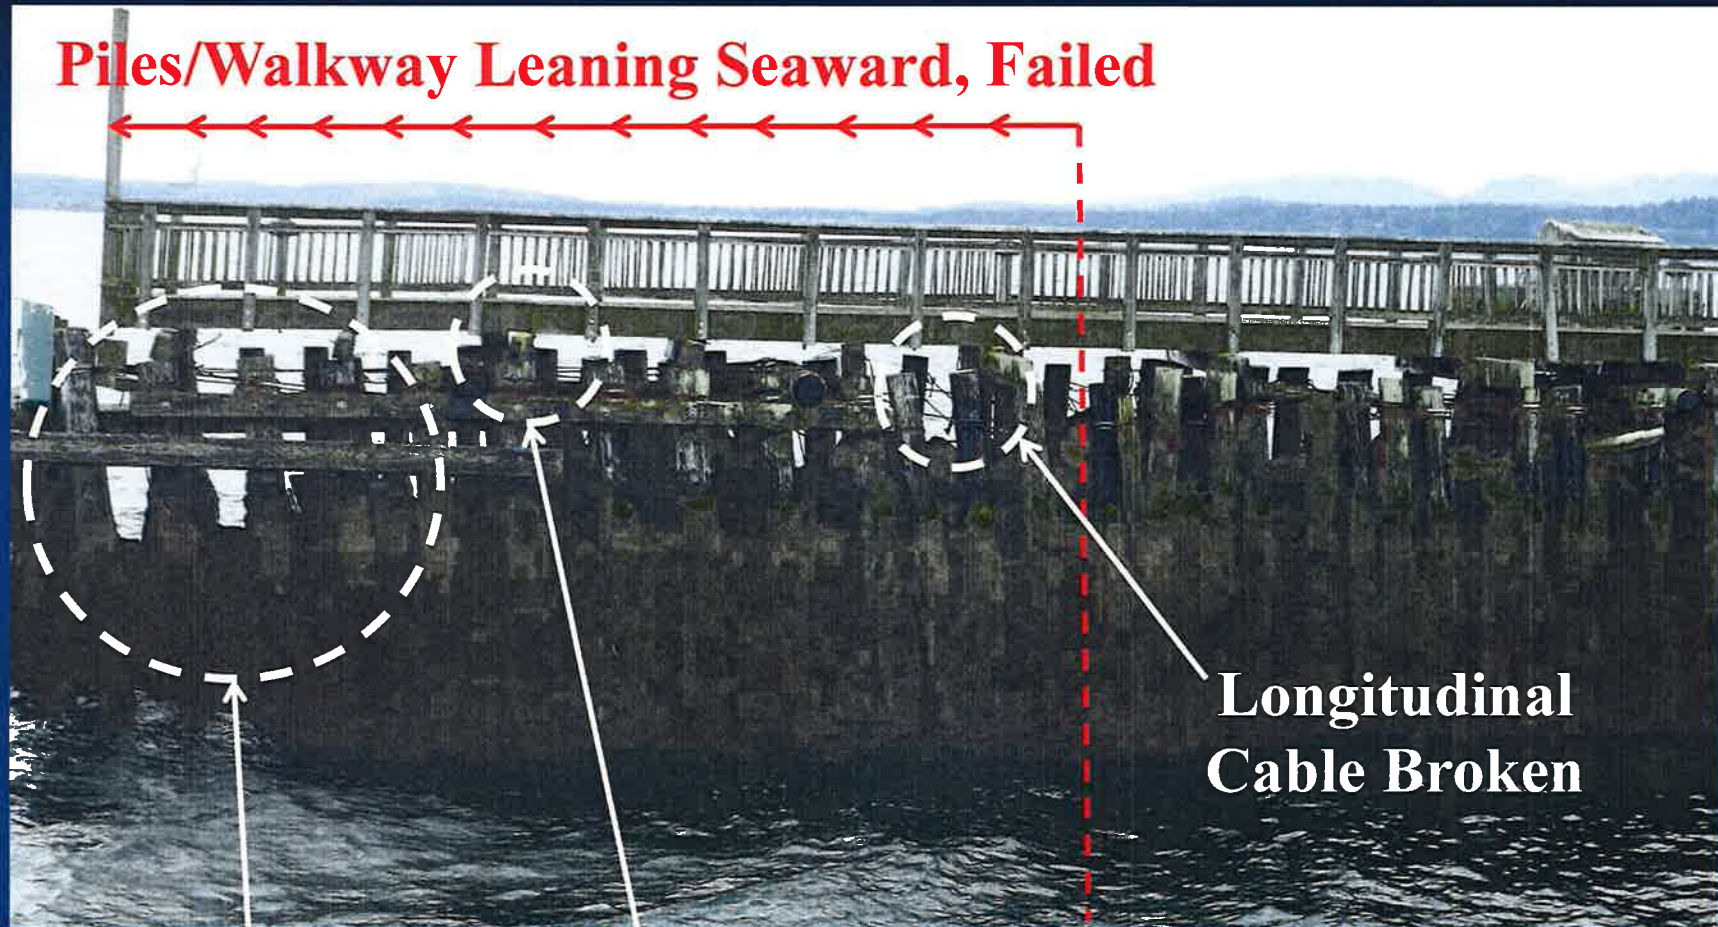
Lost Stone

**Stringer Nearly
Unseated, Pile
Cap Rotated**

**Longitudinal
Cable Broken**

- Breakwater End Under Walkway Failing – Maintenance Staff Needs to Closely Monitor Condition.
- Further Failure/Shifting May be Grounds For Closure of Approx. 60' End Portion.
- Port Maintenance to Monitor Pile Caps, Stringer Splices for any Change in Condition.

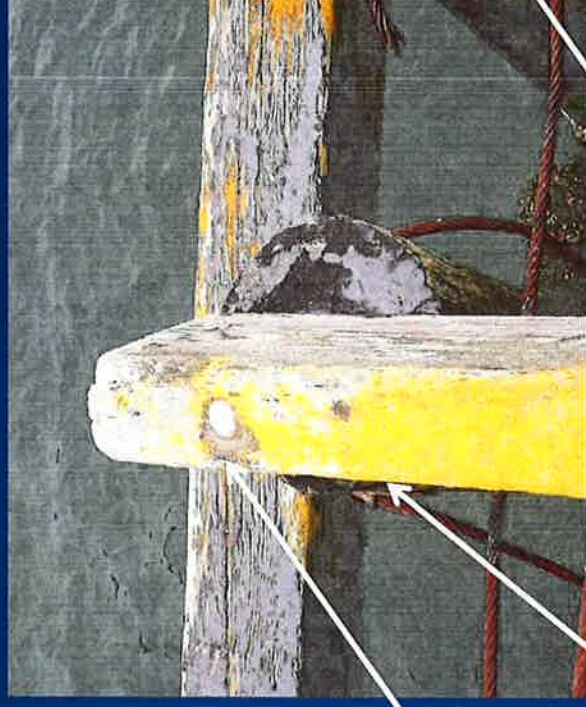
**Bent Shear
Pin**

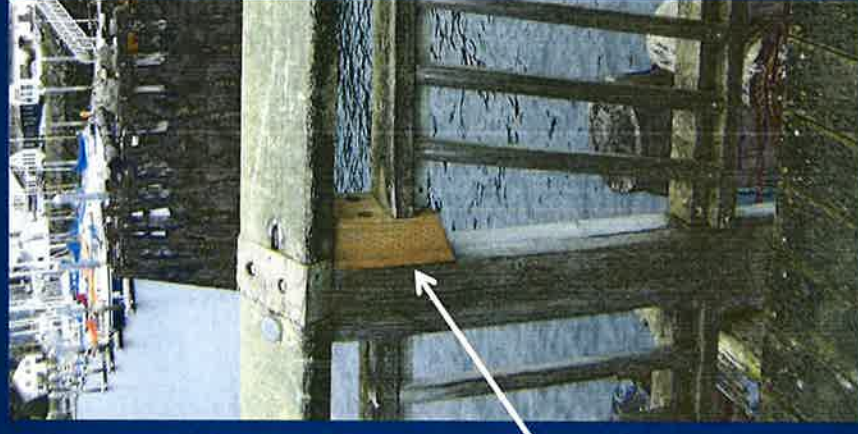
**Rail Recently
Modified for Lean**
