Point Hudson

Breakwater Improvement Project Update

Public Meeting June 9, 2021

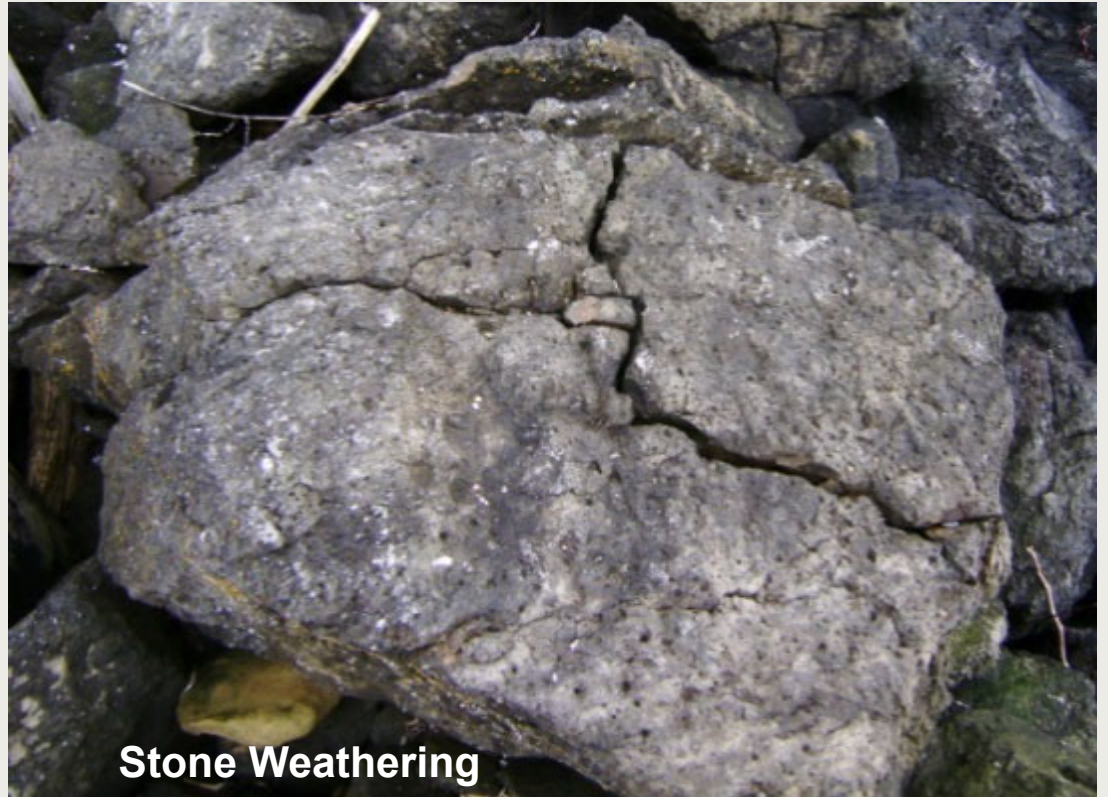
Existing Condition

Timber piles, walers, cable tiebacks, and armor rock are at or beyond useful life. Stability of the overall structural system is compromised.

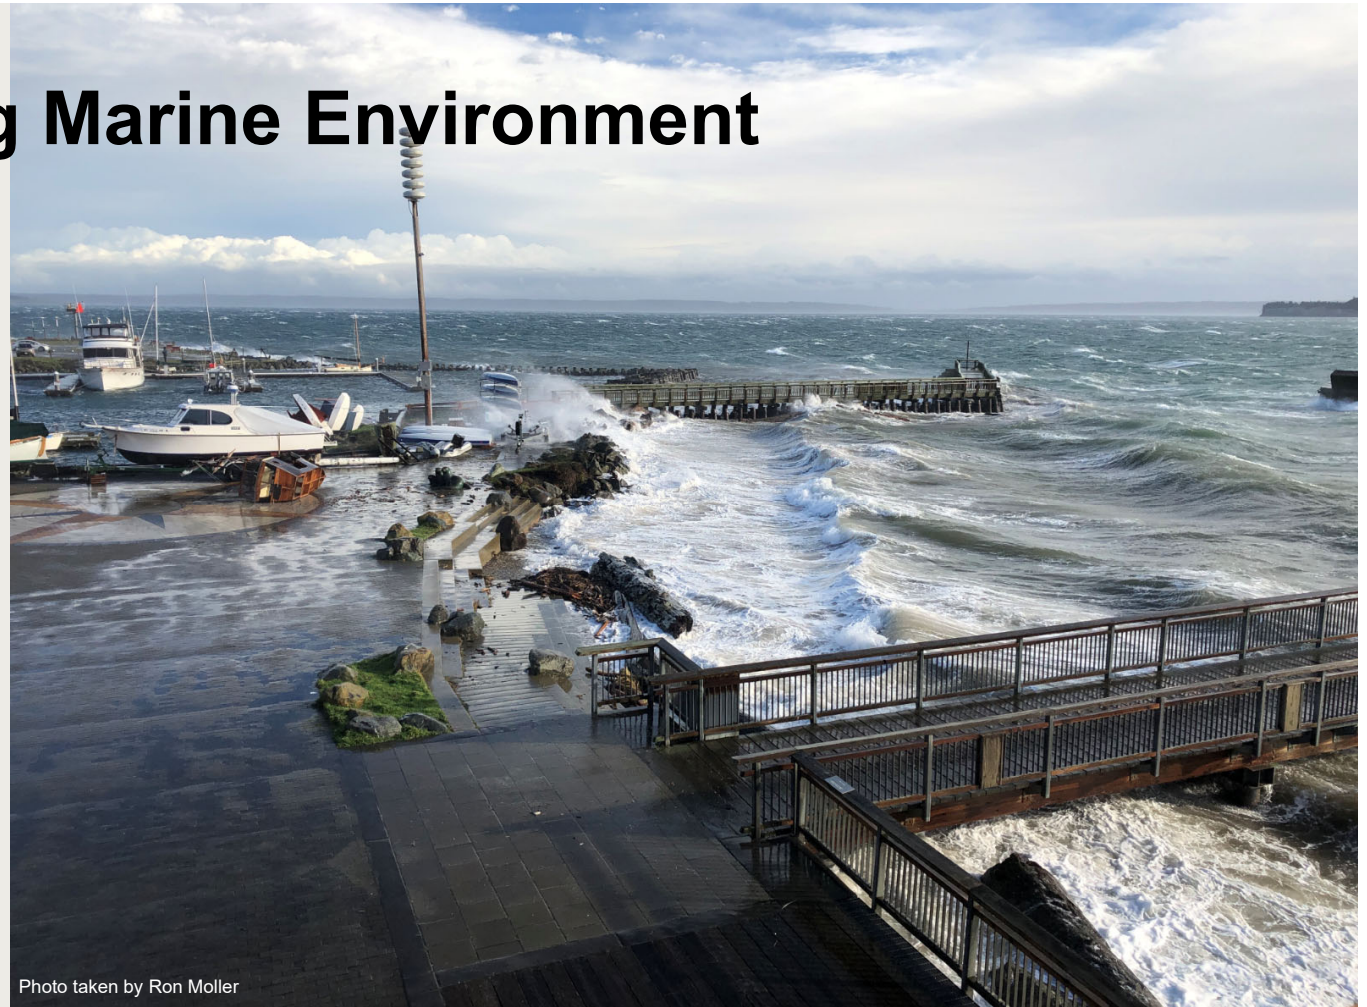
- A 2018 storm damaged the breakwaters, breaking pile tops, severing cable ties and further eroding the armor rock core

A December 2018 storm sweeps over the jetties and into the Point Hudson Marina.
