March 9, 2022

Port of Port Townsend
ATTN: Eron Berg
Executive Director
2710 Jefferson St.
Port Townsend, WA 98368

Re: Poplar Trees - Sims Way, Port of Port Townsend

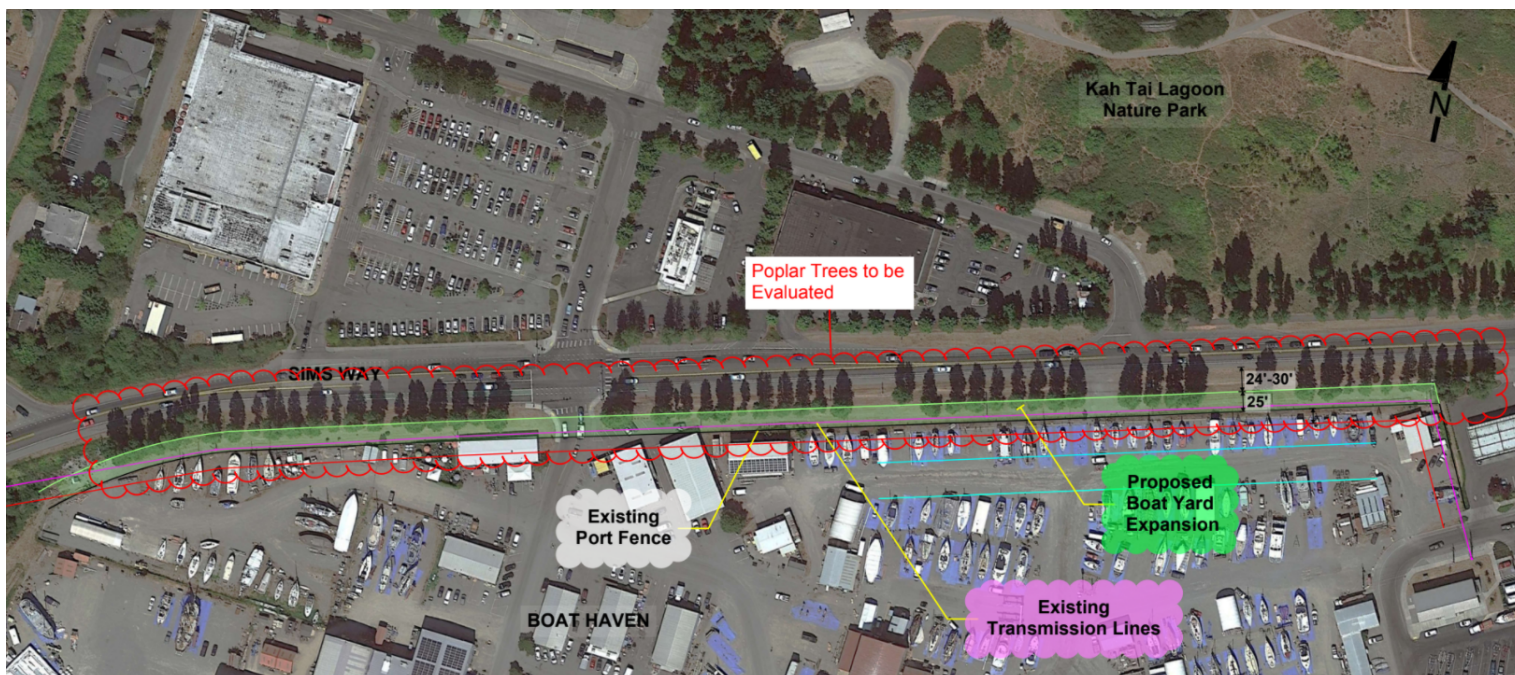
Map 1

During this meeting we discussed the desire by PUD to underground transmission lines that currently stand south of the row of trees, and the desire of the Port to expand their boatyard property north to incorporate currently undeveloped land south of the trees. These areas and the trees are shown in Map 1.
