PORT OF PORT TOWNSEND

Point Hudson Marina Entrance Breakwater Feasibility Assessment

May 28, 2014

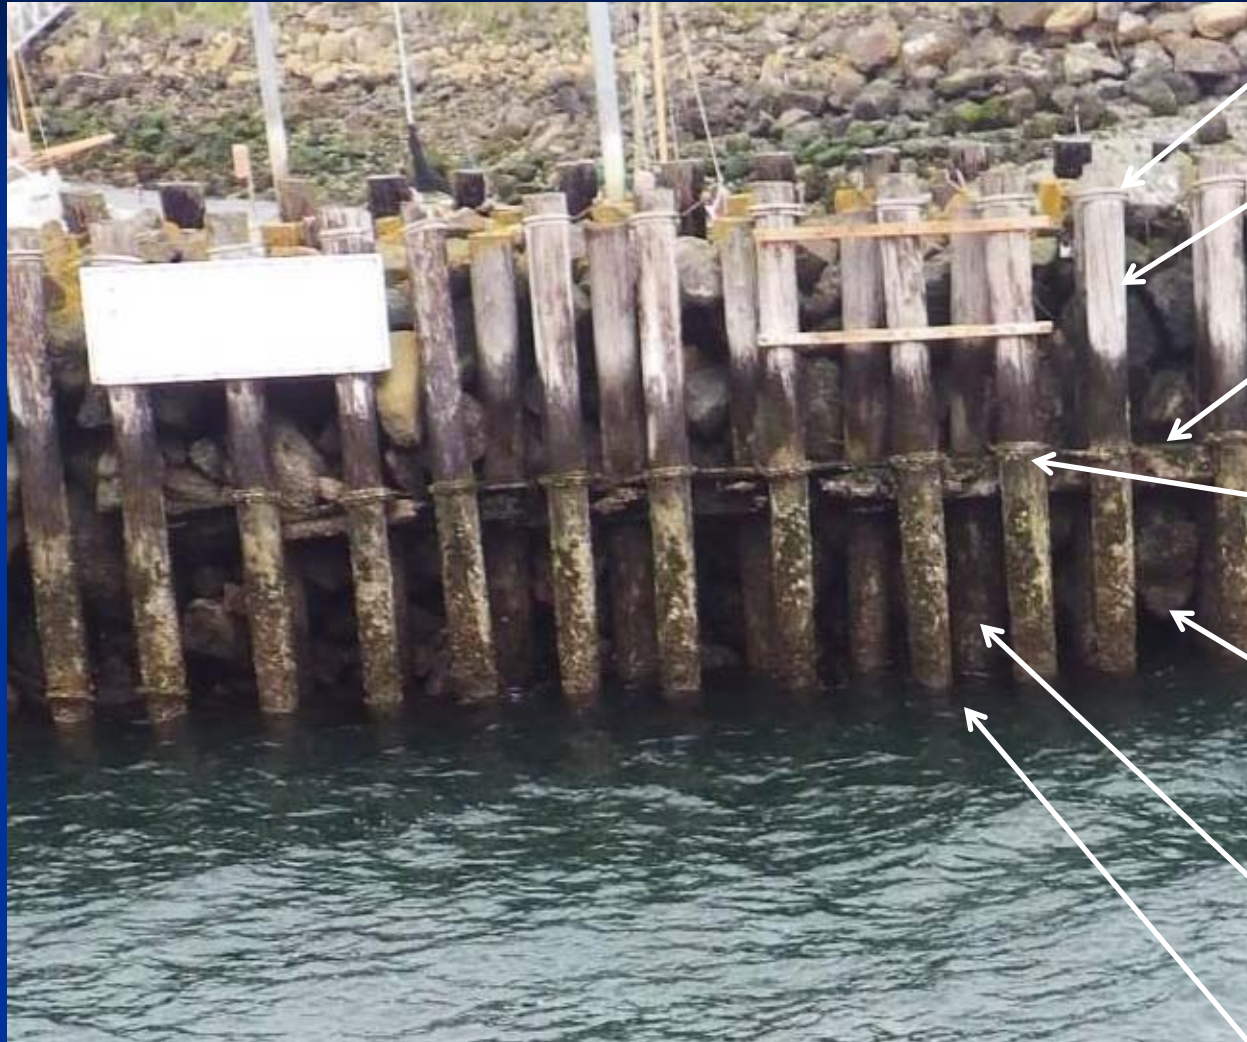
Note: >75% Inner Piles (1935) Observed to be Highly Deteriorated, Not Contributing to Structural Stability. Assessment Focused on Outer Piles.

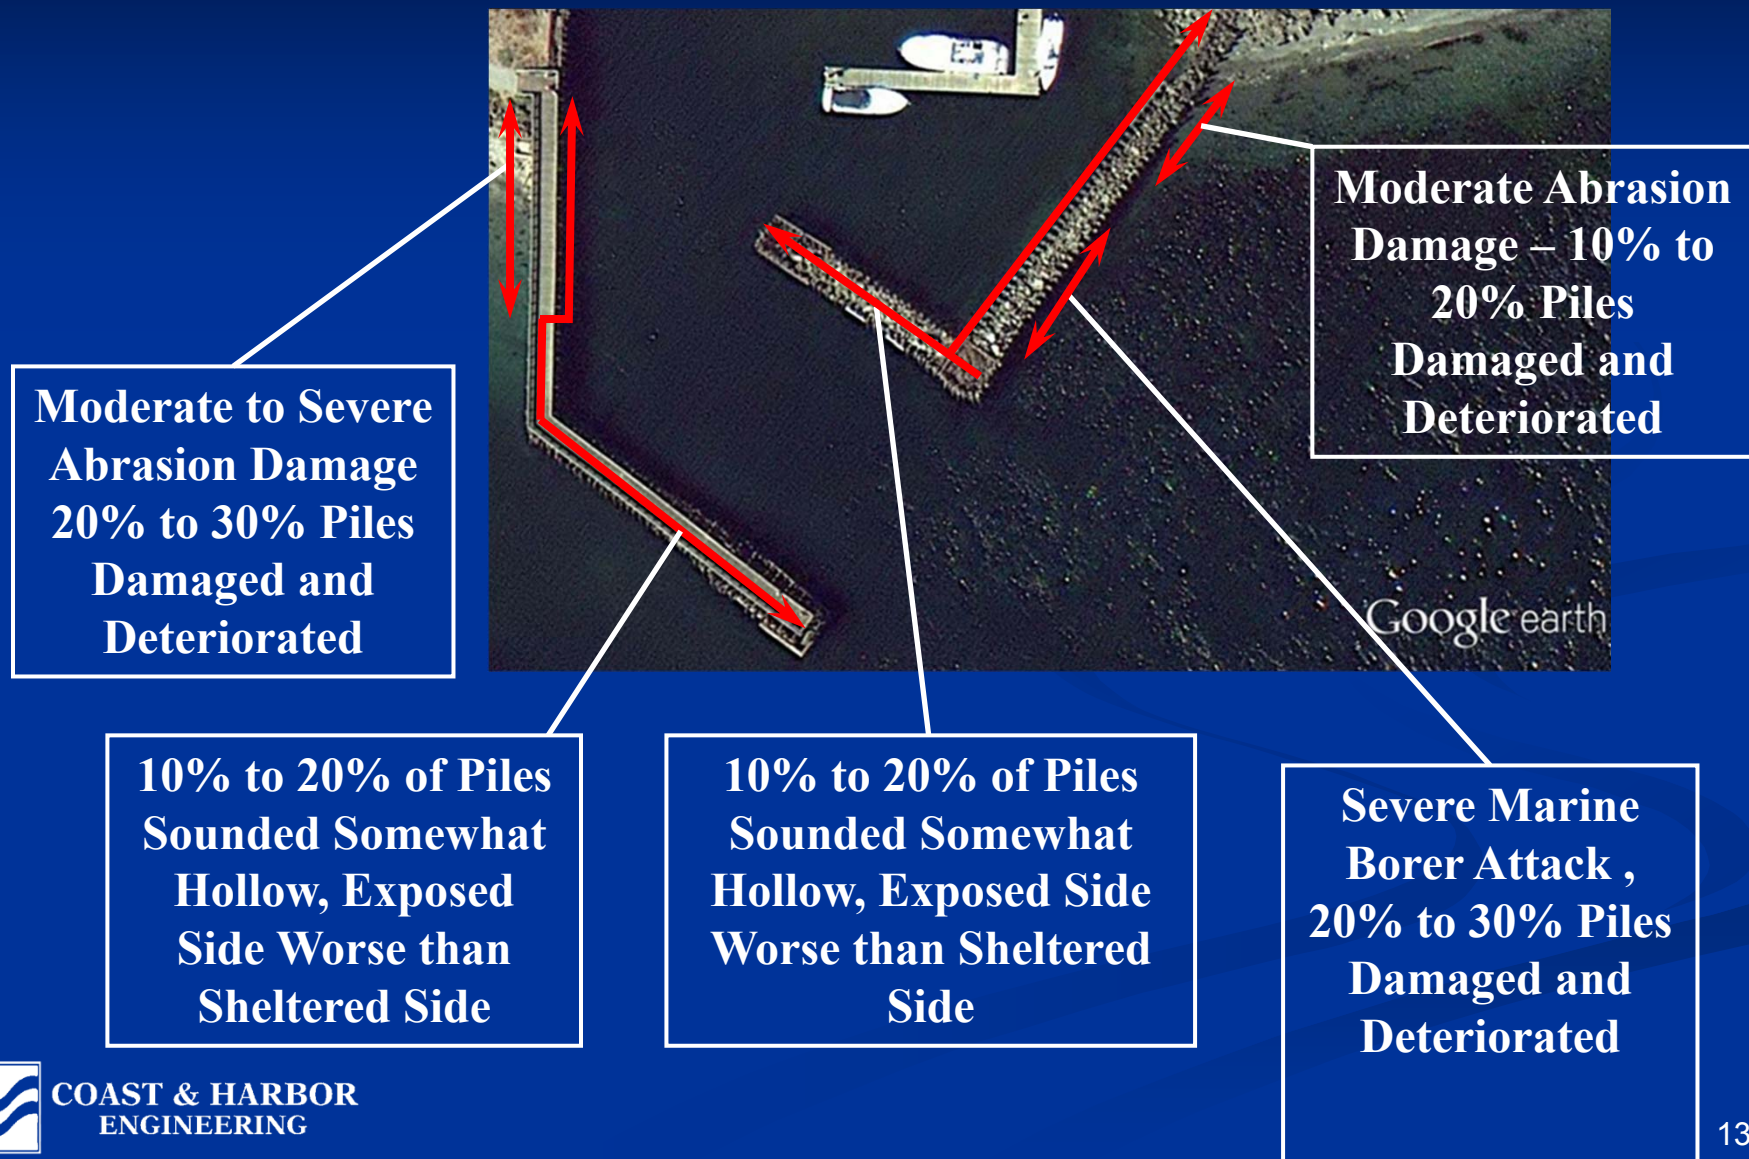
- Varying Levels of Deterioration Depending on Exposure, Damage
- Likely Shallow Embedment – Highly Compacted Sand Layer 0.8ft to 2ft Below Mudline (Landau Biological Assessment/Evaluation, September 2005)
- Piles Beyond Useful Service Life

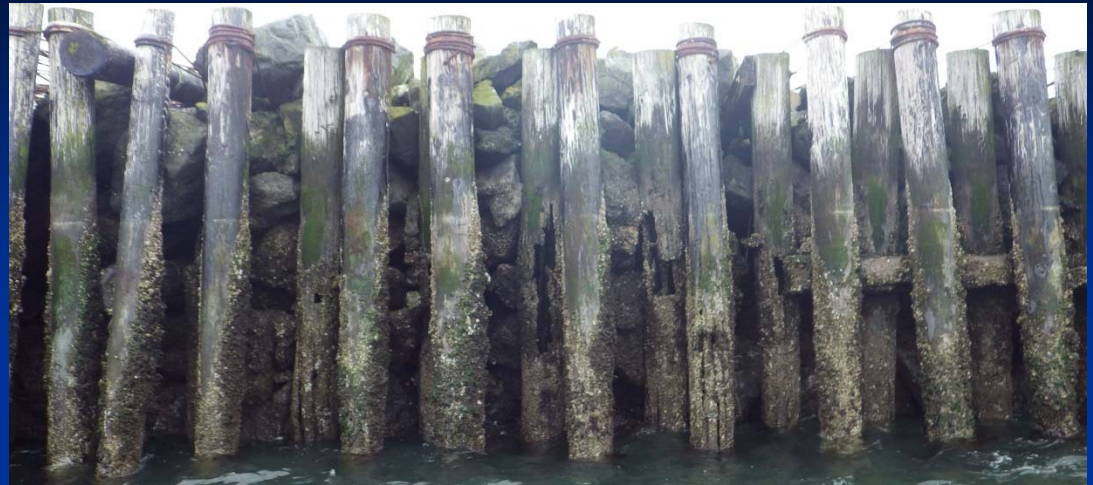
Piles in Poor Condition

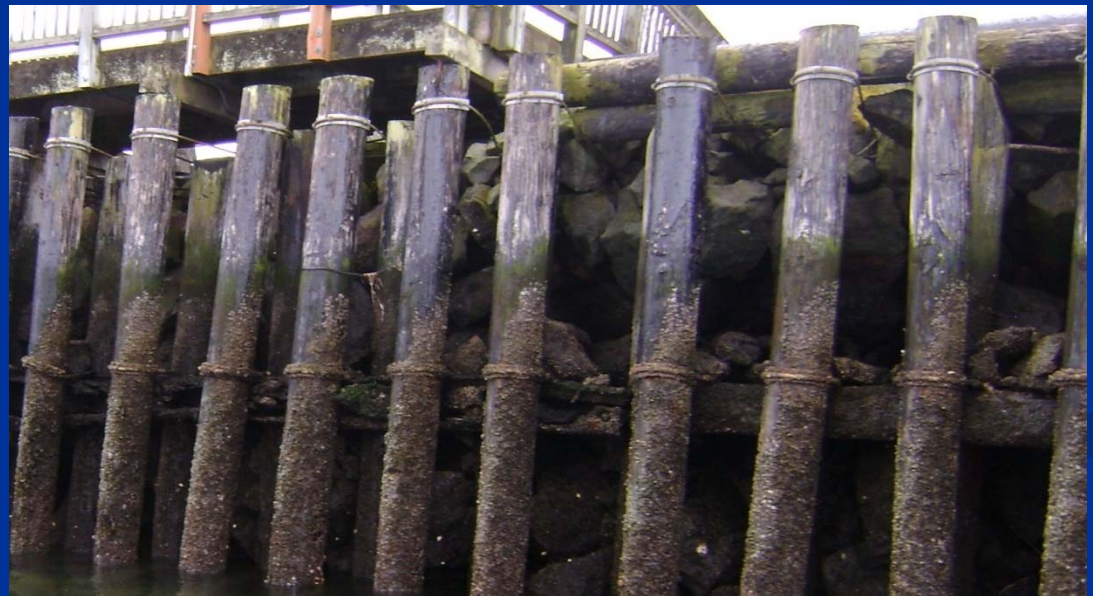
Piles in Fair Condition

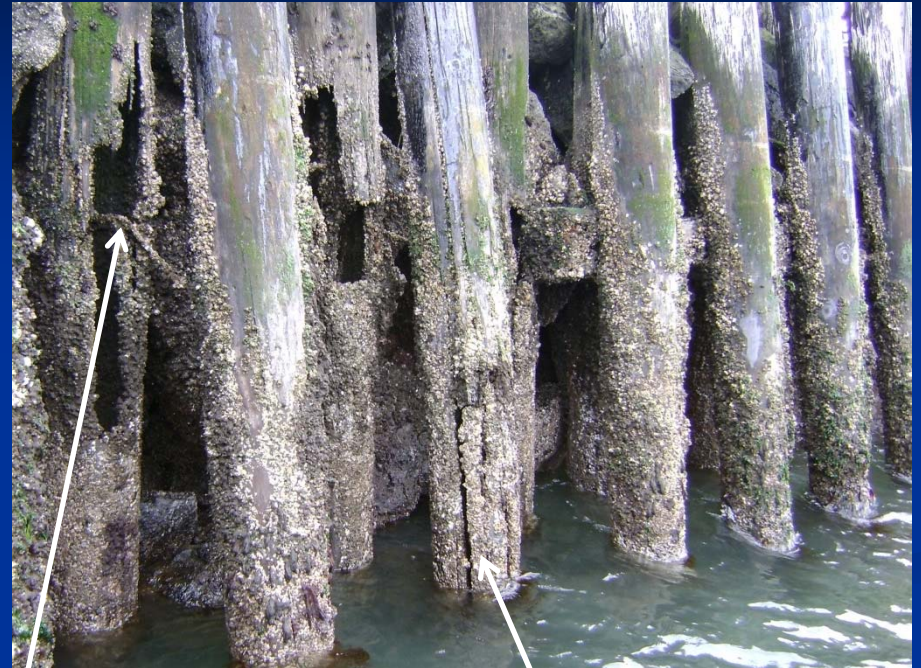
- Marine Borer Attack
- Varying Levels of Deterioration
- Decay Where Creosote Treatment Penetrated by Bolts, Thru Rods

**Inner Pile
(1934) :
Decay at
Penetration**

**Outer Pile
(1969):
Marine
Borer
Attack**

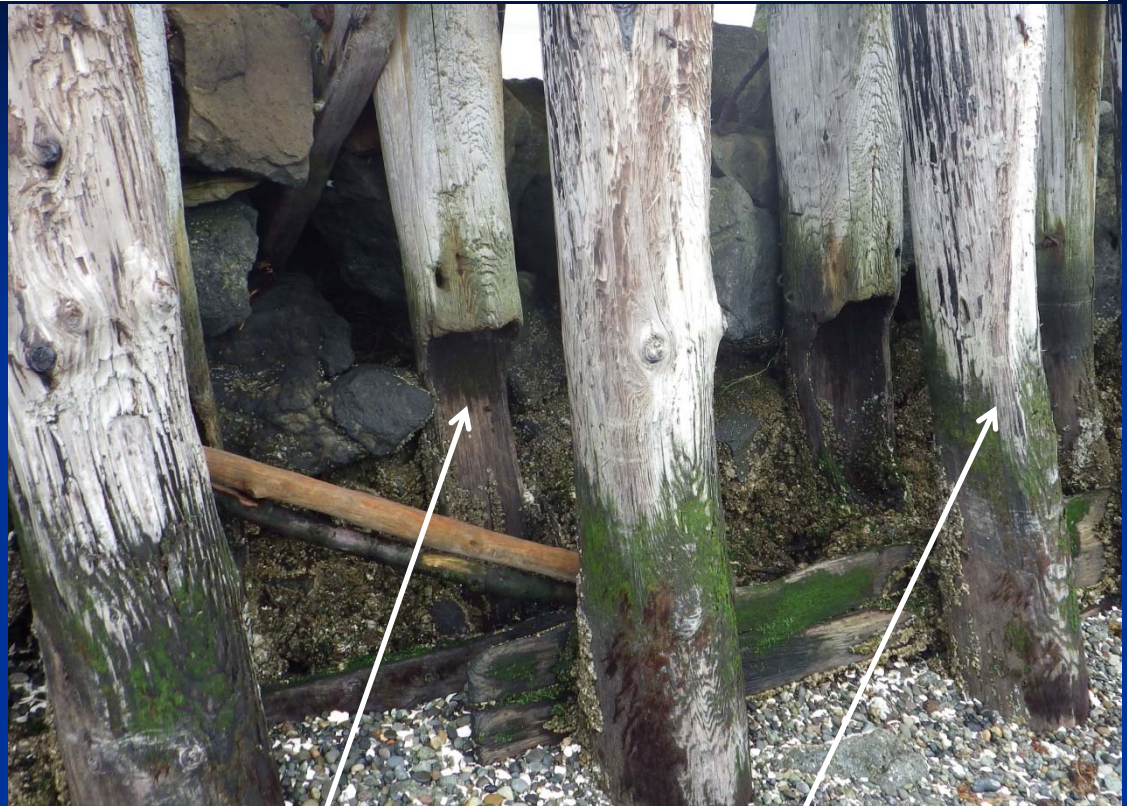
- Abrasion
Penetrated
Creosote
Protective
Treatment,
Subsequent
Decay/Marine
Borer Attack

**Inner Pile
(1934)
Abraded &
Decayed**

**Outer Pile (1969)
Abraded, Decaying
(Hollow Sounding)**

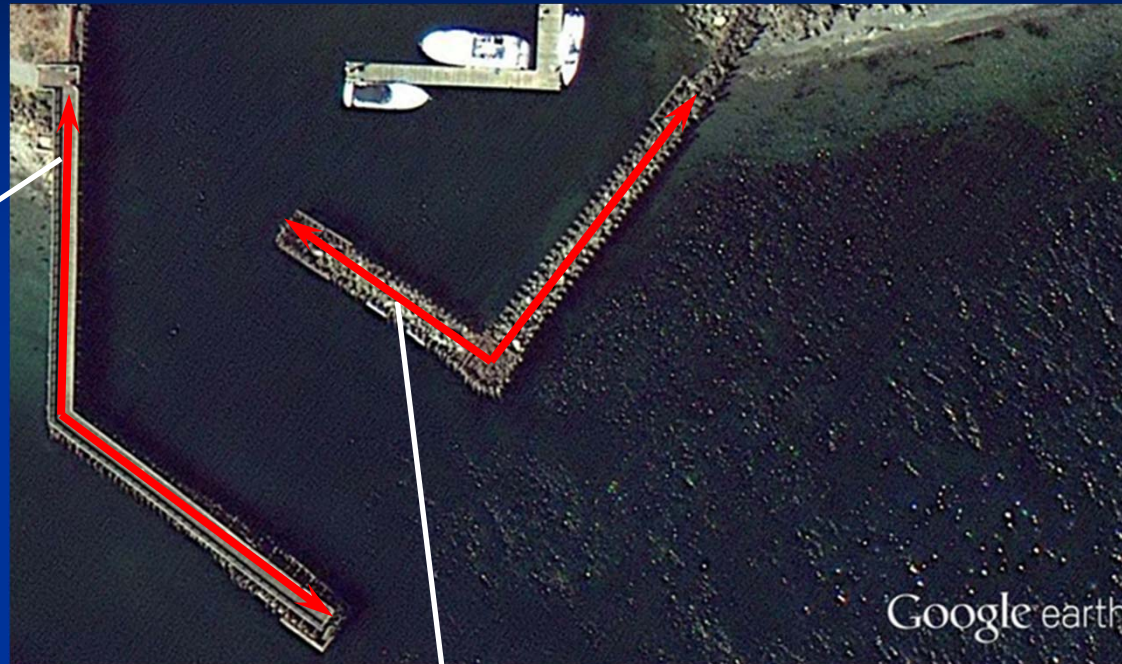
**Walers Completely
Deteriorated –
Minimal Load
Carrying Capacity**

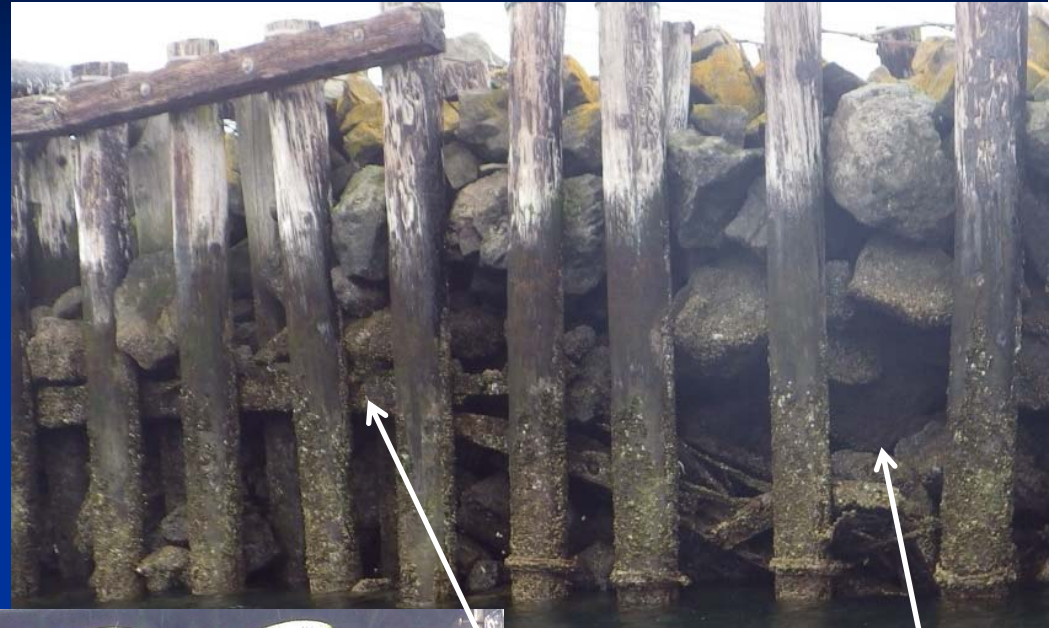
- Highly Deteriorated – Minimal Capacity
- Minimal Contribution to Structure Stability – Decreased System Capacity
- Loss of Stone Confinement
- Walers Beyond Useful Service Life

**Deteriorated
Waler**

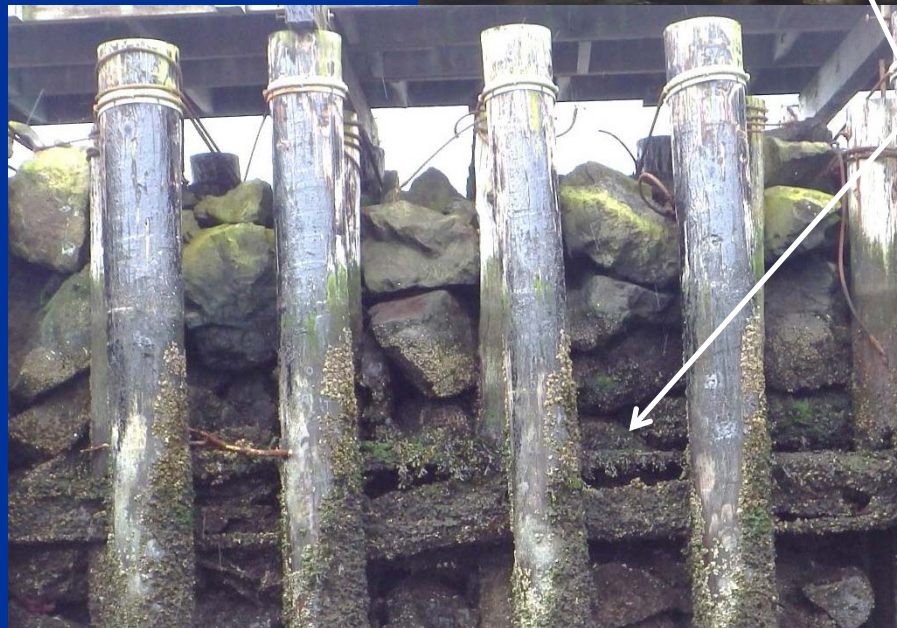
**Loss of
Armor Rock**

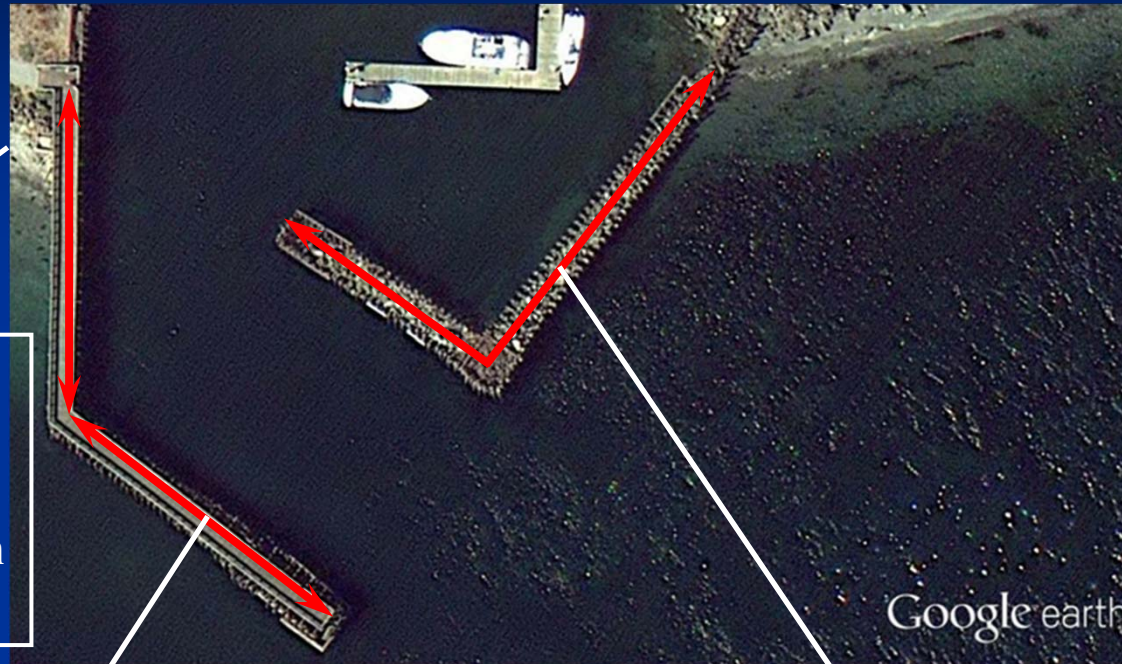
**10% Cables Severed,
Remainder
Deteriorated, Areas
Exposed to Wave Splash
Worst**

**10% to 20% of Cables
Severed, Remainder
Deteriorated, or
Highly Deteriorated**

**5% to 10% of
Cables Severed,
Remainder
Deteriorated**

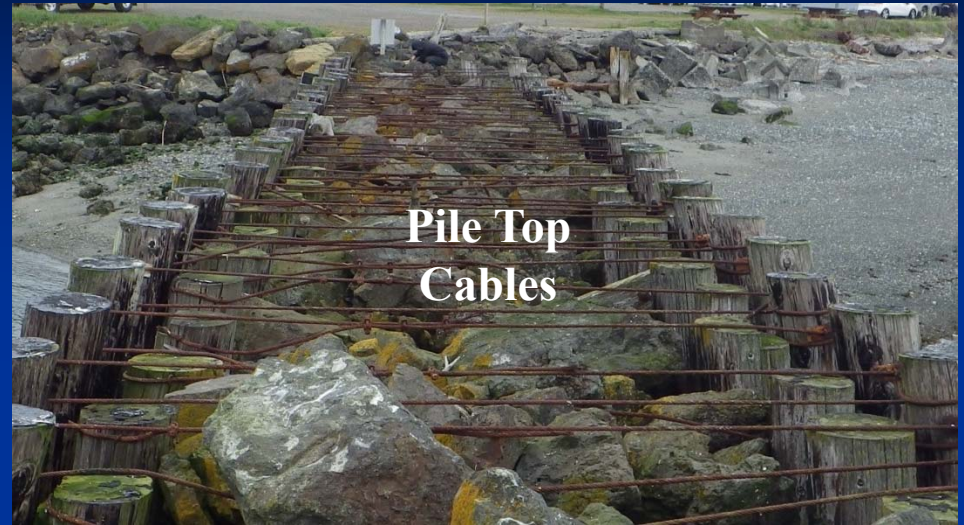
Pile Top
Cables

- Pile Top – Cables Wrapped Around Pile Tops to Provided Lateral Support
- Intermediate – Cables Wrapped Between New and Old Piling – 90%+ Missing, Remainder Highly Deteriorated

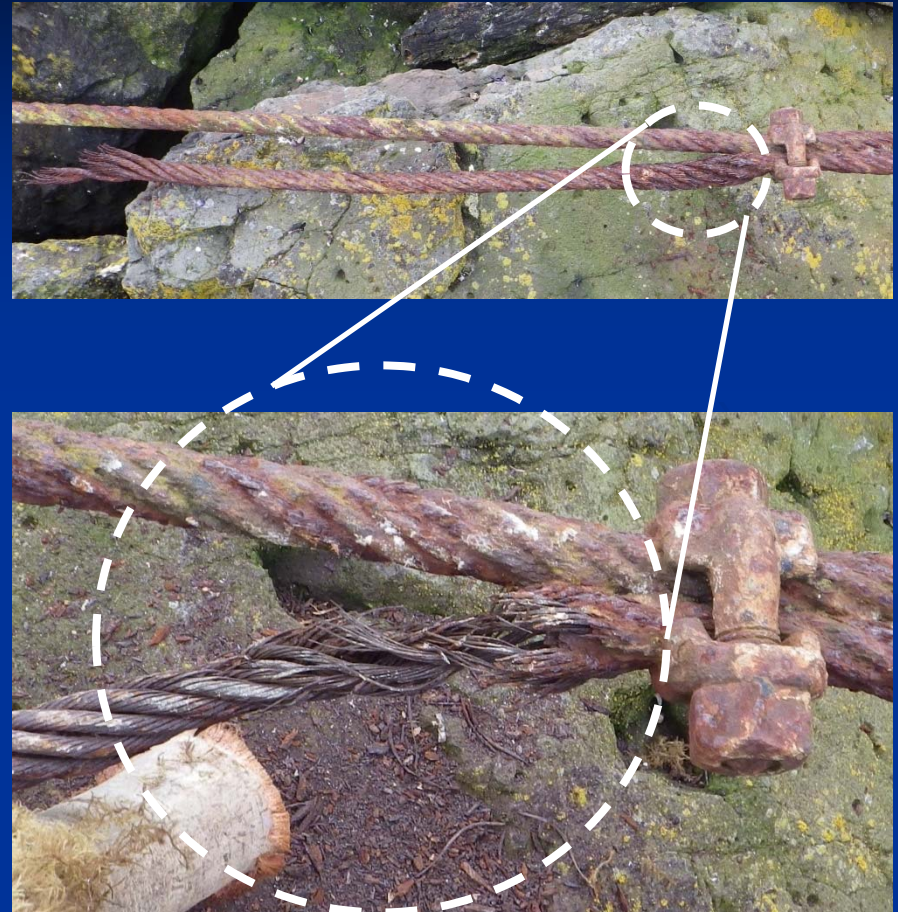
- Level of Deterioration Difficult to Determine Visually
- Caked on Rust
- Cable End Examined, Estimated $<10\%$ Capacity Remaining
- Cable Beyond Useful Service Life

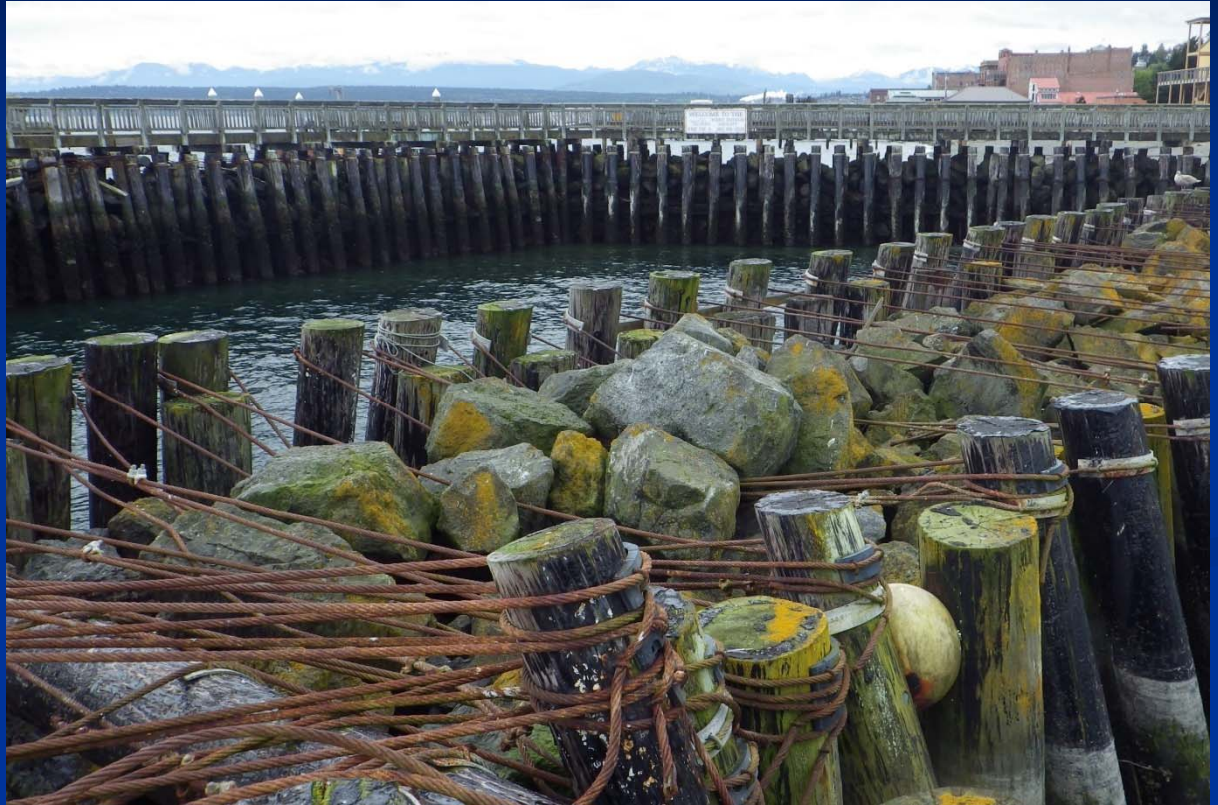
- Supplementary Armor Piled on Cables – Potentially Causing Damage

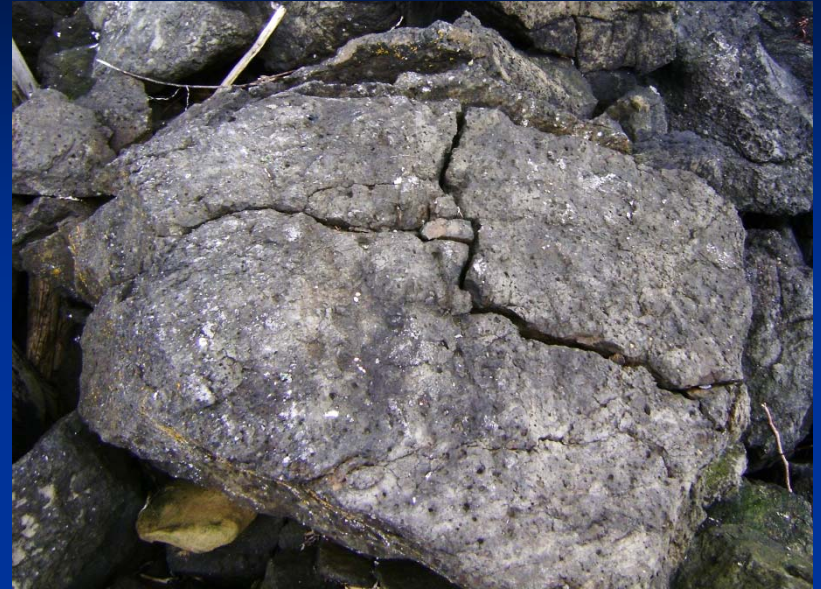
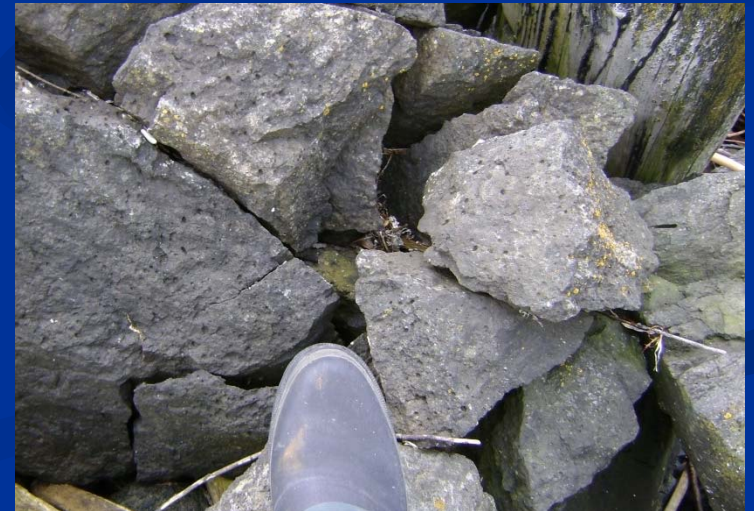
- Appears to be Matts Matts Sourced Marine Basalt – Low Quality Stone
- Highly Fractured
- >50% of Stone in Deteriorated to Highly Deteriorated State

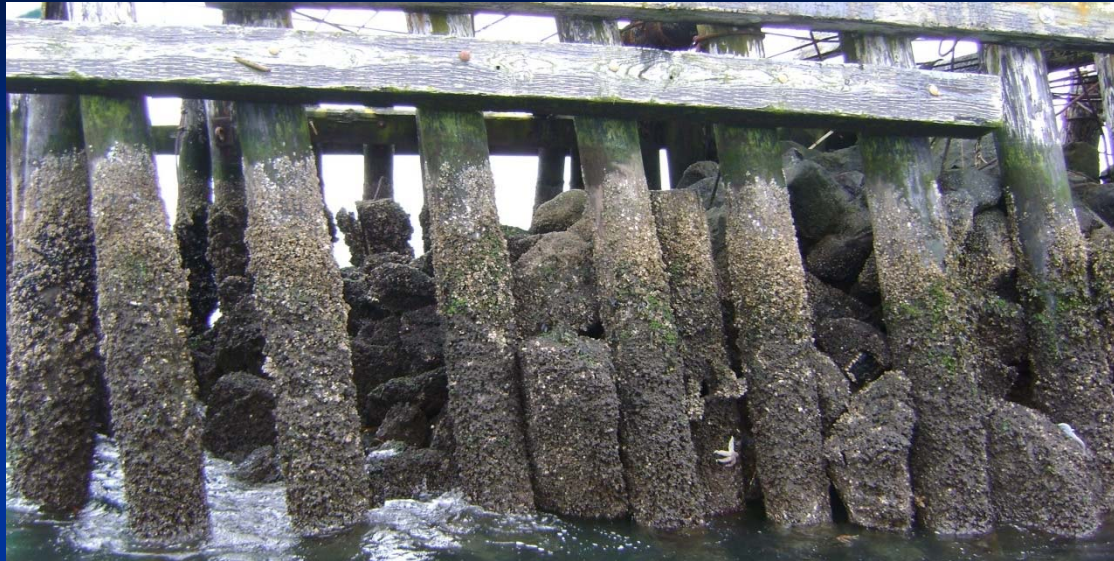
- Armor Rock Spalls to 12" x 12" x 8" Pieces, Which are Being Pulled From Between Piles by Wave Action
- Loss of Waler Results in Decreased Confinement of Armor Rock

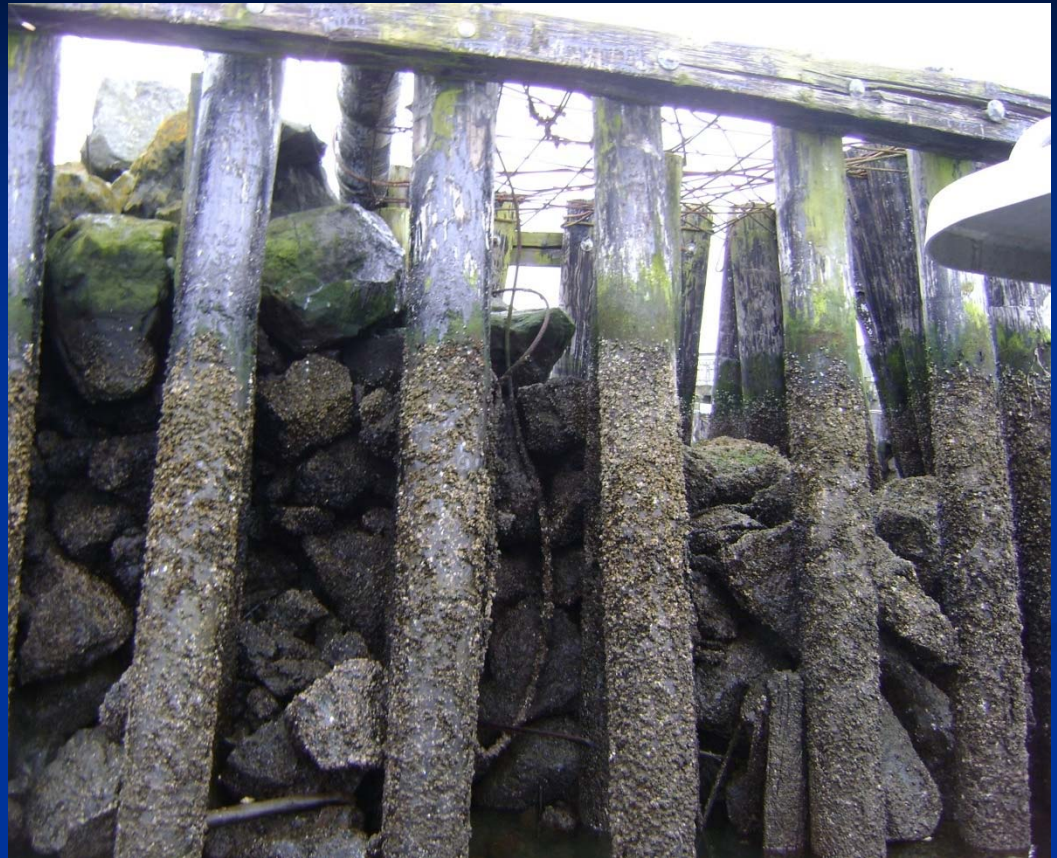
- Substantial Armor Rock Loss at Venerable Breakwater Ends – Approx. 6' Height of Material Lost
- 10% to 15% Voids in Face Stone in Contact With Vert. Pile
- Armor Rock Beyond Useful Service Life

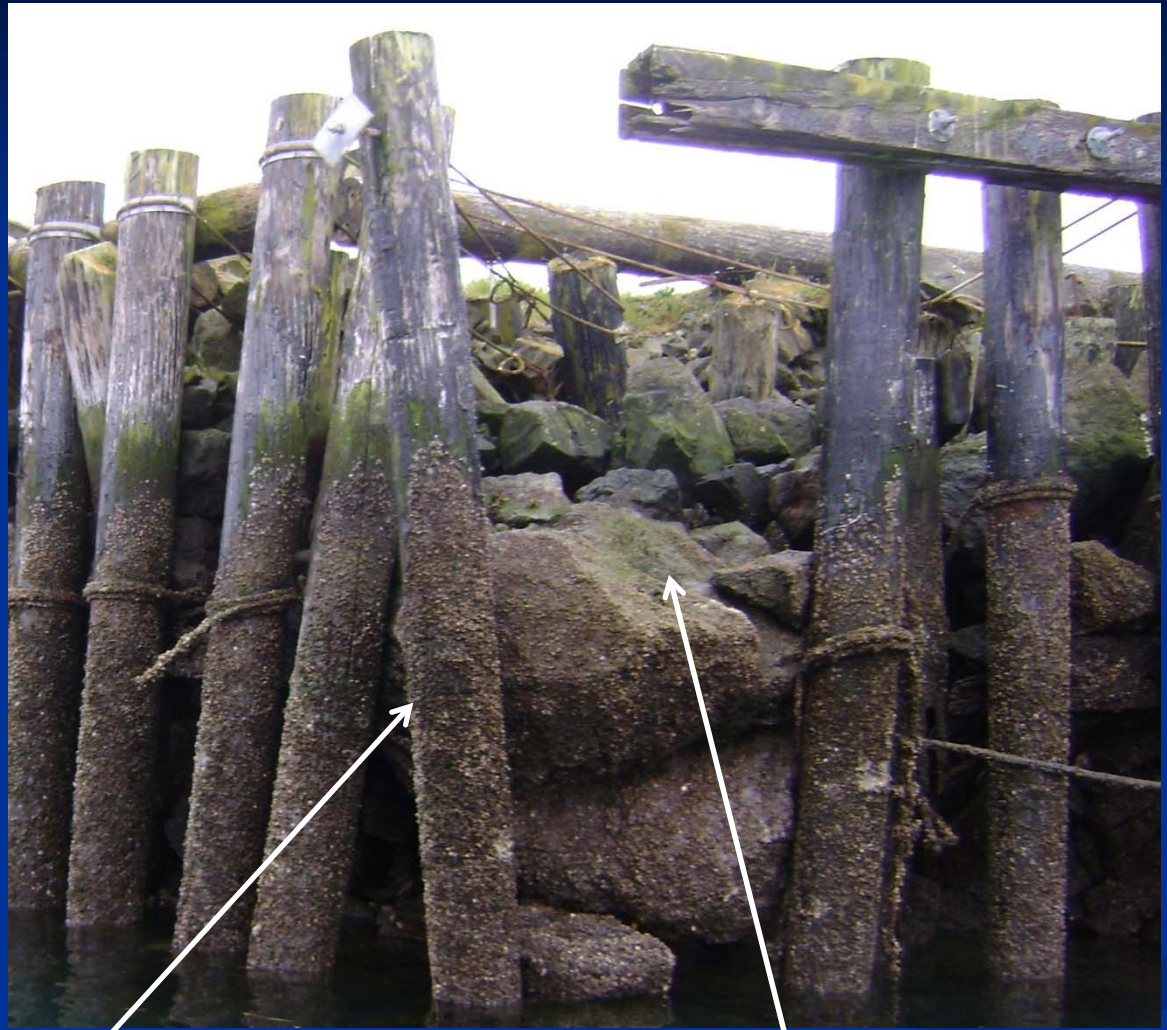
- Barge Impact Shows Consequences of Lost Pile: Armor Rock Falling Through Hole Gap in Piles Created by Pile Failure

Impact-Damaged Pile

Loss of Armor Rock

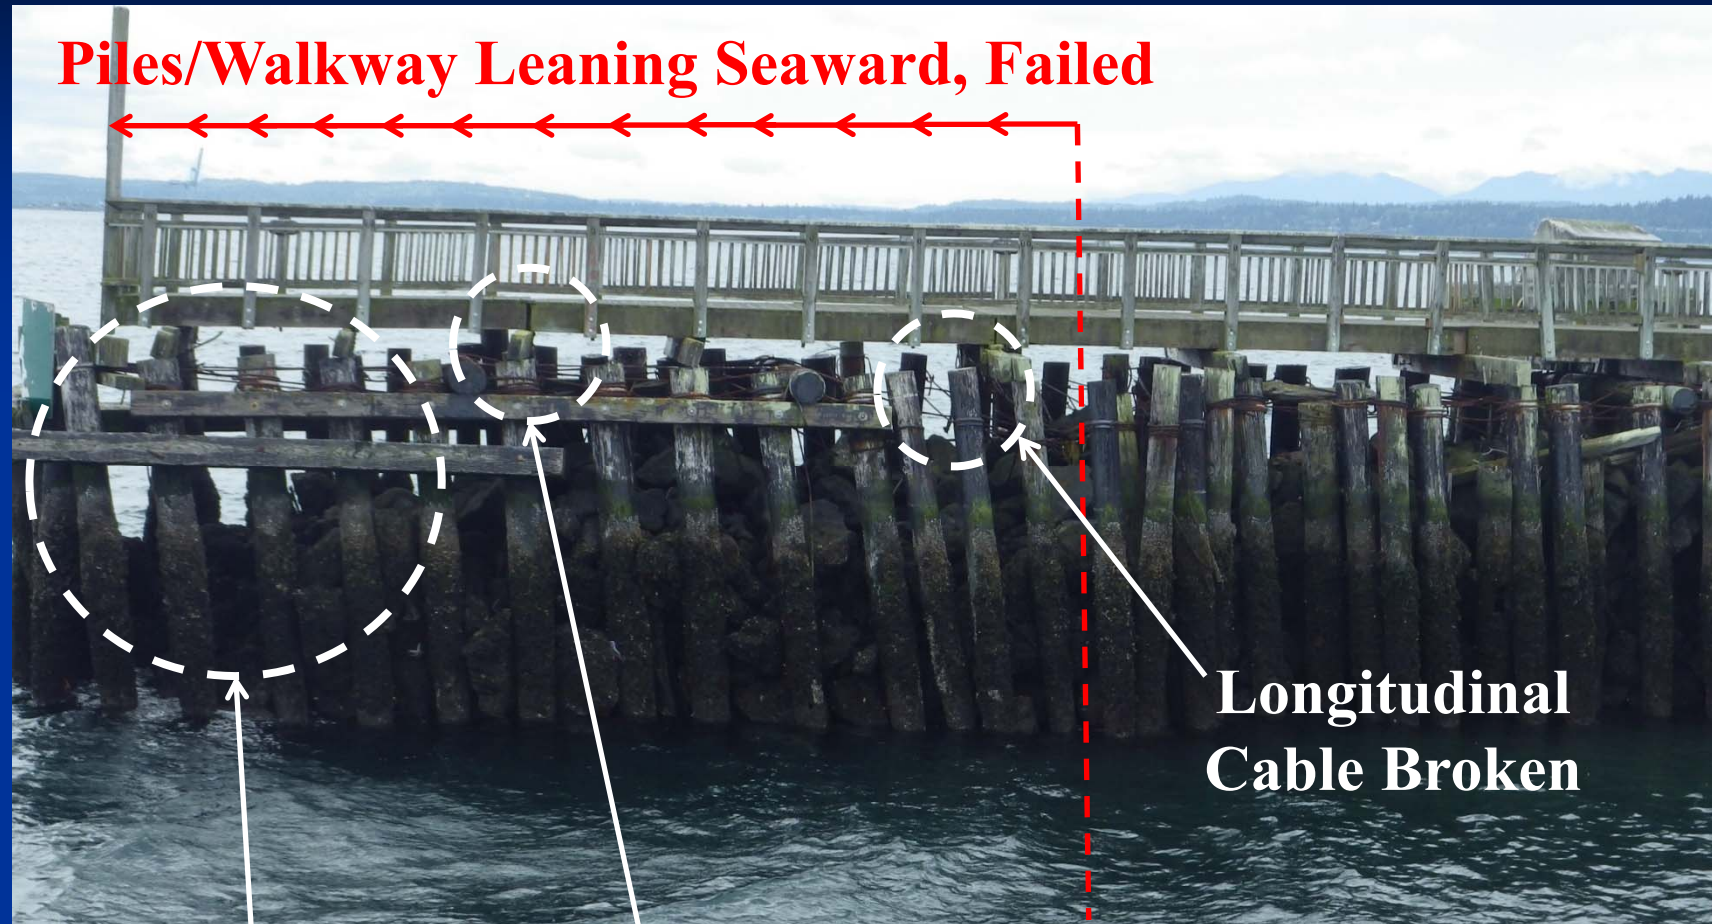
Piles/Walkway Leaning Seaward, Failed

**Longitudinal
Cable Broken**

Lost Stone

**Stringer Nearly
Unseated, Pile
Cap Rotated**

- Breakwater End Under Walkway Failing – Maintenance Staff Needs to Closely Monitor Condition.
- Further Failure/Shifting May be Grounds For Closure of Approx. 60' End Portion.
- Port Maintenance to Monitor Pile Caps, Stringer Splices for any Change in Condition.

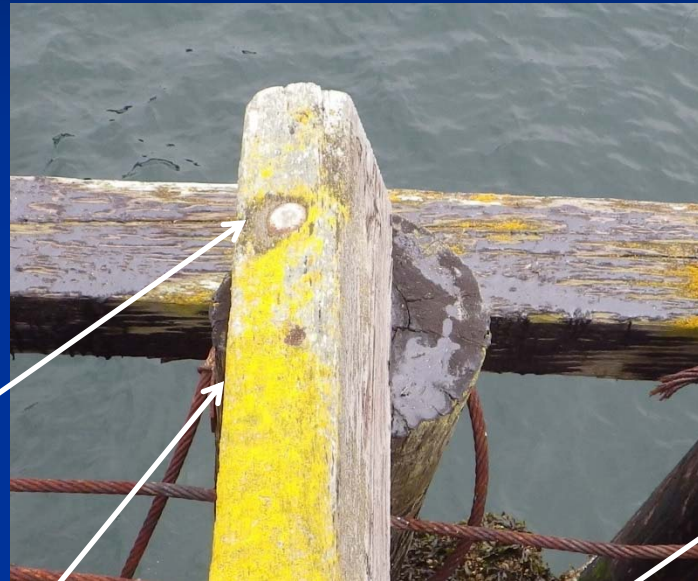
**Bent Shear
Pin**

Pile Cap

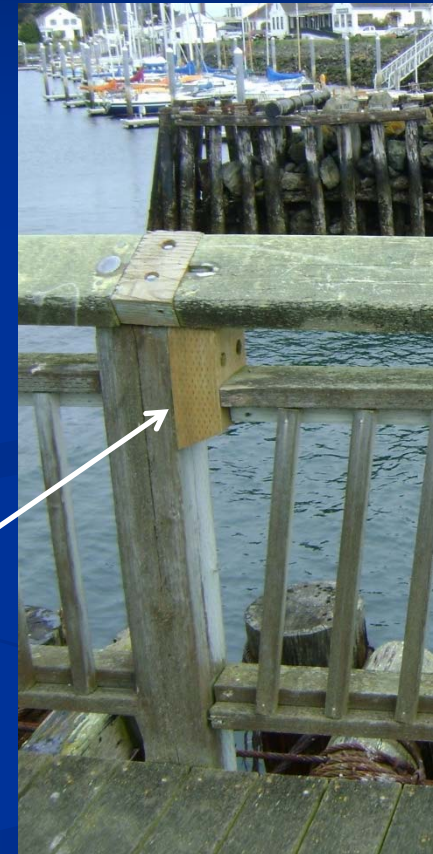
**Rail Recently
Modified for Lean**

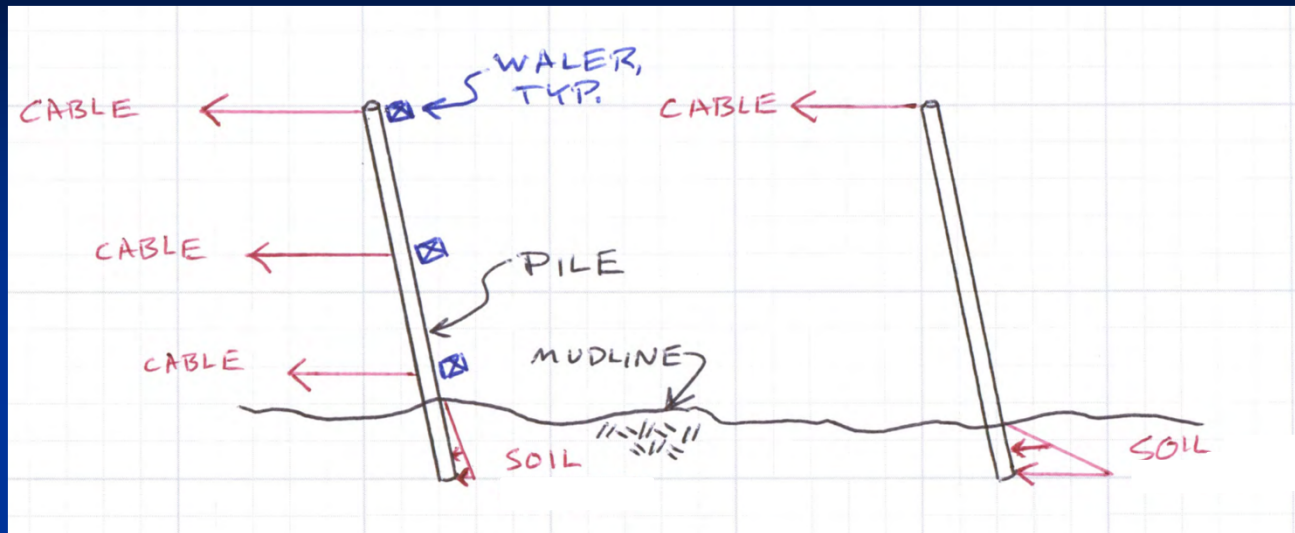
- Series of Cables Minimized Pile Stresses
- Minimal Reliance on Soil Capacity
- Minimal Reliance on Pile Capacity and Soil Capacity

- Only Top Cable Remaining
- Top Cable is Deteriorated – Reduced Capacity
- Stability Heavily Reliant on Pile Capacity and Soil Capacity

- System Capacity Significantly Reduced due to Deterioration. System Degradation Leading to Increased Pile Loading
- Outer Pile Load Demand Increased Significantly due to
 - Failed Walers (2 Rows)
 - Failed Thru-Rods (2 Rows)
- Outer Piles are Deteriorated Relative to New Condition – Resulting in Reduced Capacity
- Conclusion: Replacement/Rehabilitation Recommended
