Herb Beck Marina

Breakwater Condition Assessment and
Marina Entrance Dredging Assessment

Condition Assessment

August 11, 2022

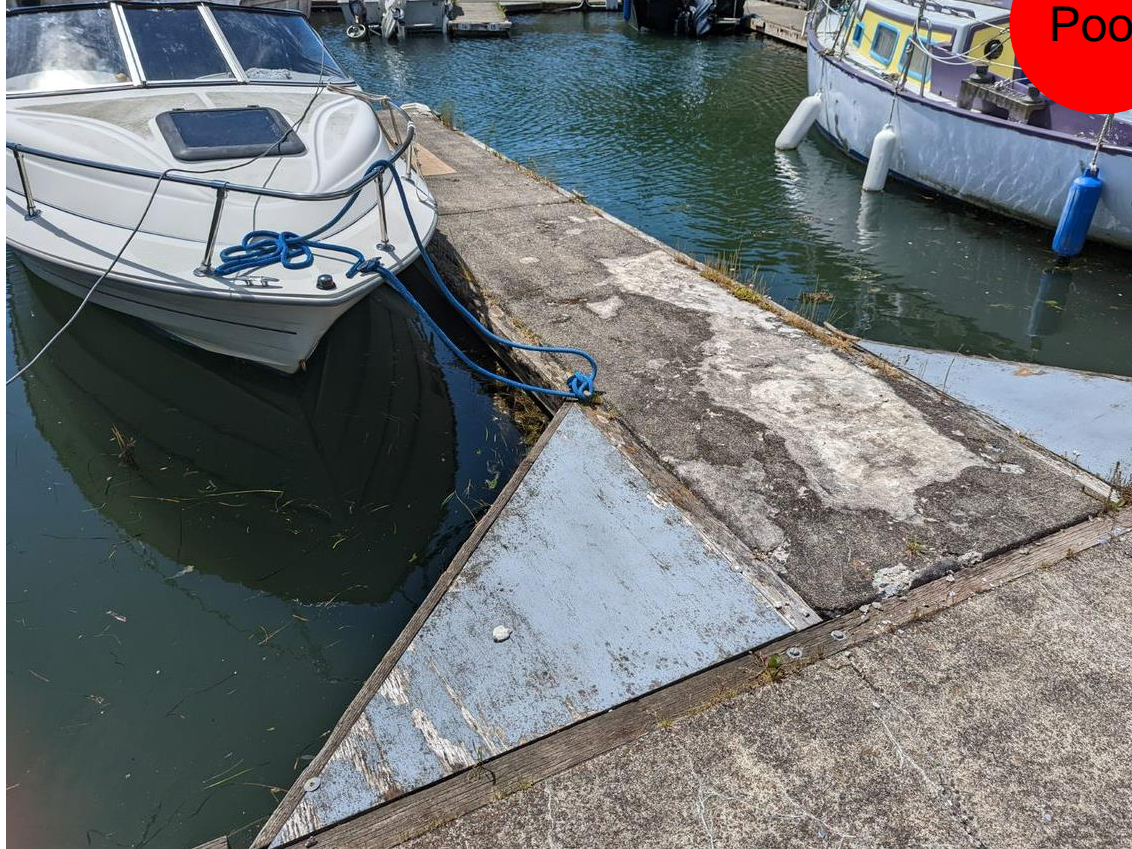
Concrete floats

Poor

- Surface cracks and spalling of concrete observed in select locations
- Deterioration of timber walers observed along a significant portion of the concrete floats
- Listing of select floats was observed

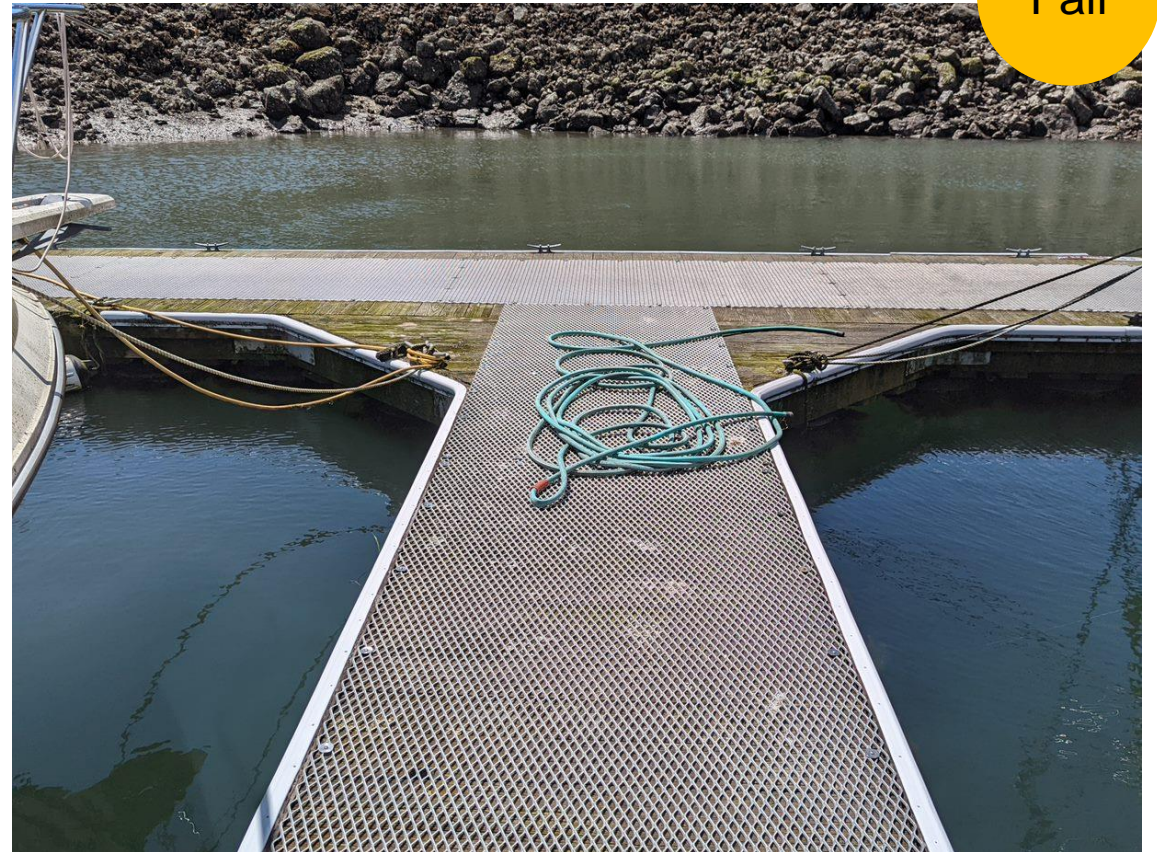
Timber floats

Fair

- Deterioration of timbers under grating observed
- Connections rusted

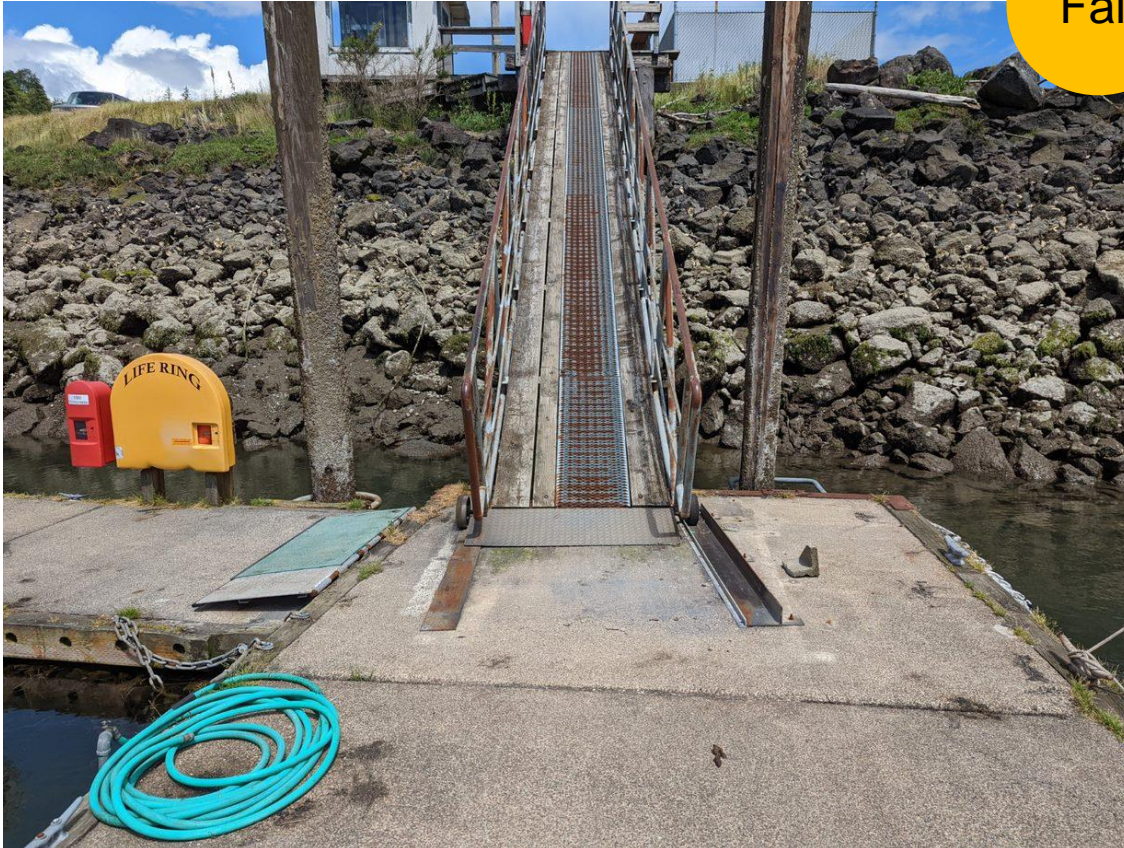
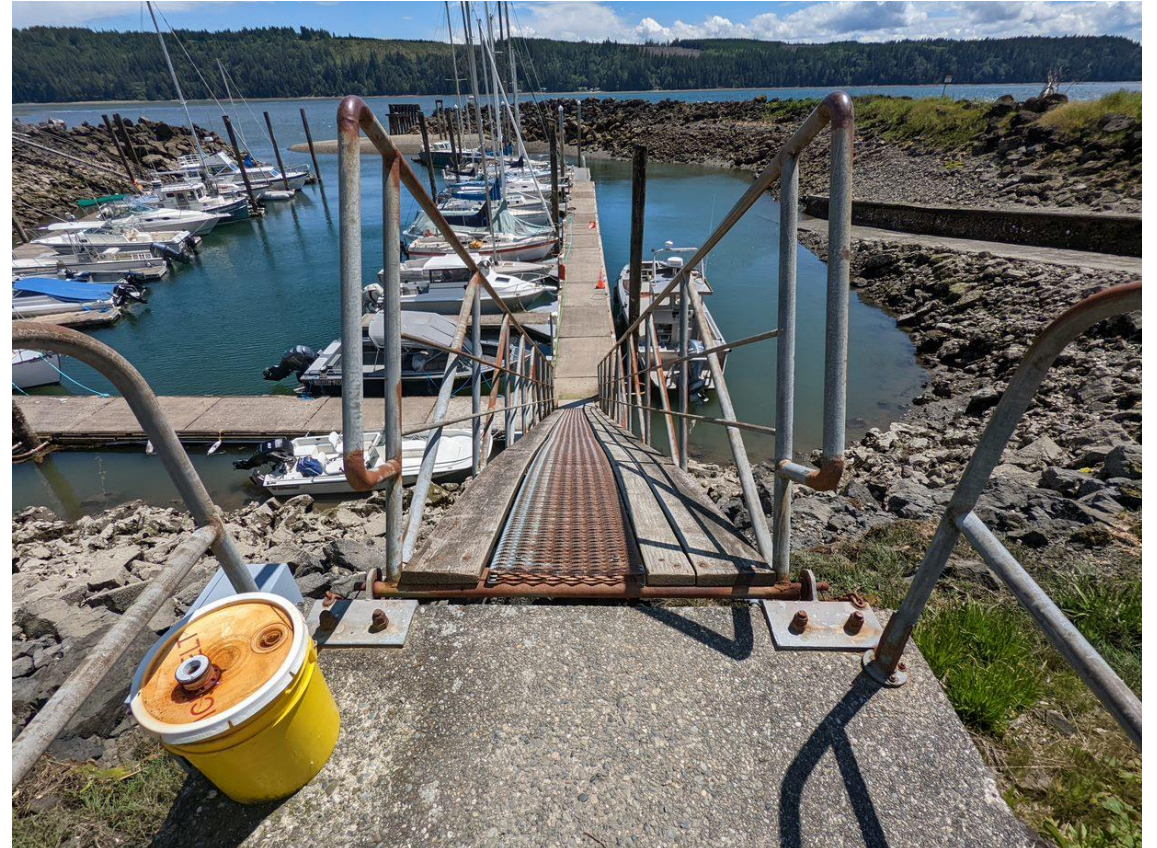
Marina - Gangway

Fair

- Deterioration (rust) observed on structure, connections, and handrails of both gangways
- Entire Deck could be replaced with fiberglass decking to improve traction

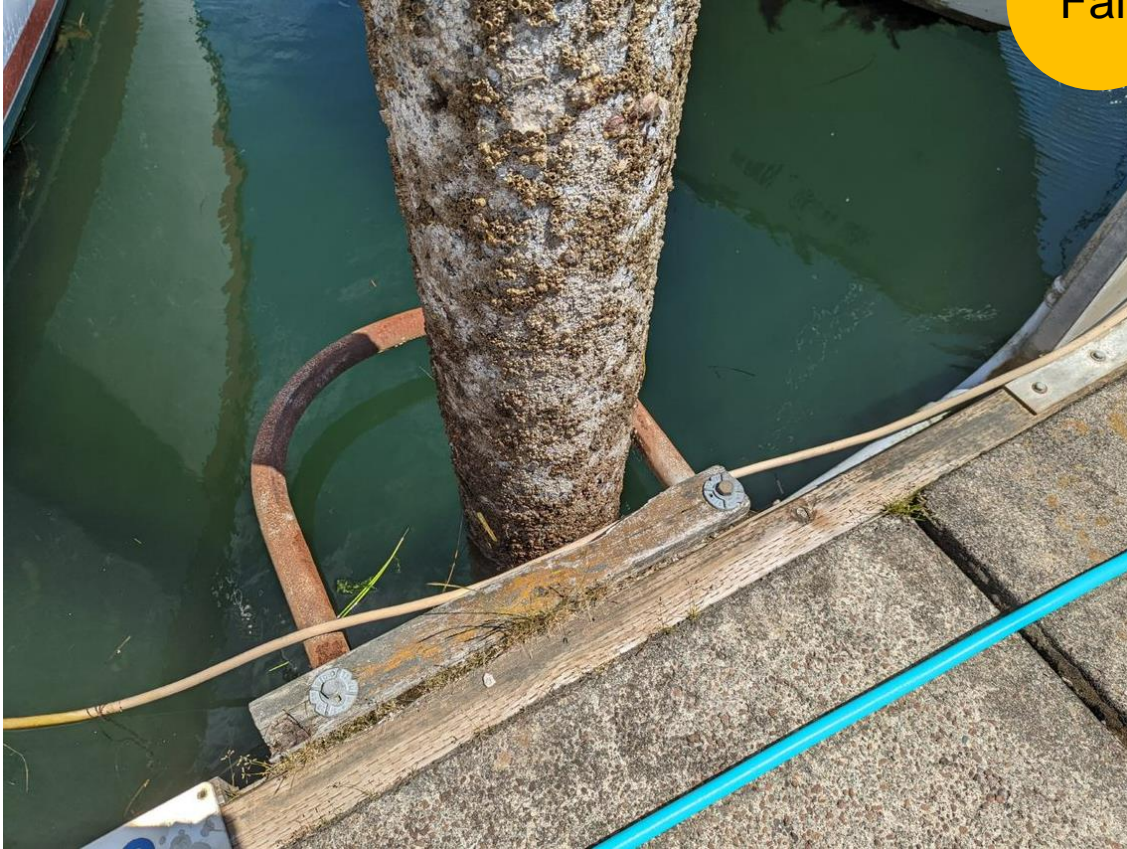
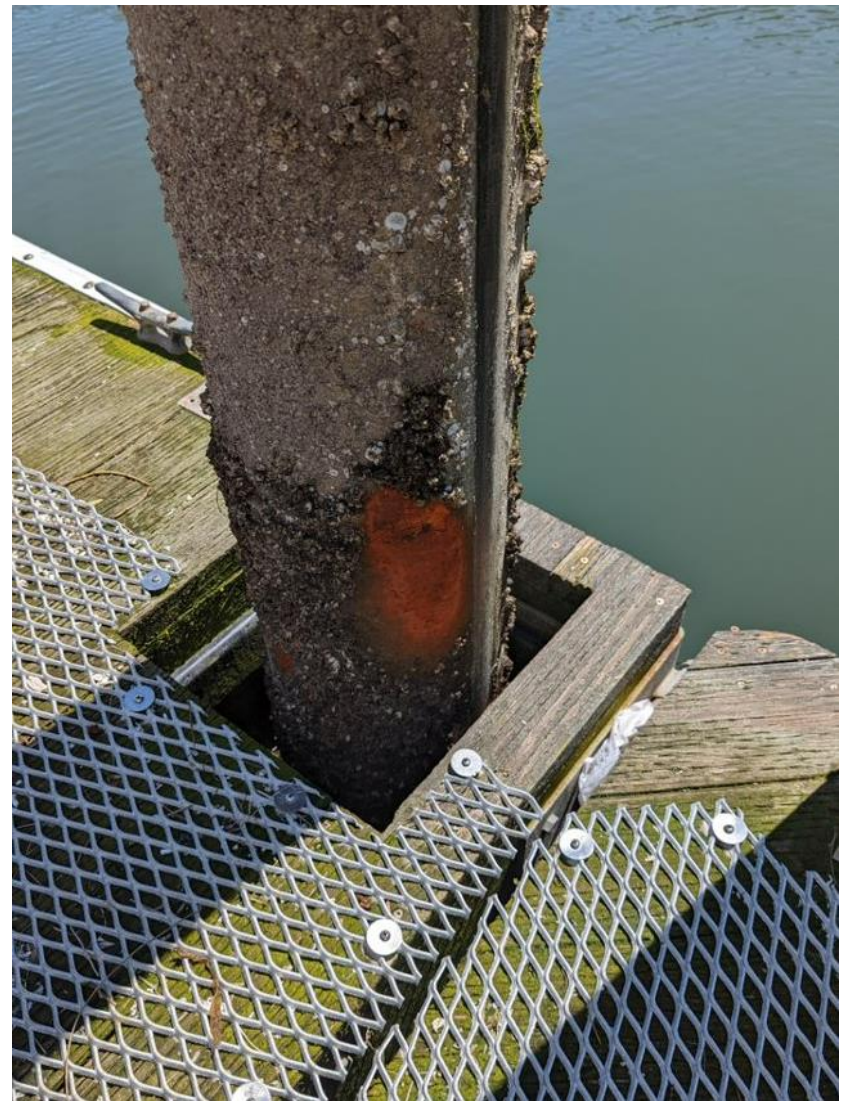
Marina - Piles

Fair

- Variety of pile hoops and both timber and steel piles observed
- Significant marine growth observed on both pile types
- Deterioration noted on both type of piles, likely timber piles have failed and been replaced with steel

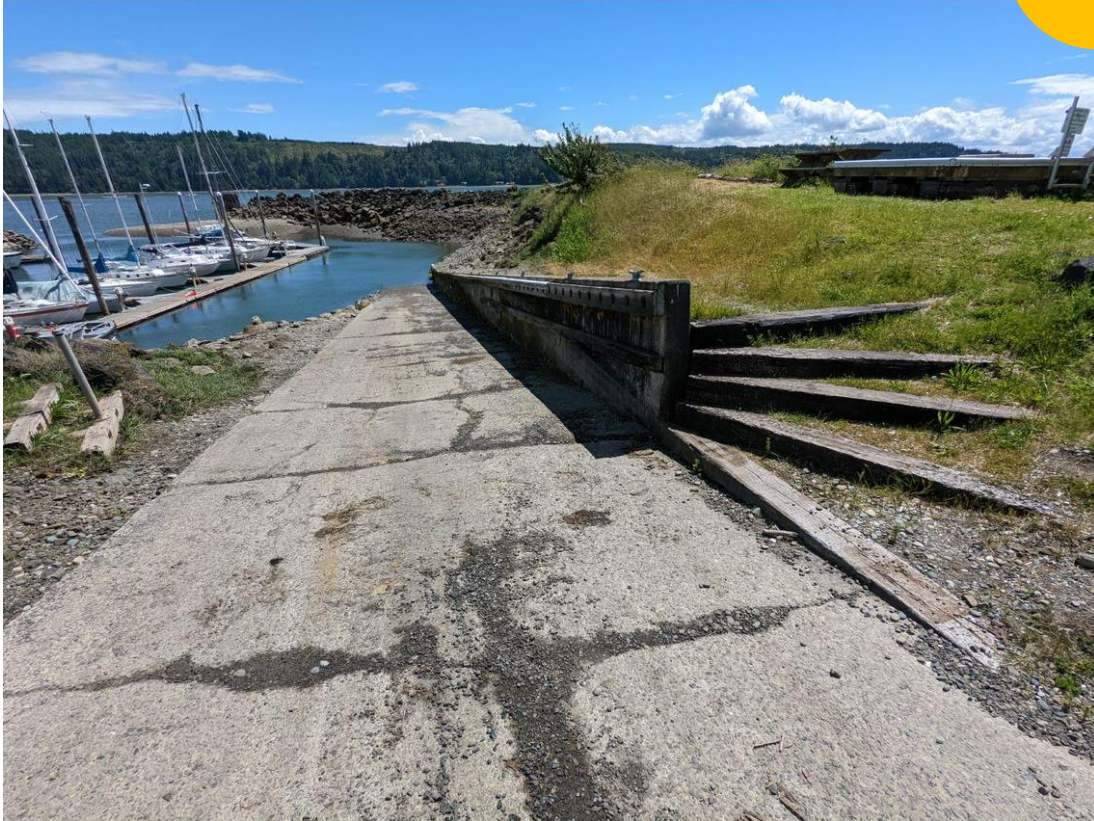
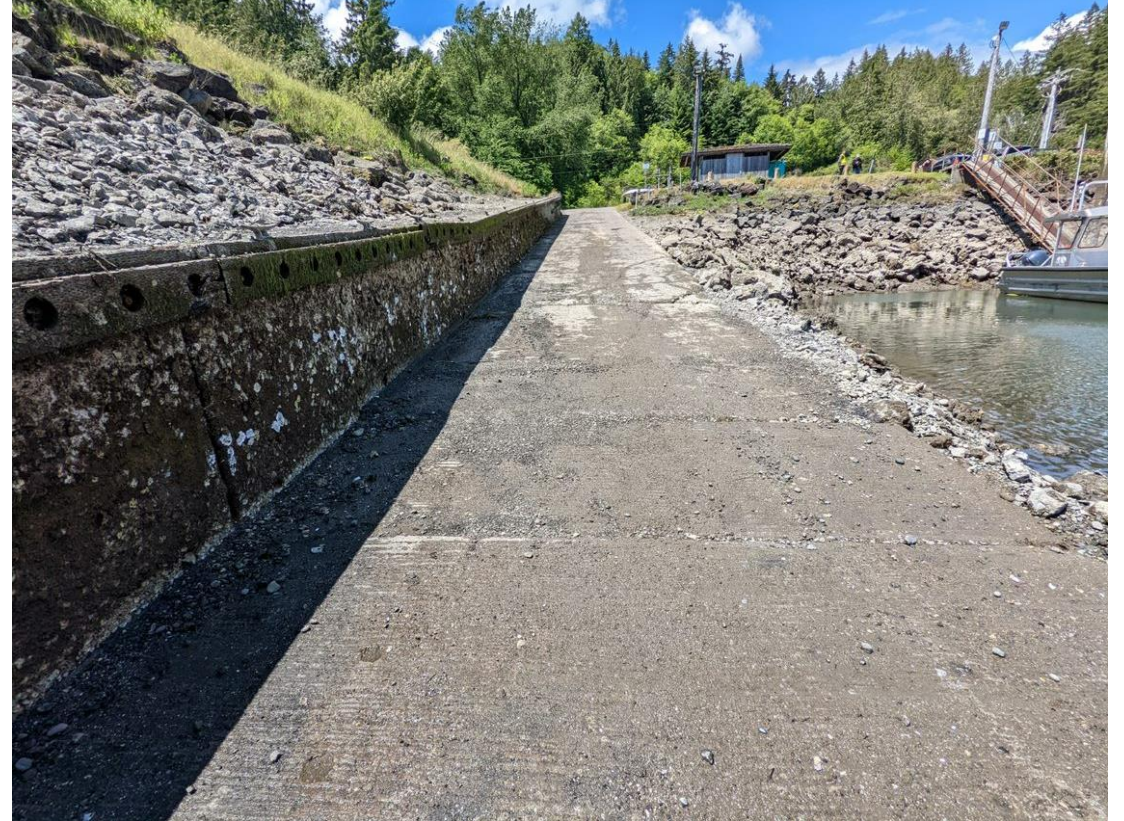
Marina – Boat Ramp

Fair

- Concrete cracking and spalling observed
- Minor undermining of panel near bottom of ramp observed

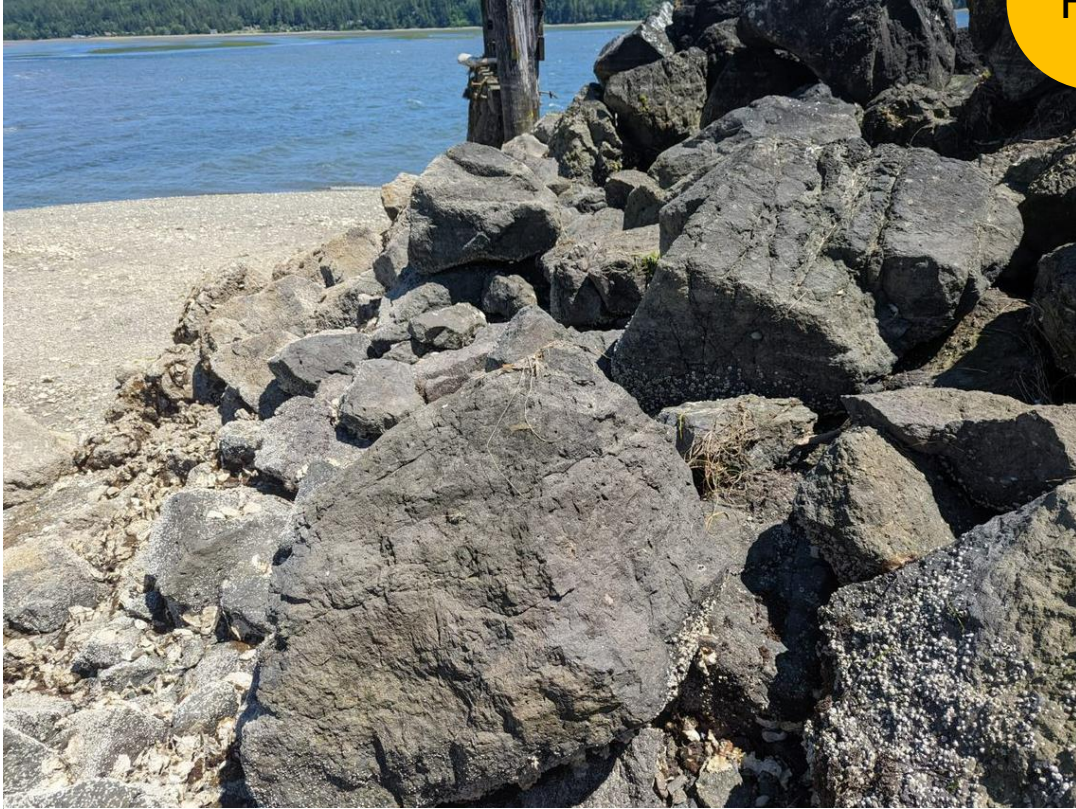
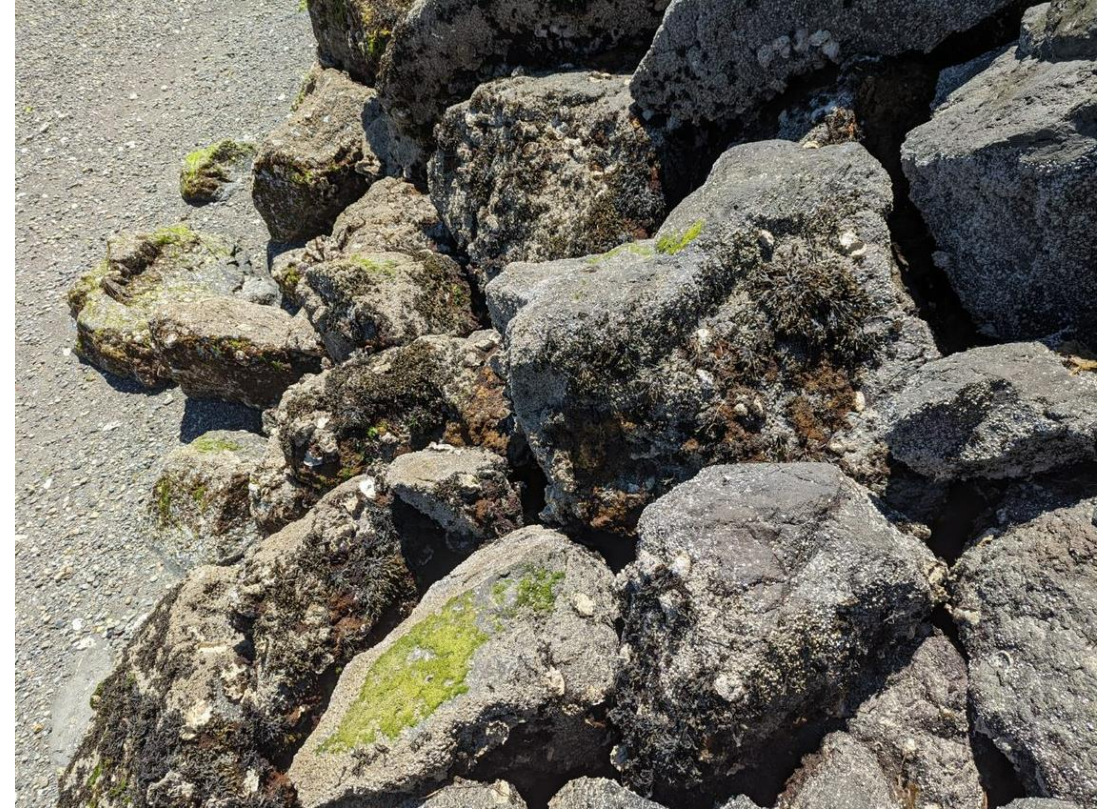
Armor Stone - Condition

Fair

- Basalt rock deterioration
- Cracks resulting in rocks breaking into smaller pieces
- Marine growth
- Freeze-Thaw
- Wave Action

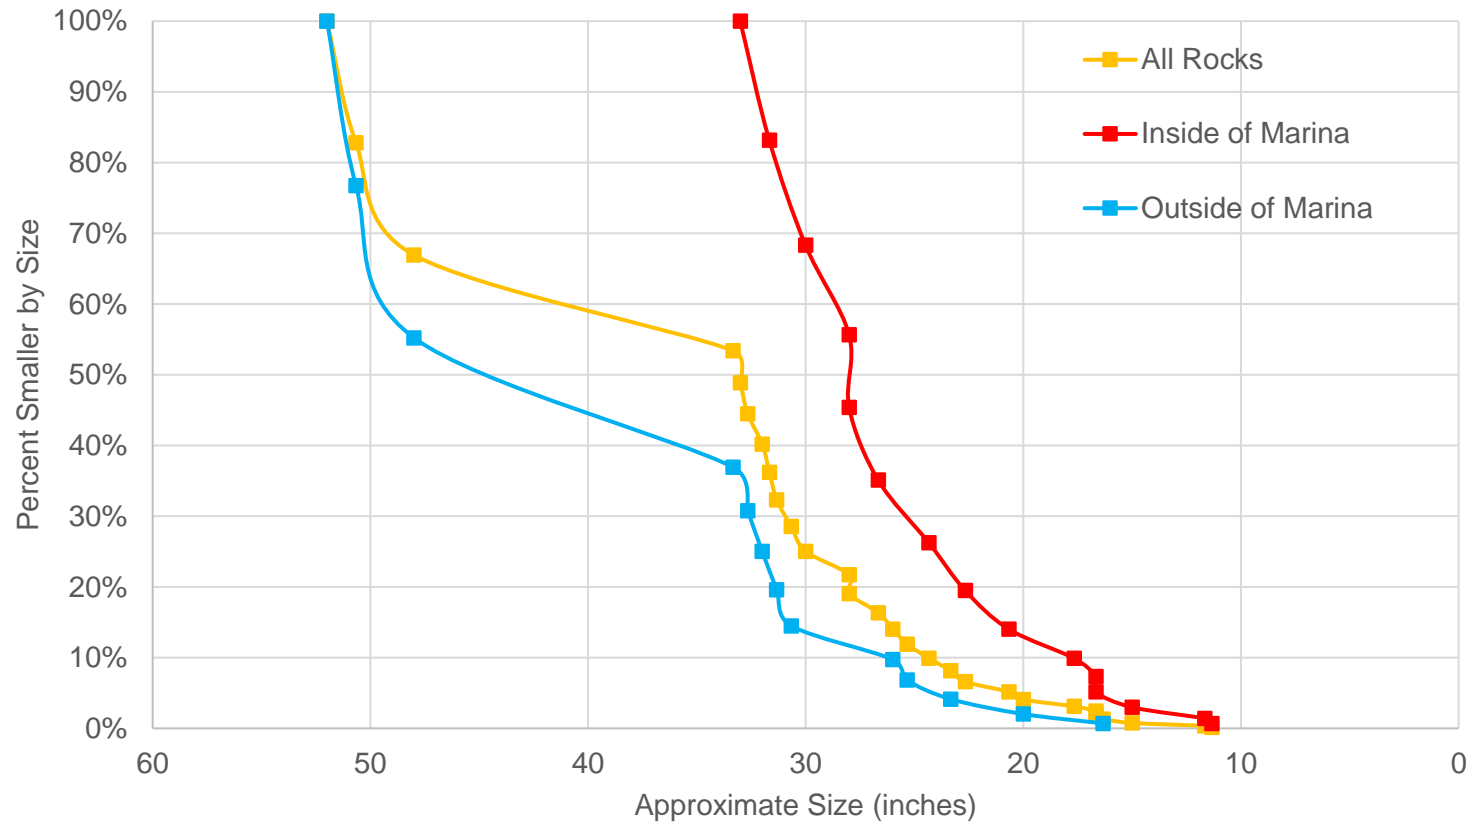
Armor Stone - Size

- Variation in rock size on the marina side of the breakwater vs the bay side of the breakwater.
- Unlikely caused by erosion from wave action, more likely being built intentionally
