PORT OF PORT TOWNSEND

Point Hudson Marina Breakwater Improvement Project

Work Status Update

June 8th 2016

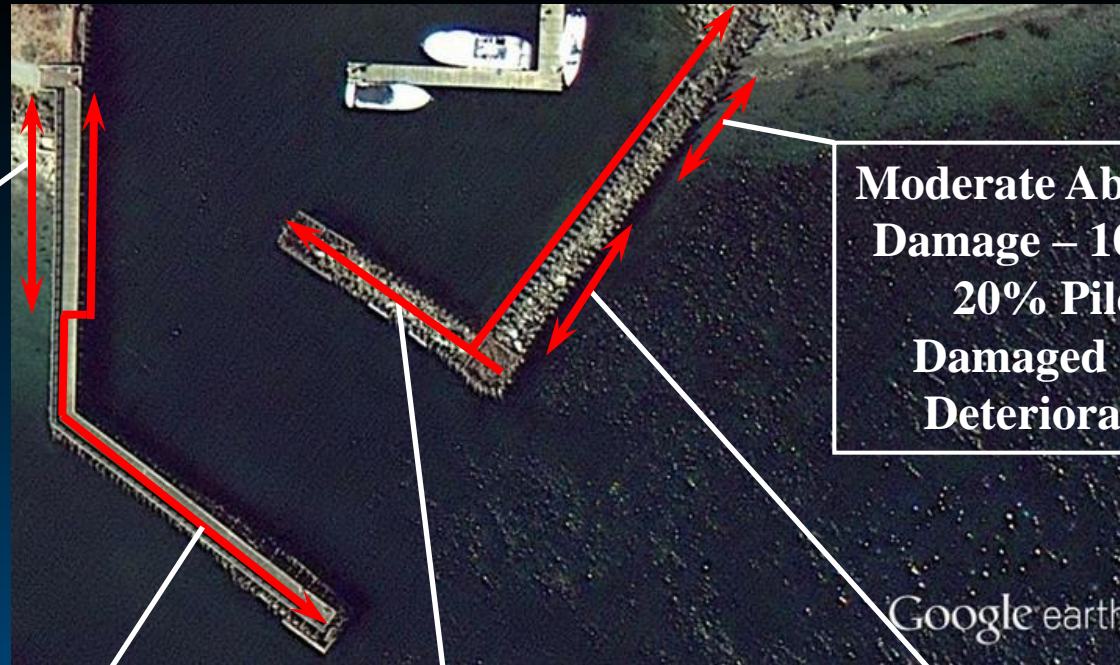
**Moderate to Severe
Abrasion Damage
20% to 30% Piles
Damaged and
Deteriorated**

**Moderate Abrasion
Damage – 10% to
20% Piles
Damaged and
Deteriorated**

**10% to 20% of Piles
Sounded Somewhat
Hollow, Exposed
Side Worse than
Sheltered Side**

**10% to 20% of Piles
Sounded Somewhat
Hollow, Exposed Side
Worse than Sheltered
Side**

**Severe Marine
Borer Attack ,
20% to 30% Piles
Damaged and
Deteriorated**

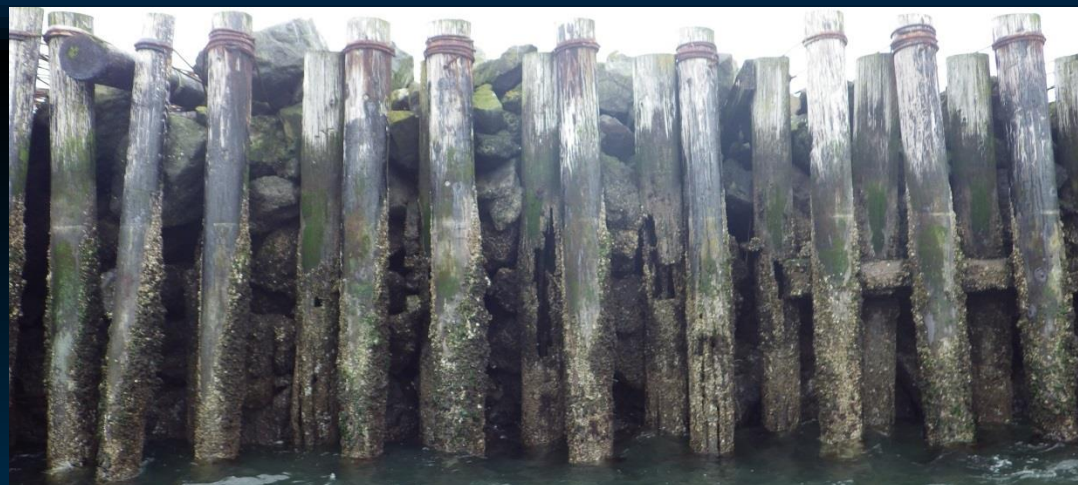
- Varying Levels of Deterioration Depending on Exposure, Damage
- Likely Shallow Embedment – Highly Compacted Sand Layer 0.8ft to 2ft Below Mudline (Landau Biological Assessment/Evaluation, September 2005)
- Piles Beyond Useful Service Life

Piles in Poor Condition

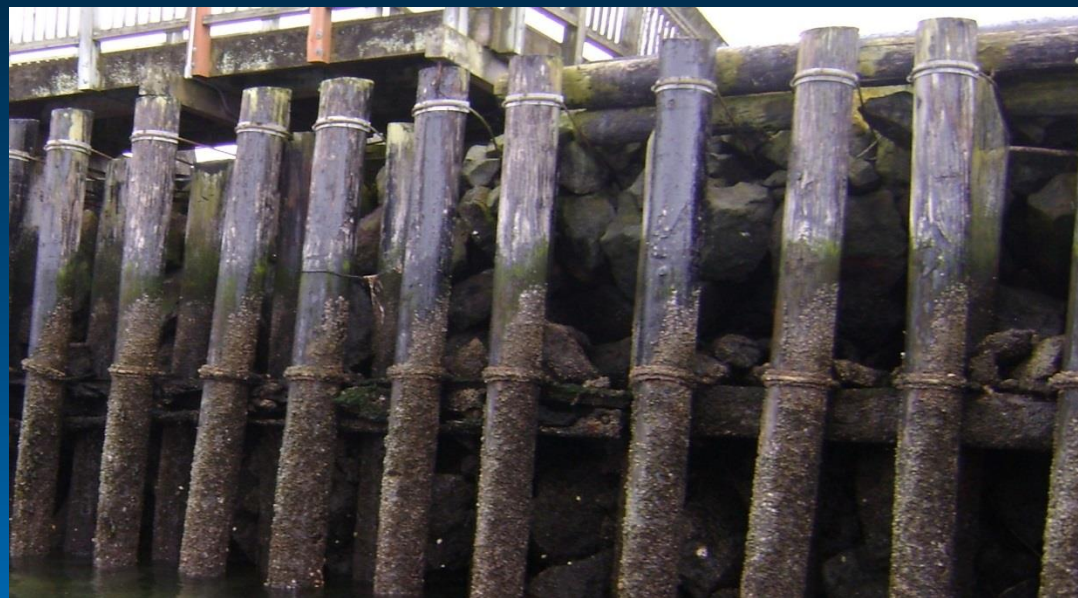
Piles in Fair Condition

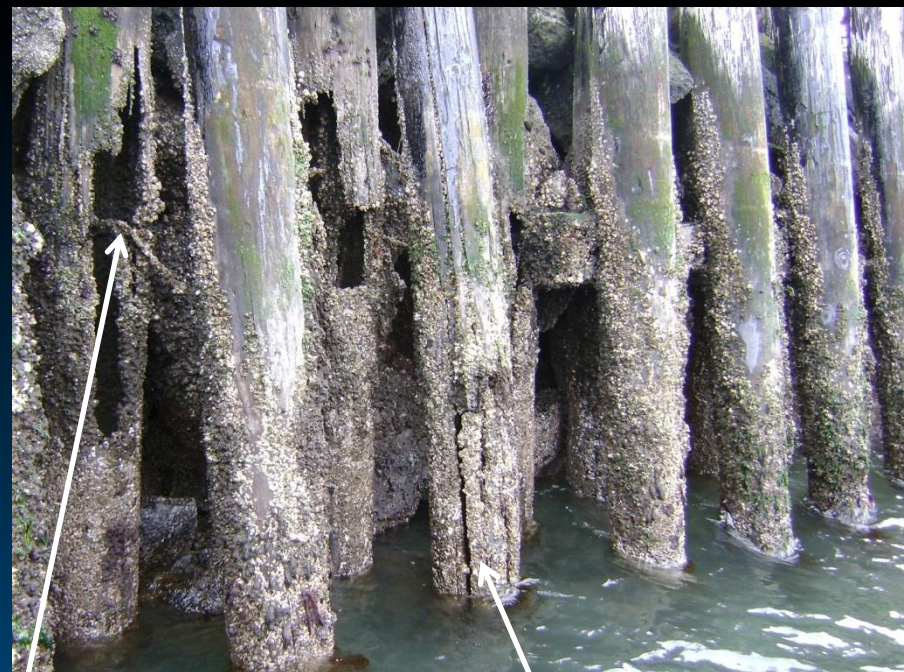
- Marine Borer Attack
- Varying Levels of Deterioration
- Decay Where Creosote Treatment Penetrated by Bolts, Thru Rods

**Inner Pile
(1934) :
Decay at
Penetration**

**Outer Pile
(1969):
Marine
Borer
Attack**

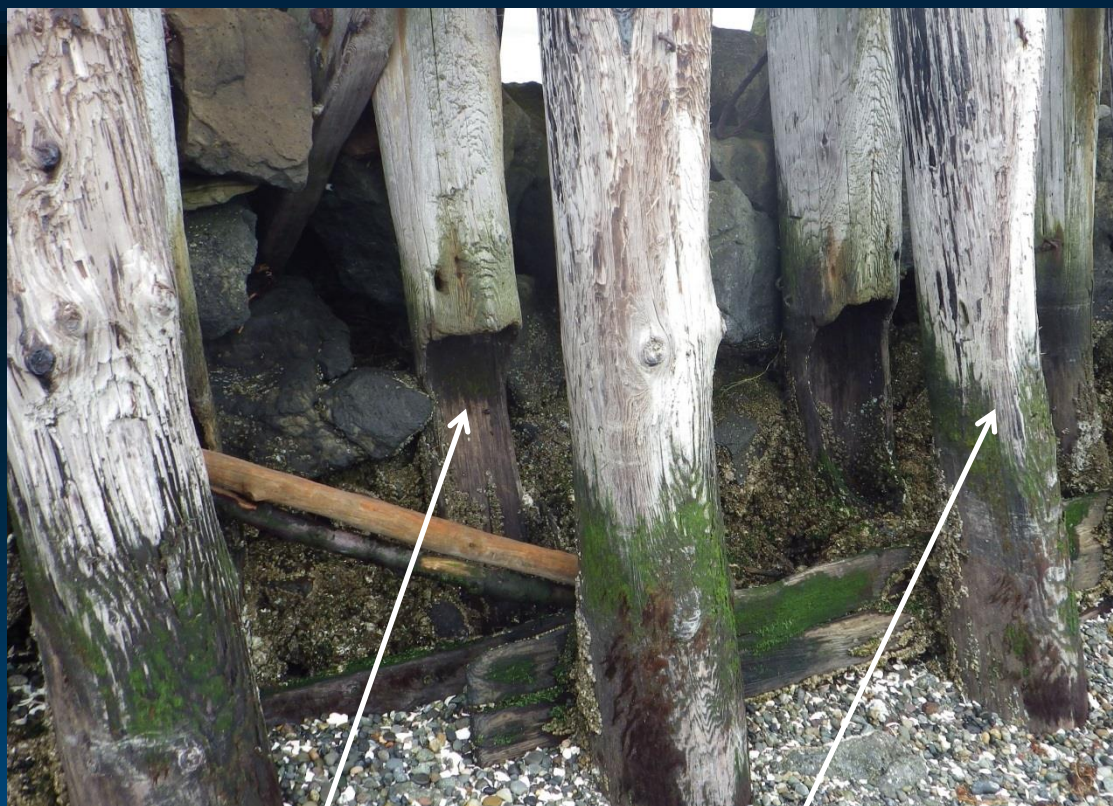
- Abrasion
Penetrated
Creosote
Protective
Treatment,
Subsequent
Decay/Marine
Borer Attack

**Inner Pile
(1934)
Abraded &
Decayed**

**Outer Pile (1969)
Abraded, Decaying
(Hollow Sounding)**

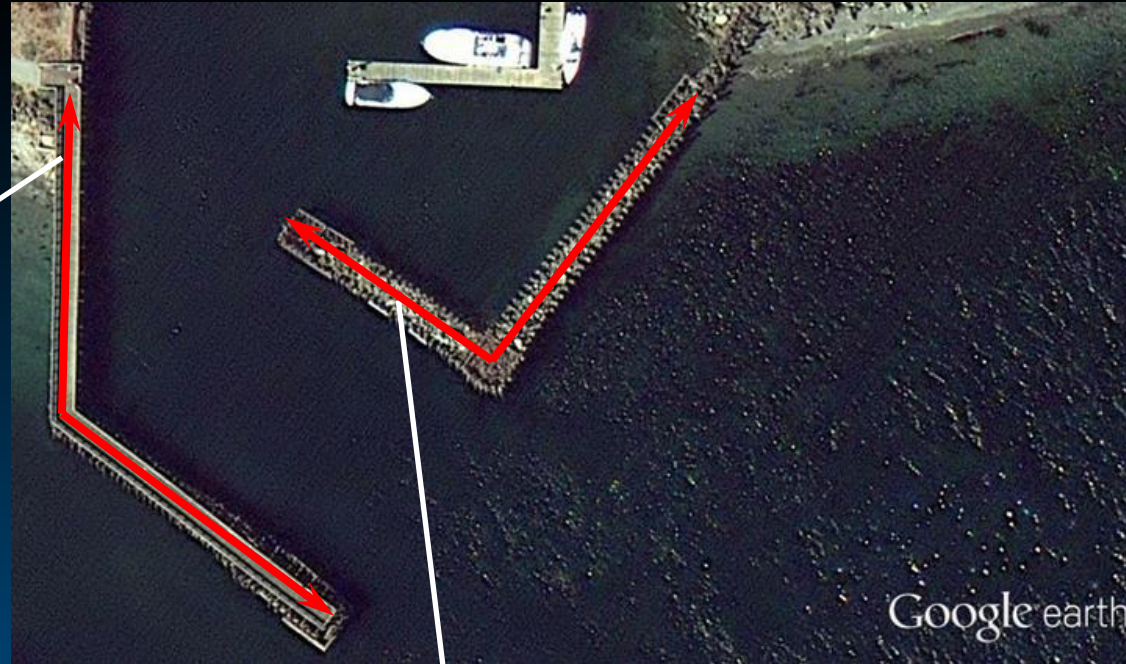
**Walers Completely
Deteriorated –
Minimal Load
Carrying Capacity**

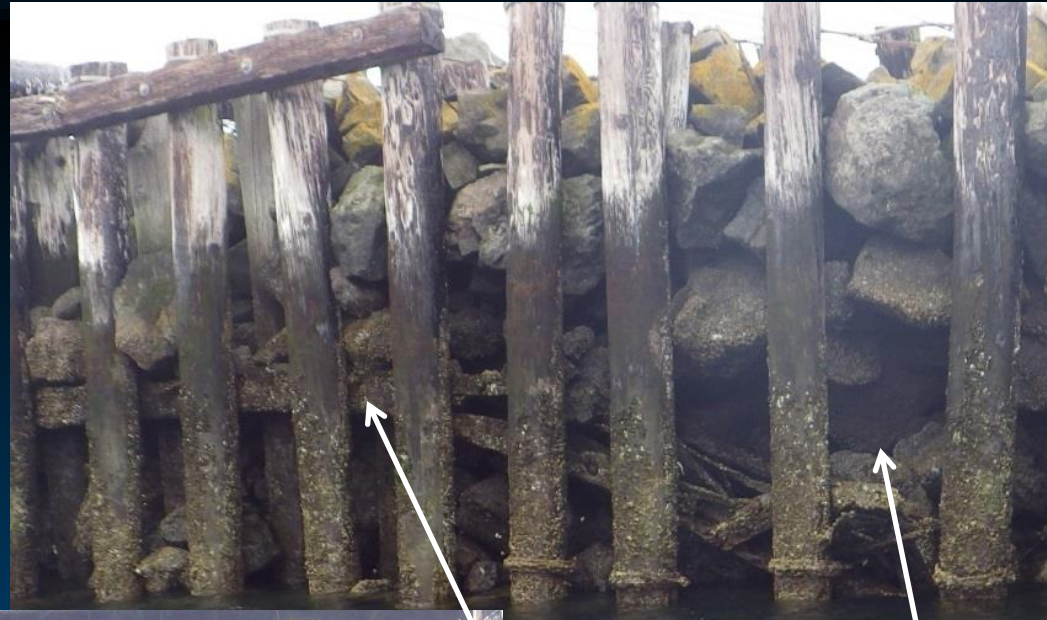
- Highly Deteriorated – Minimal Capacity
- Minimal Contribution to Structure Stability – Decreased System Capacity
- Loss of Stone Confinement
- Walers Beyond Useful Service Life

**Deteriorated
Waler**

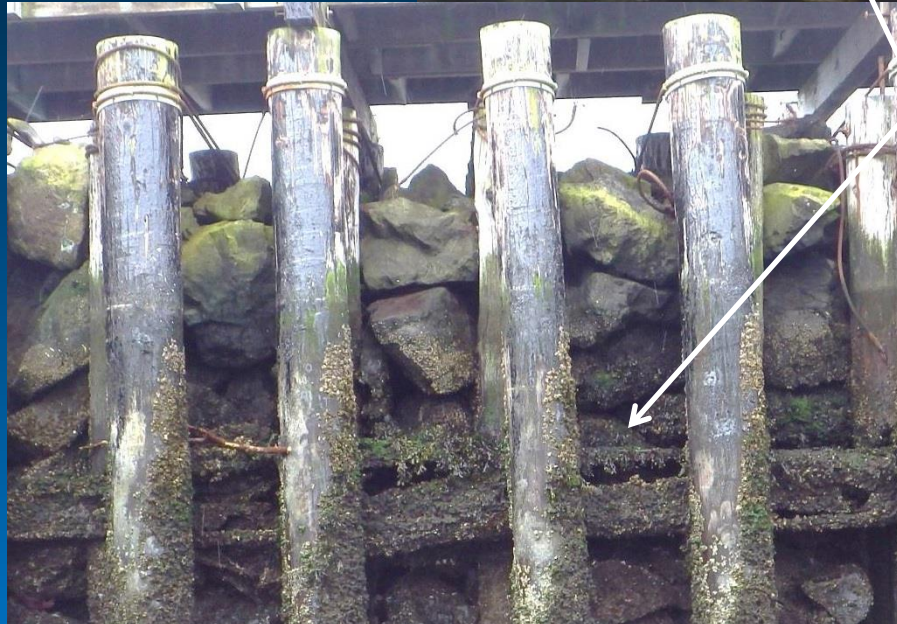
**Loss of
Armor Rock**

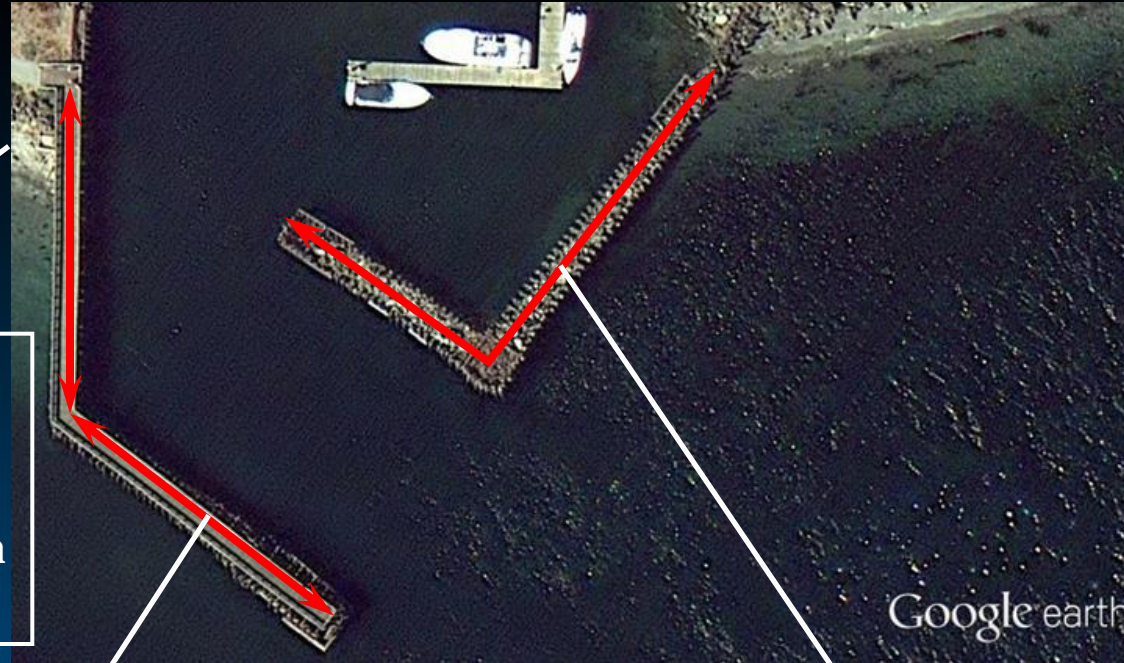
**10% Cables Severed,
Remainder
Deteriorated, Areas
Exposed to Wave Splash
Worst**

**10% to 20% of Cables
Severed, Remainder
Deteriorated, or
Highly Deteriorated**

**5% to 10% of
Cables Severed,
Remainder
Deteriorated**

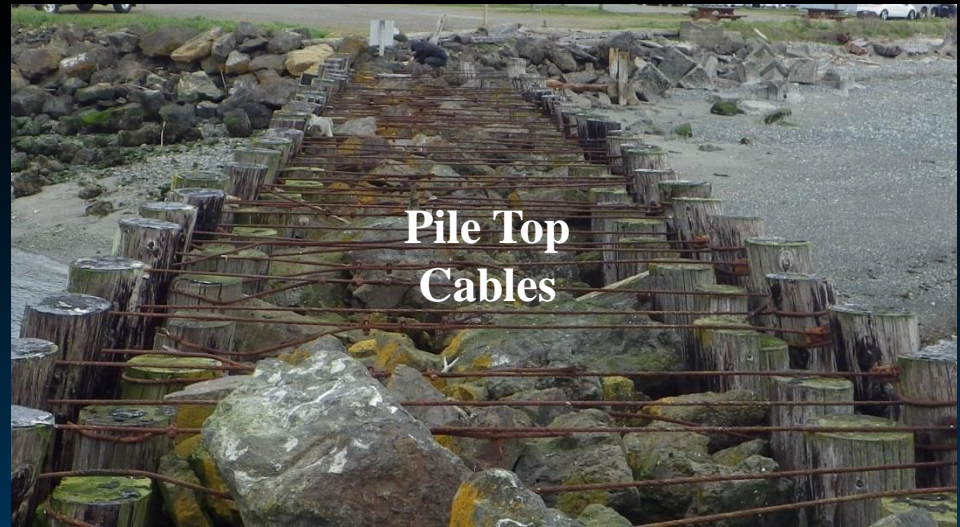
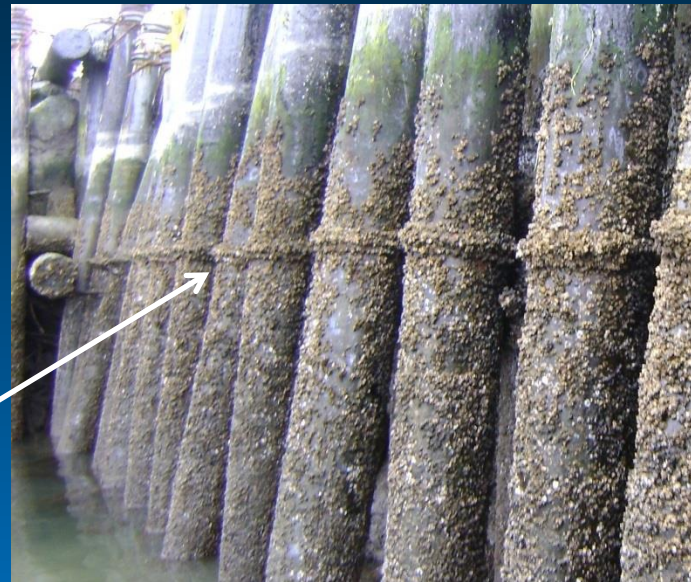
- Pile Top – Cables Wrapped Around Pile Tops to Provided Lateral Support
- Intermediate – Cables Wrapped Between New and Old Piling – 90%+ Missing, Remainder Highly Deteriorated

Intermediate Cables

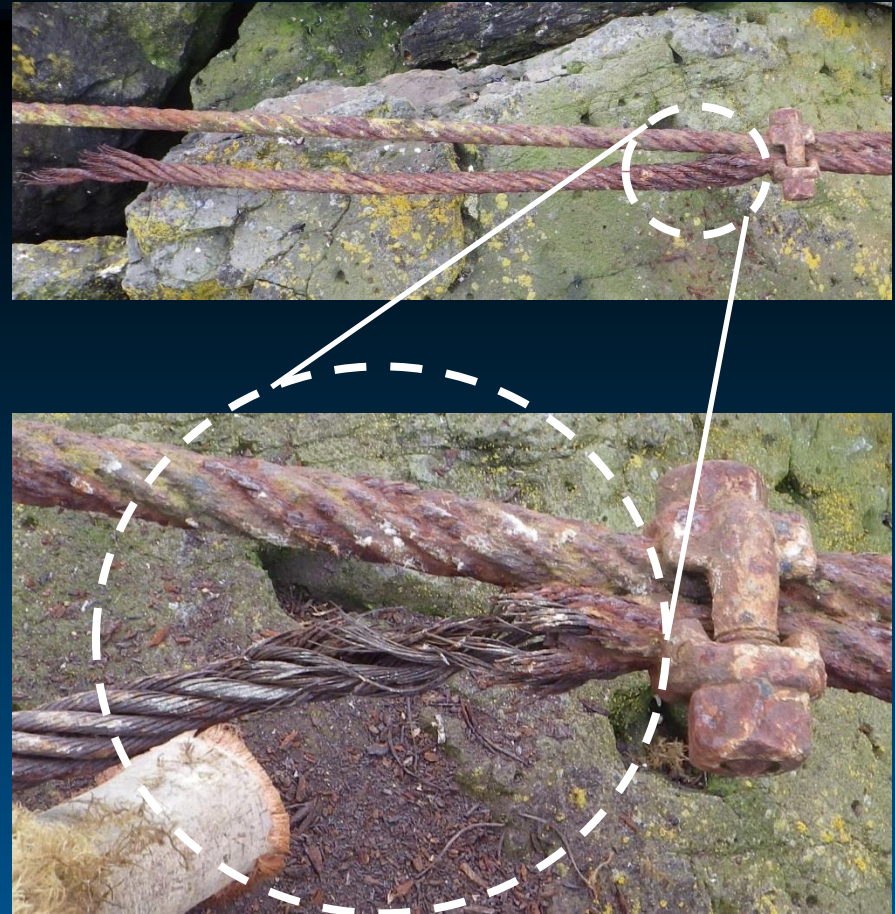
- Level of Deterioration Difficult to Determine Visually
- Caked on Rust
- Cable End Examined, Estimated $<10\%$ Capacity Remaining
- Cable Beyond Useful Service Life

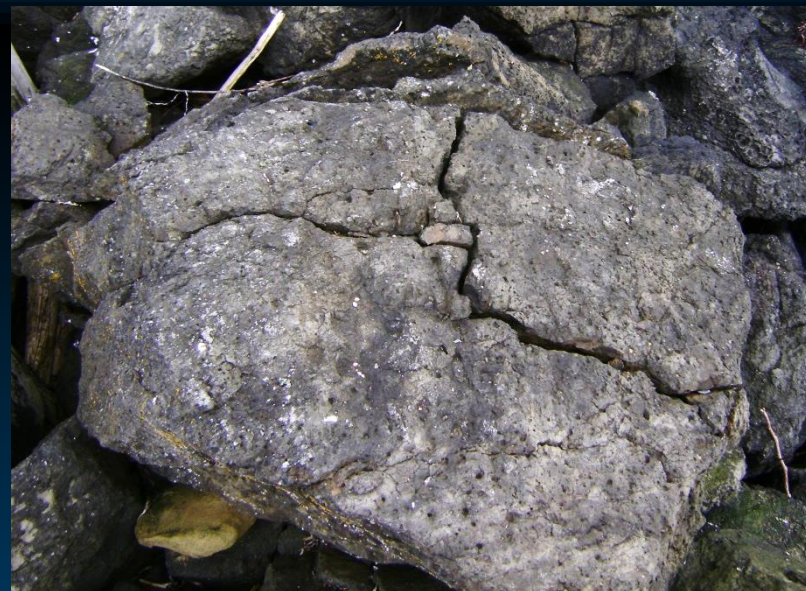
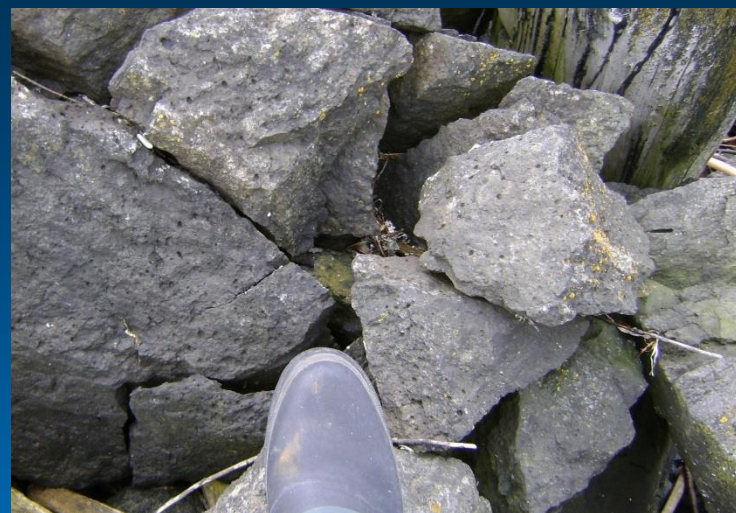
- Appears to be Matts Matts Sourced Marine Basalt – Low Quality Stone
- Highly Fractured
- >50% of Stone in Deteriorated to Highly Deteriorated State; beyond its useful service life

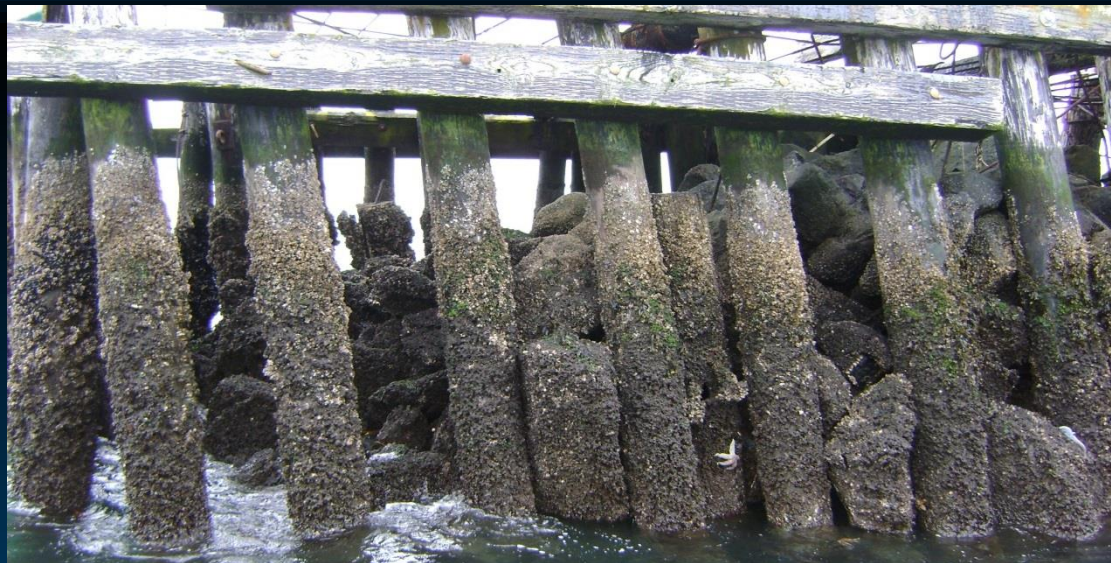
- Armor Rock Spalls to 12" x 12" x 8" Pieces, Which are Being Pulled From Between Piles by Wave Action
- Loss of Waler Results in Decreased Confinement of Armor Rock
- Large rock loss at vulnerable breakwater ends

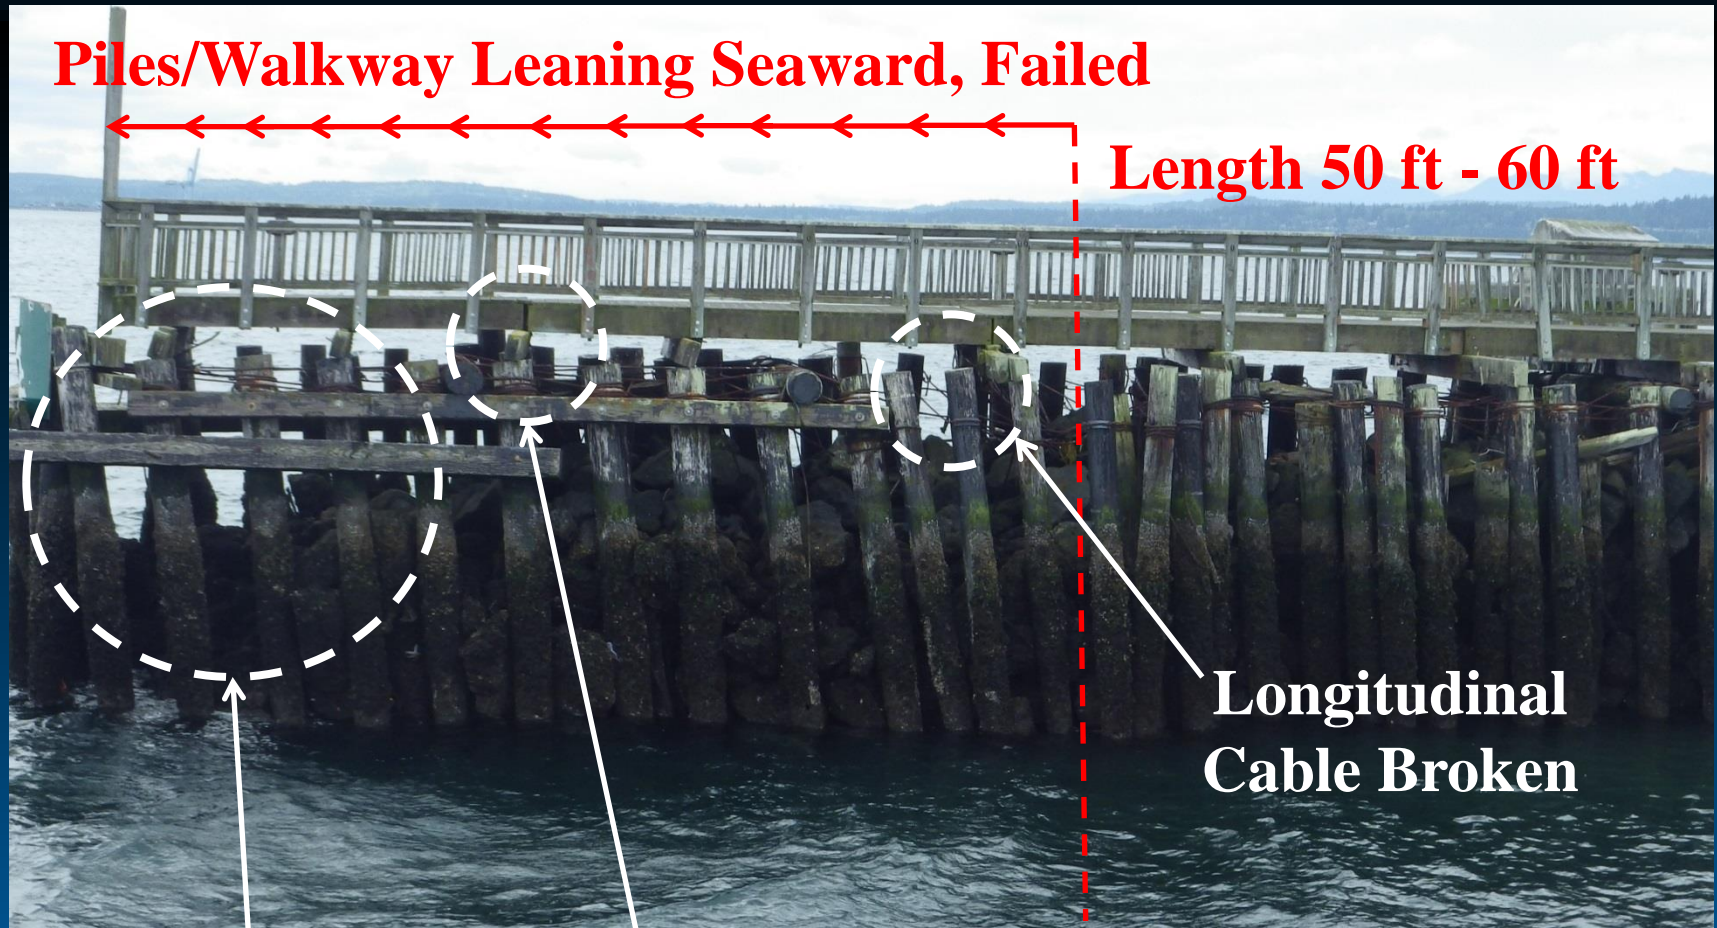
Piles/Walkway Leaning Seaward, Failed

Length 50 ft - 60 ft

**Longitudinal
Cable Broken**

Lost Stone

**Stringer Nearly
Unseated, Pile
Cap Rotated**

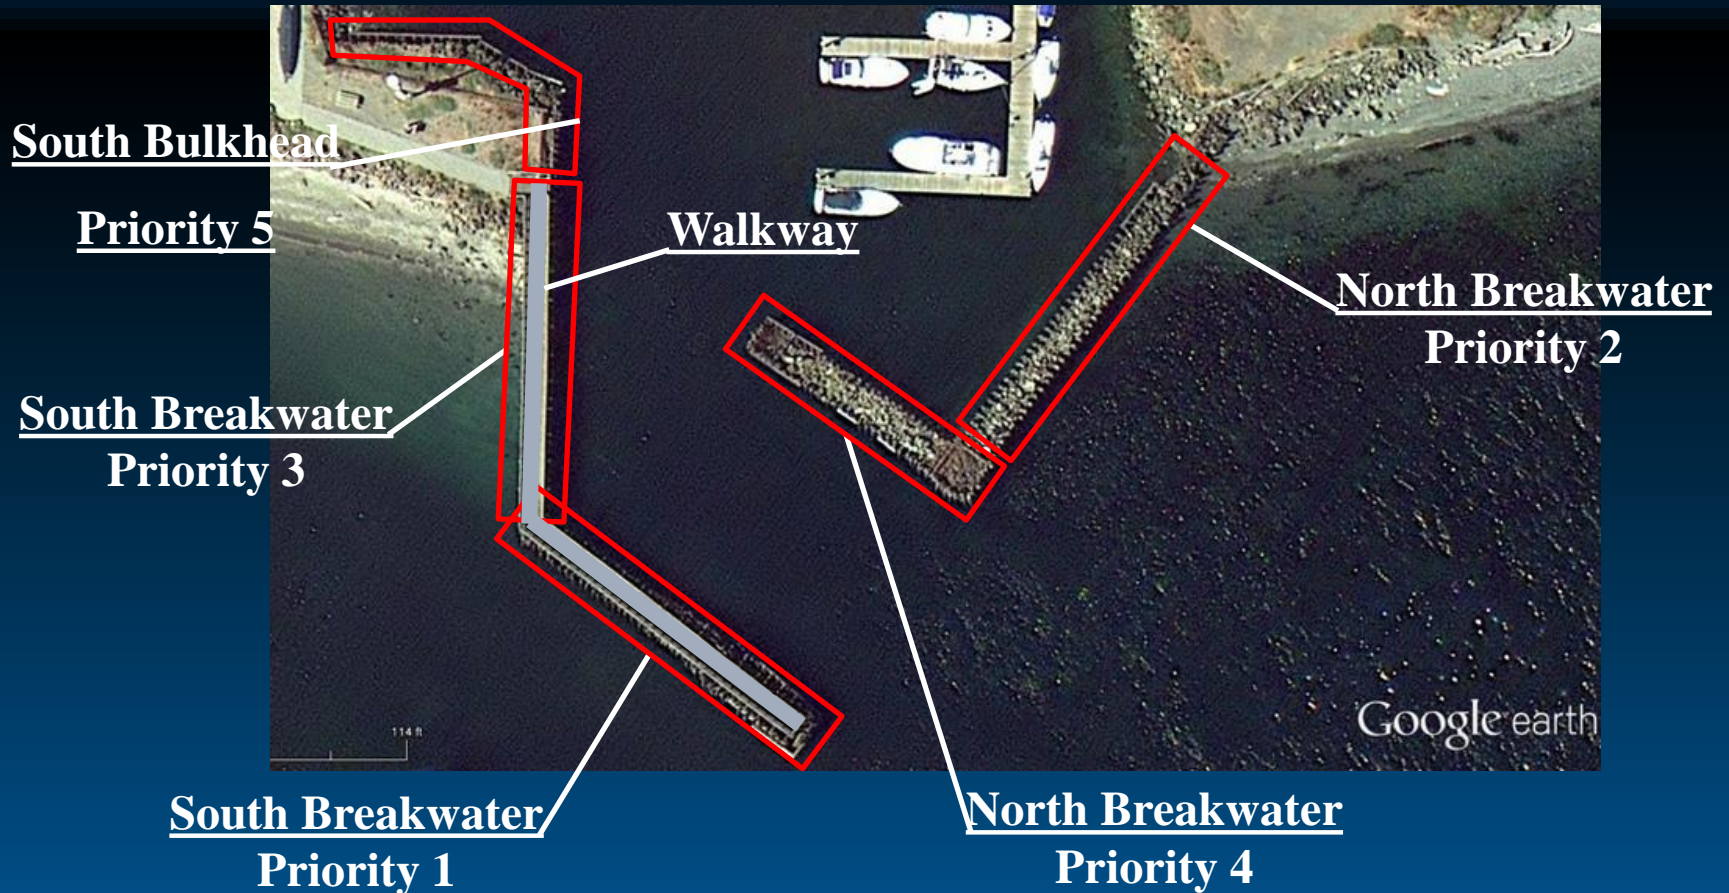
- Walers: *Highly Deteriorated, No Longer Functional*
- Steel Cable Tiebacks: *Deteriorated to Highly Deteriorated, Some Already Failed, At End of Useful Life.*
- Armor Rock: *At Age of Increasing Deterioration Rate, Beyond Useful Service Life*
- Piles: Near End of Useful Life, Abrasion Damage, Marine Borer Attack Damage, Decaying
- Overall Structural System: Substantially Less Stable than Original Construction, Higher Stresses
- S. Breakwater End: Walkway Stringer Nearly Unseated, Entire 60' End Portion Failed, Leaning Seaward
- Walkway: End 60' Near End of Useful Life, Needs Monitoring. Remainder in Good/Moderate Condition

- Full Replacement recommended
- Phasing of Replacement is possible with some localized re-habilitation
- South Breakwater is 1st Priority

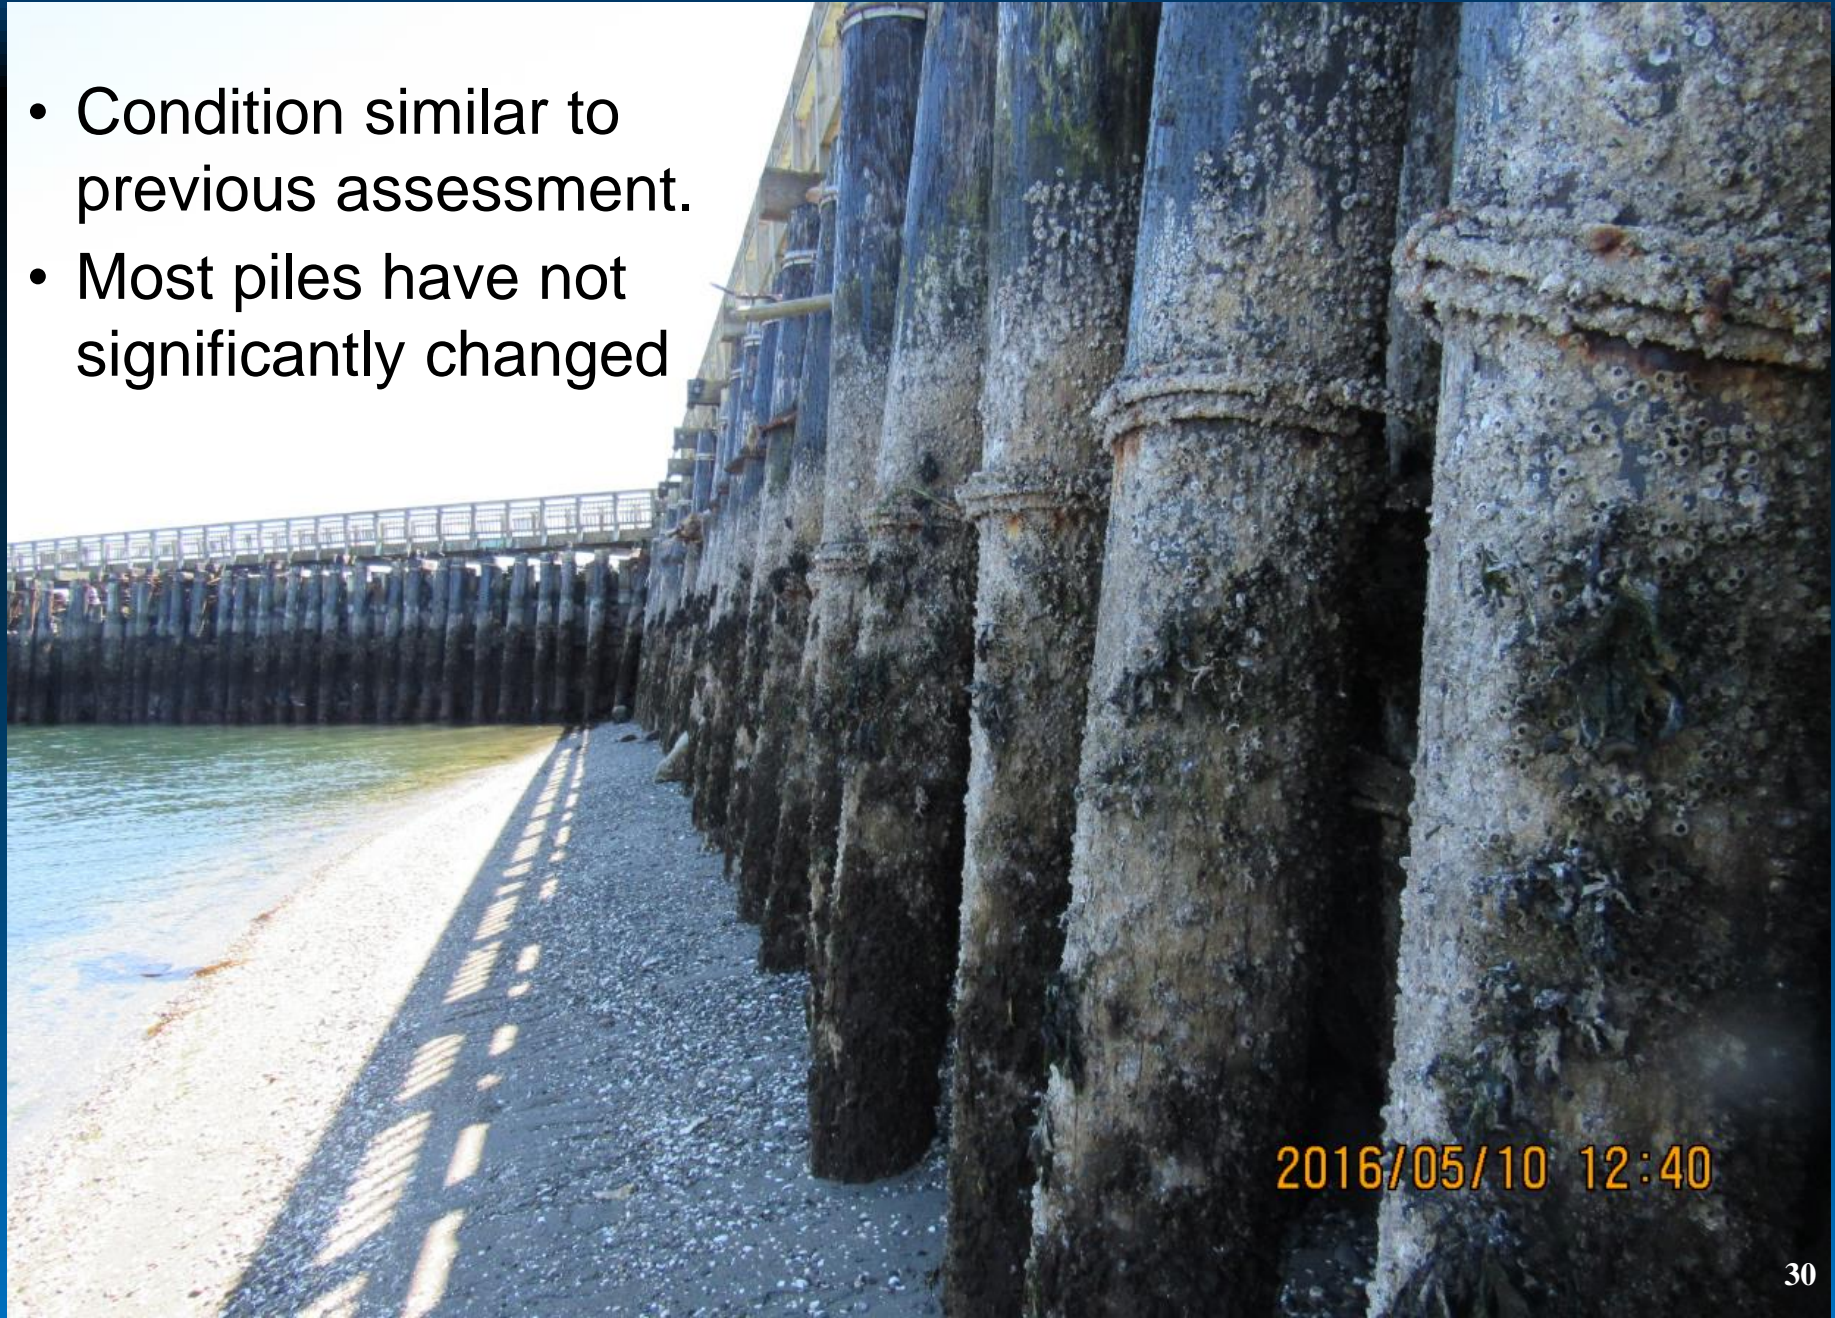
- Condition similar to previous assessment.
- Most piles have not significantly changed

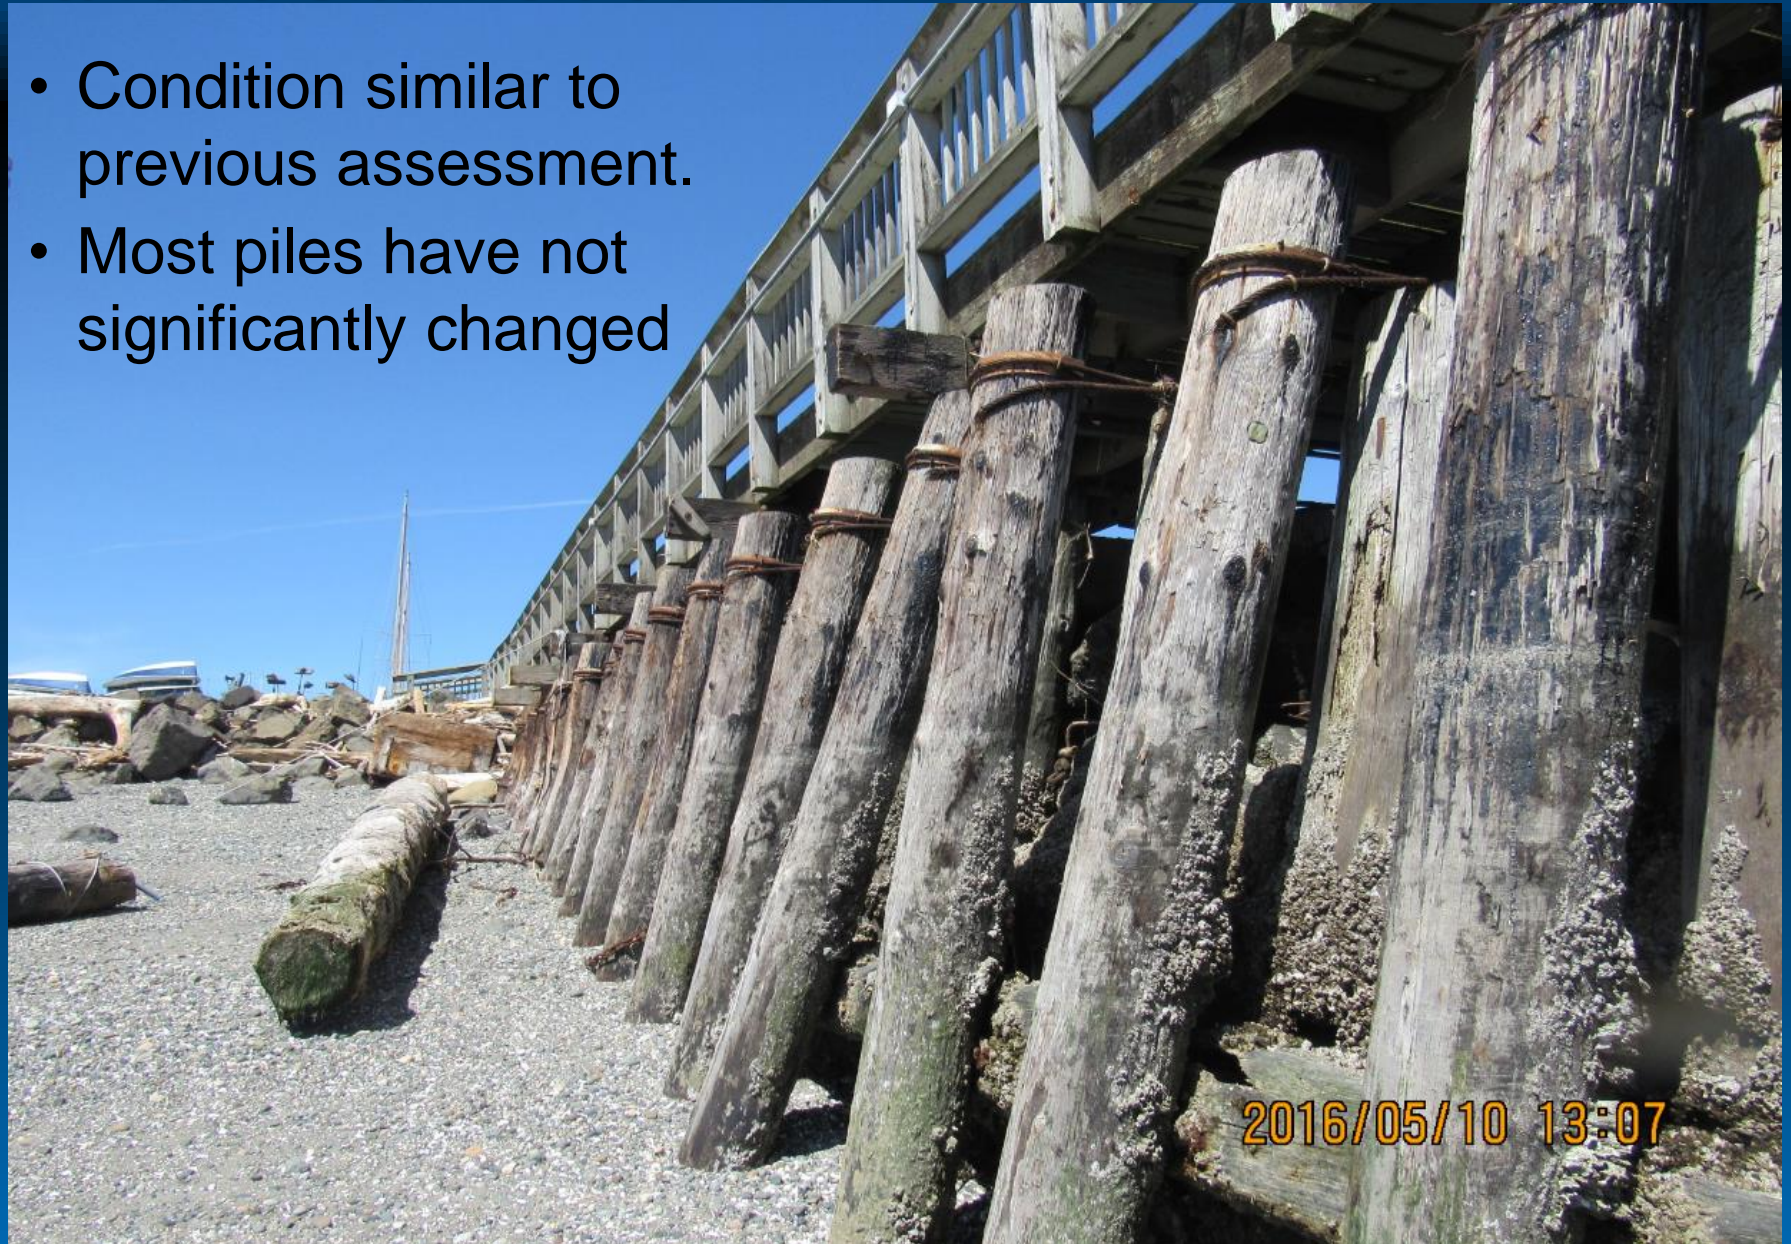
- Condition similar to previous assessment.
- Most piles have not significantly changed

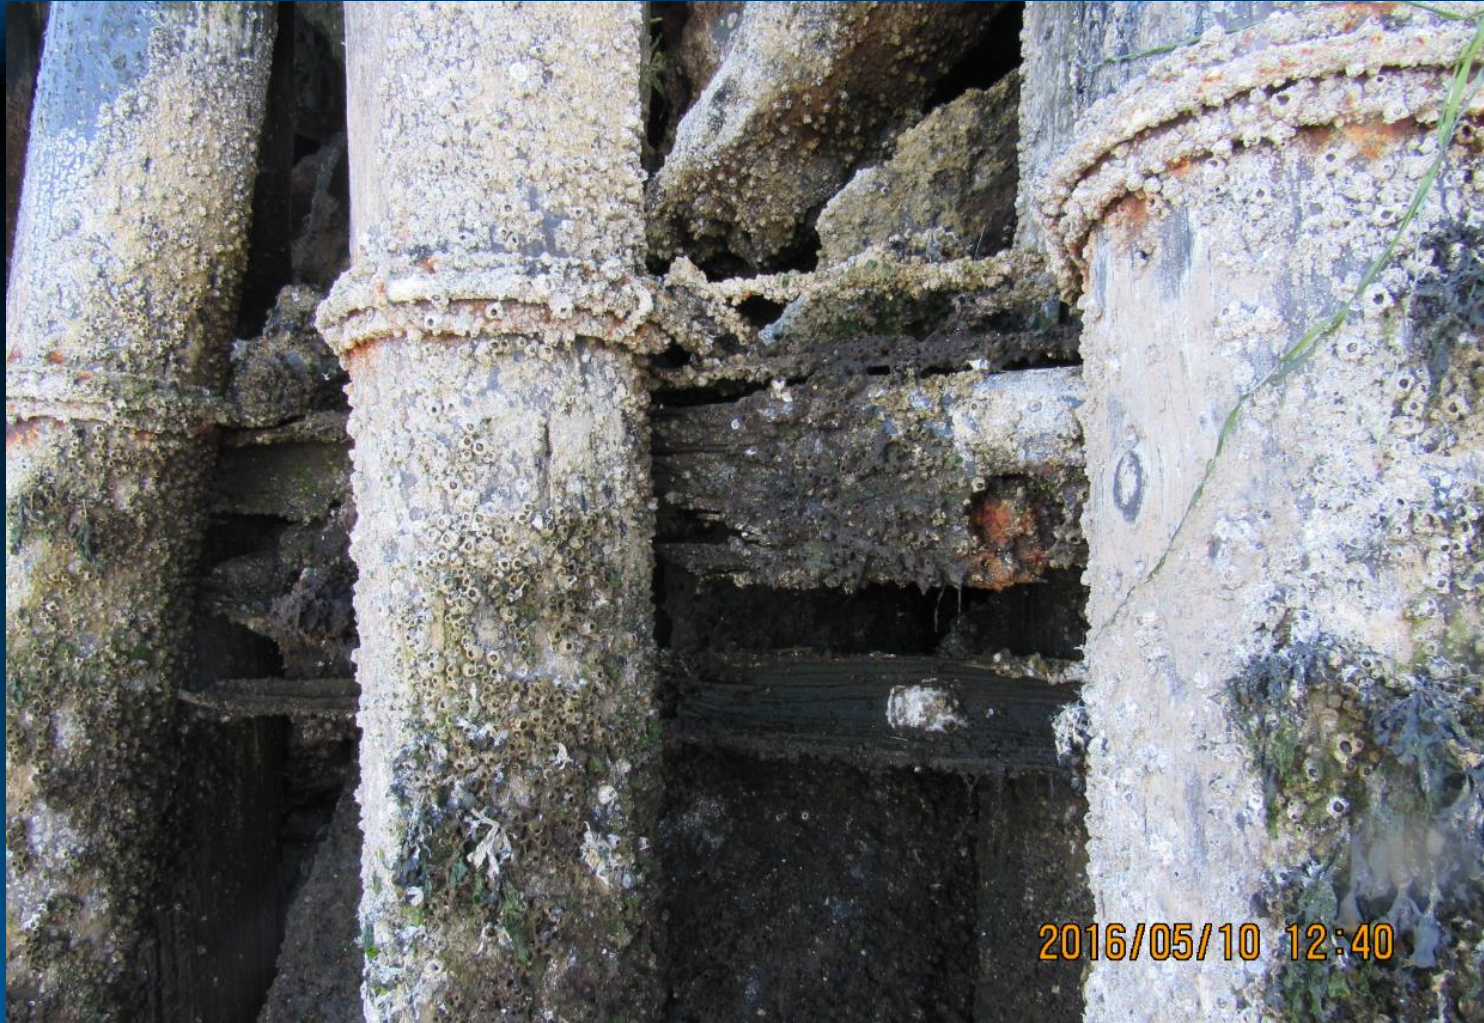
- Waler no longer functioning structurally in any capacity, only supporting some rock from coming through

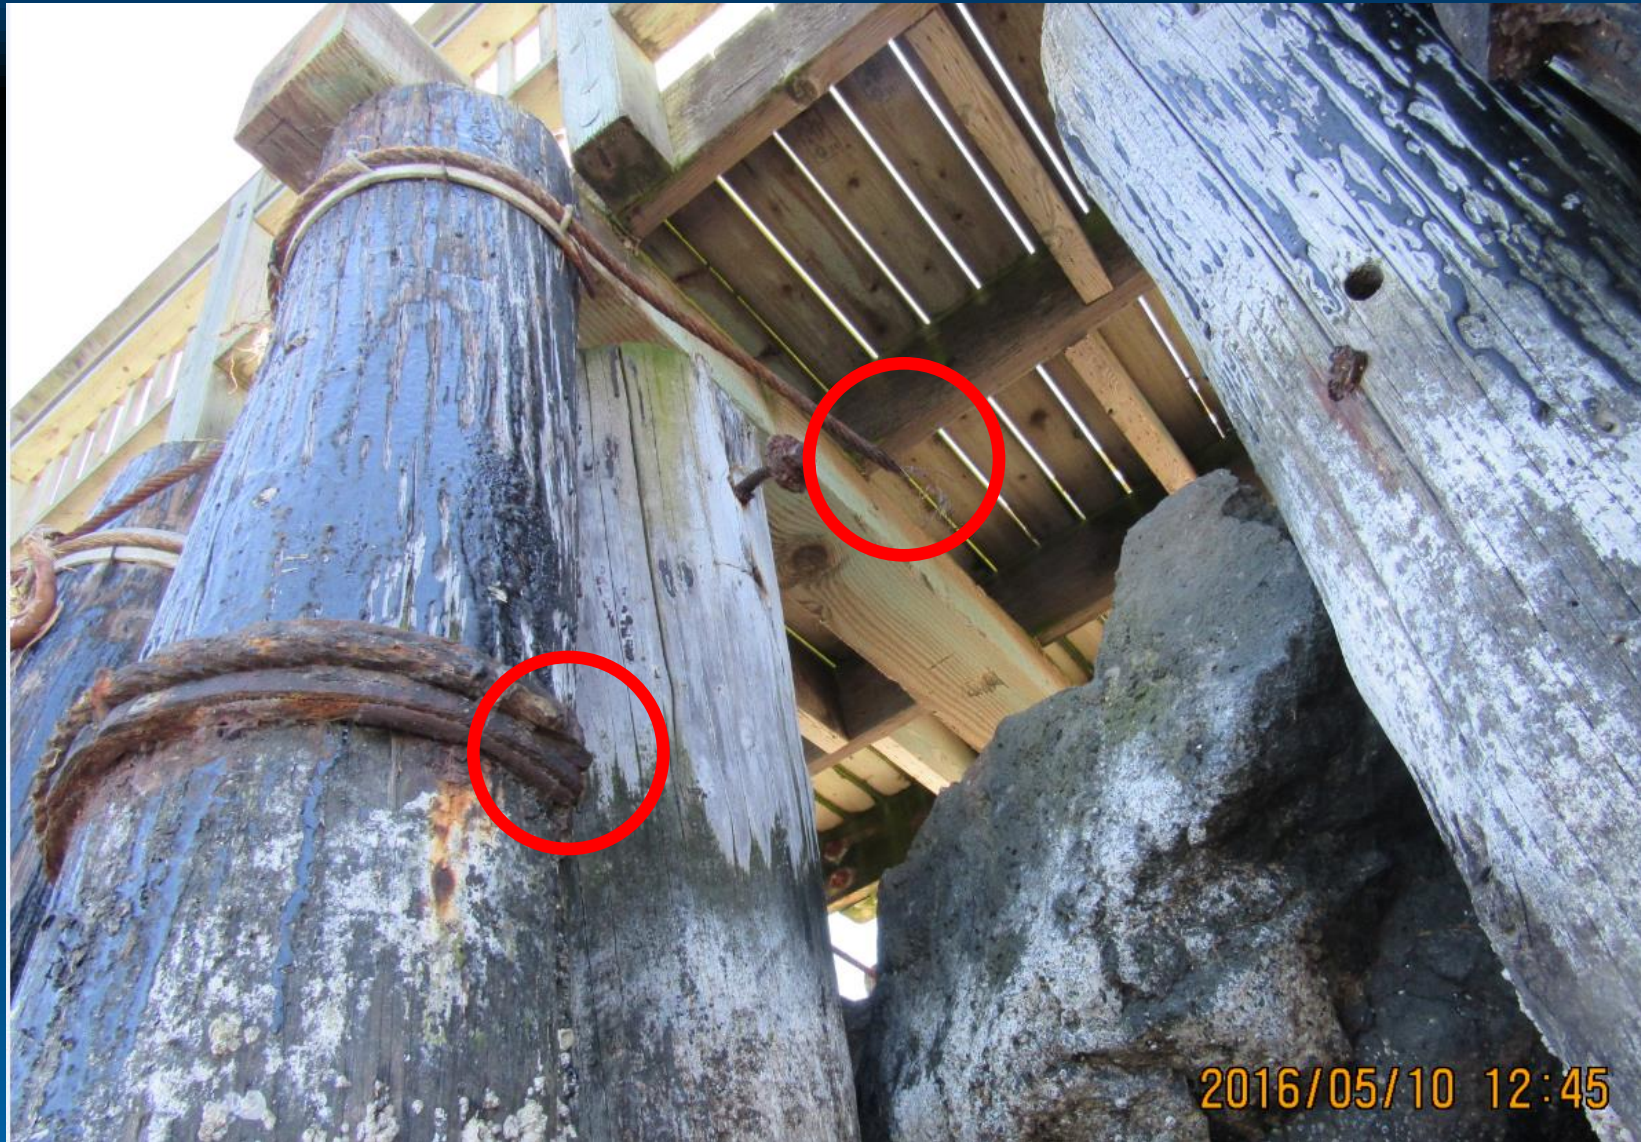
- Tiebacks very corroded, more likely broken

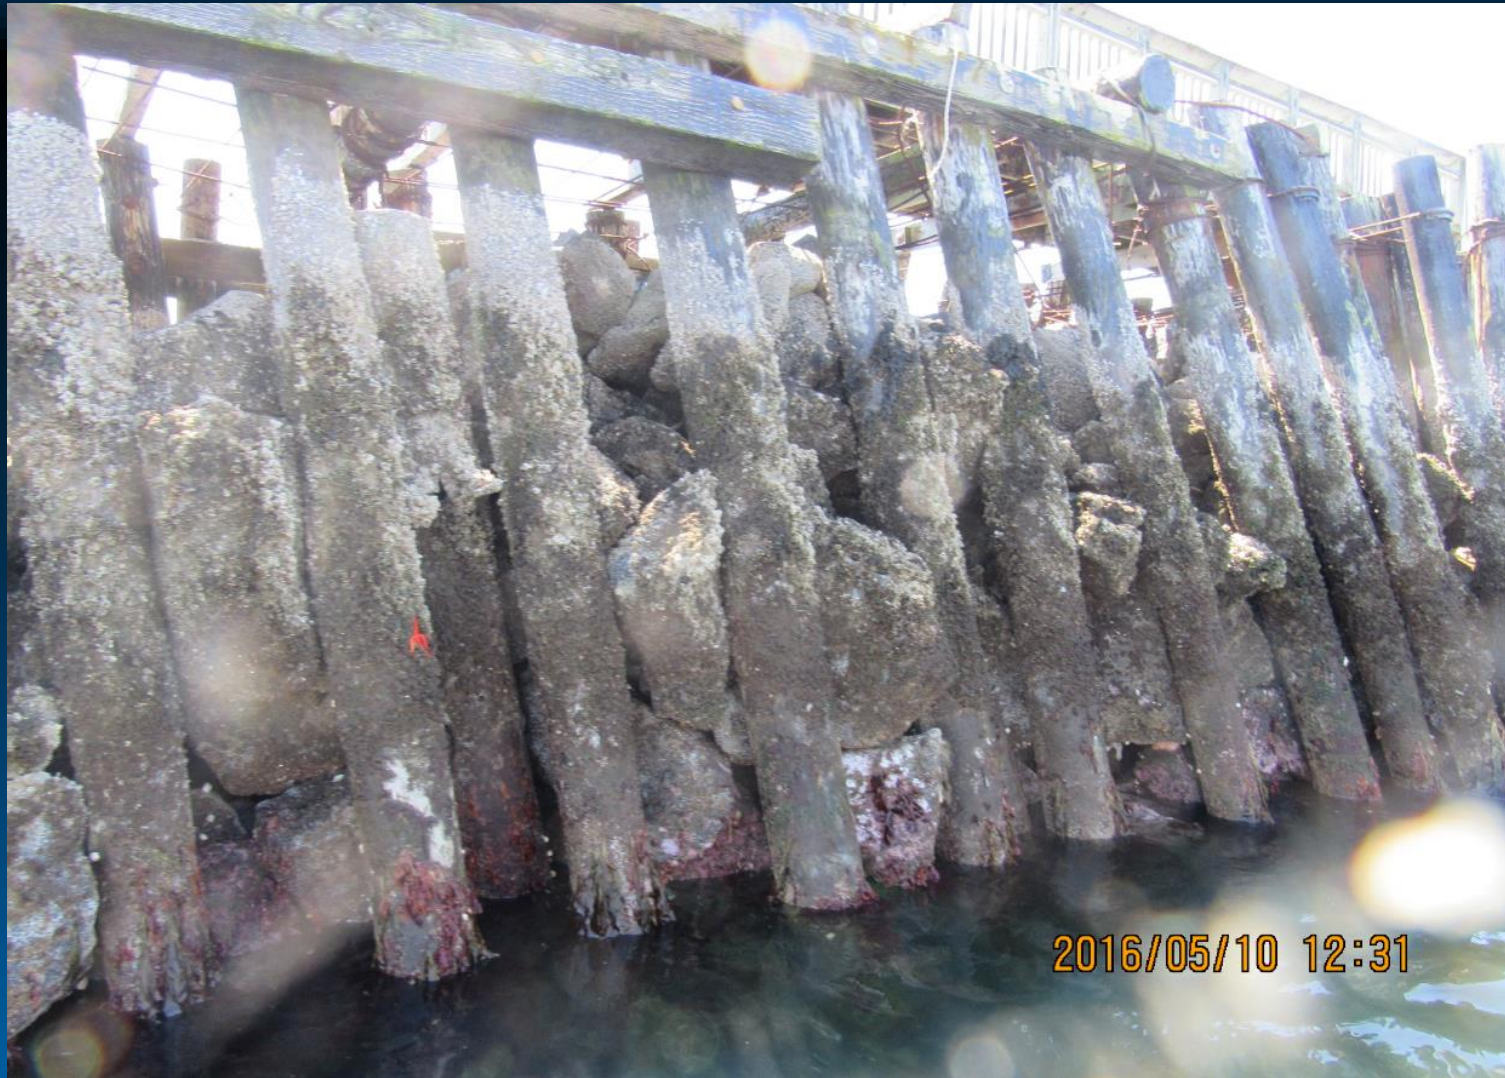
- Armor Rock continuing to break down and exit through piles
