PORT OF PORT TOWNSEND

Point Hudson Marina Breakwater Improvement Project

Work Status Update

June 8th 2016

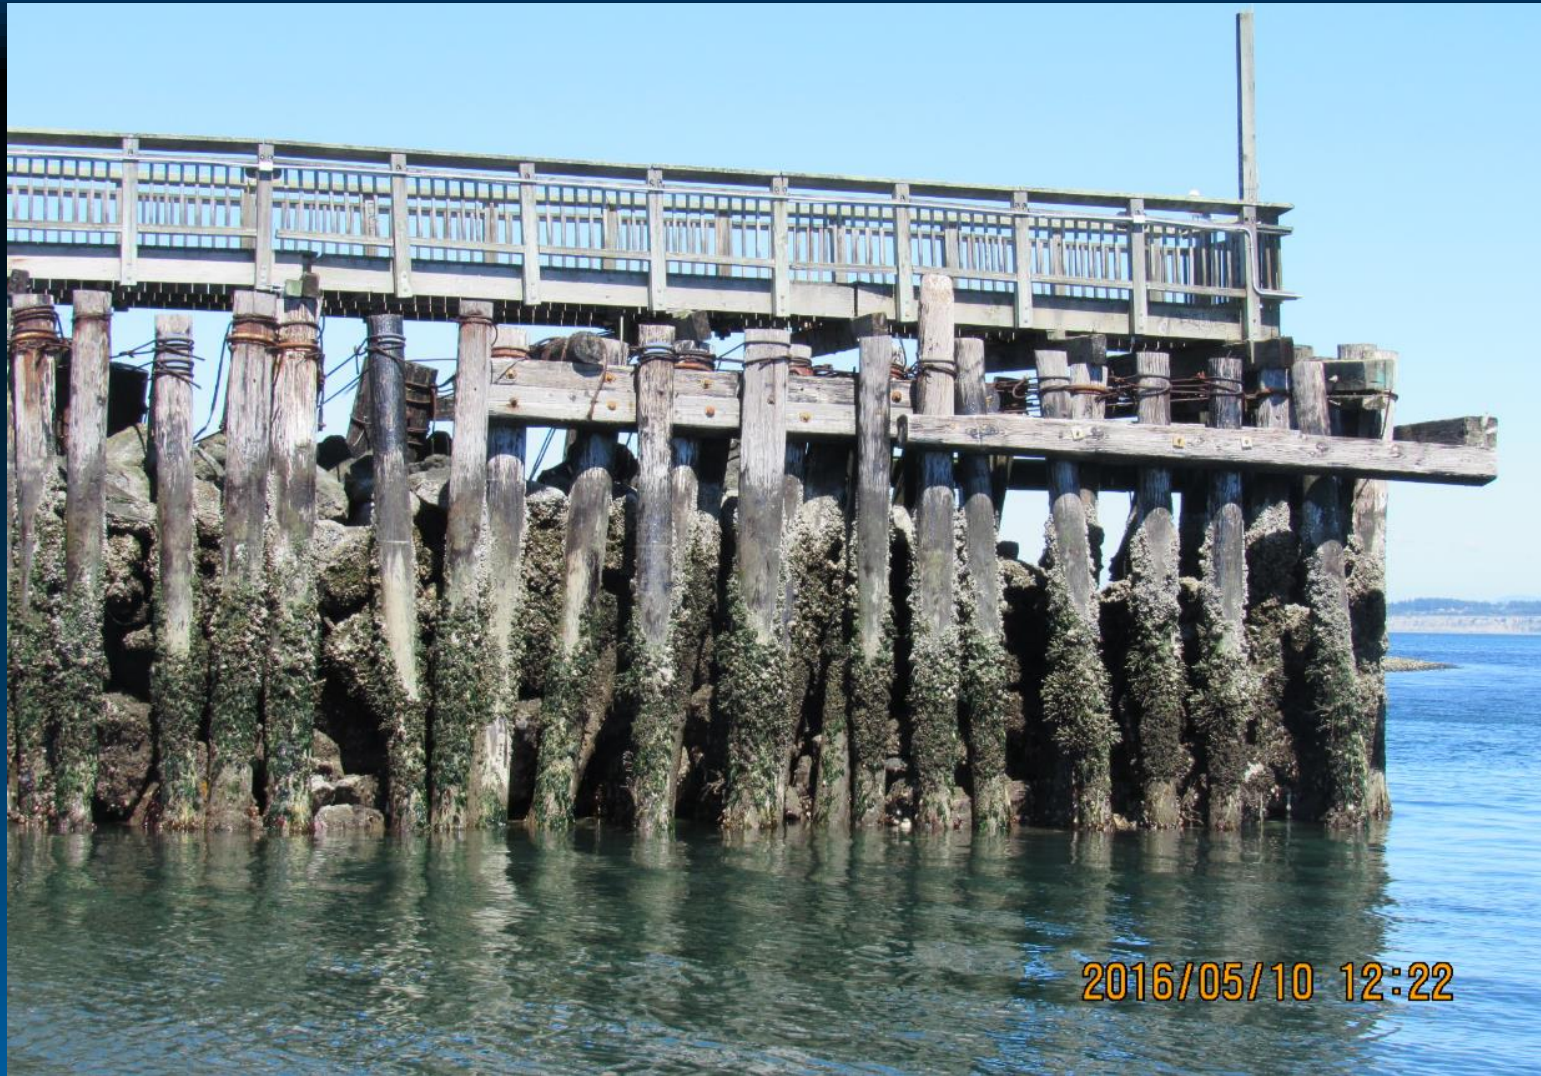
- Condition similar to previous assessment.
- May have slightly more rock loss in critical areas.

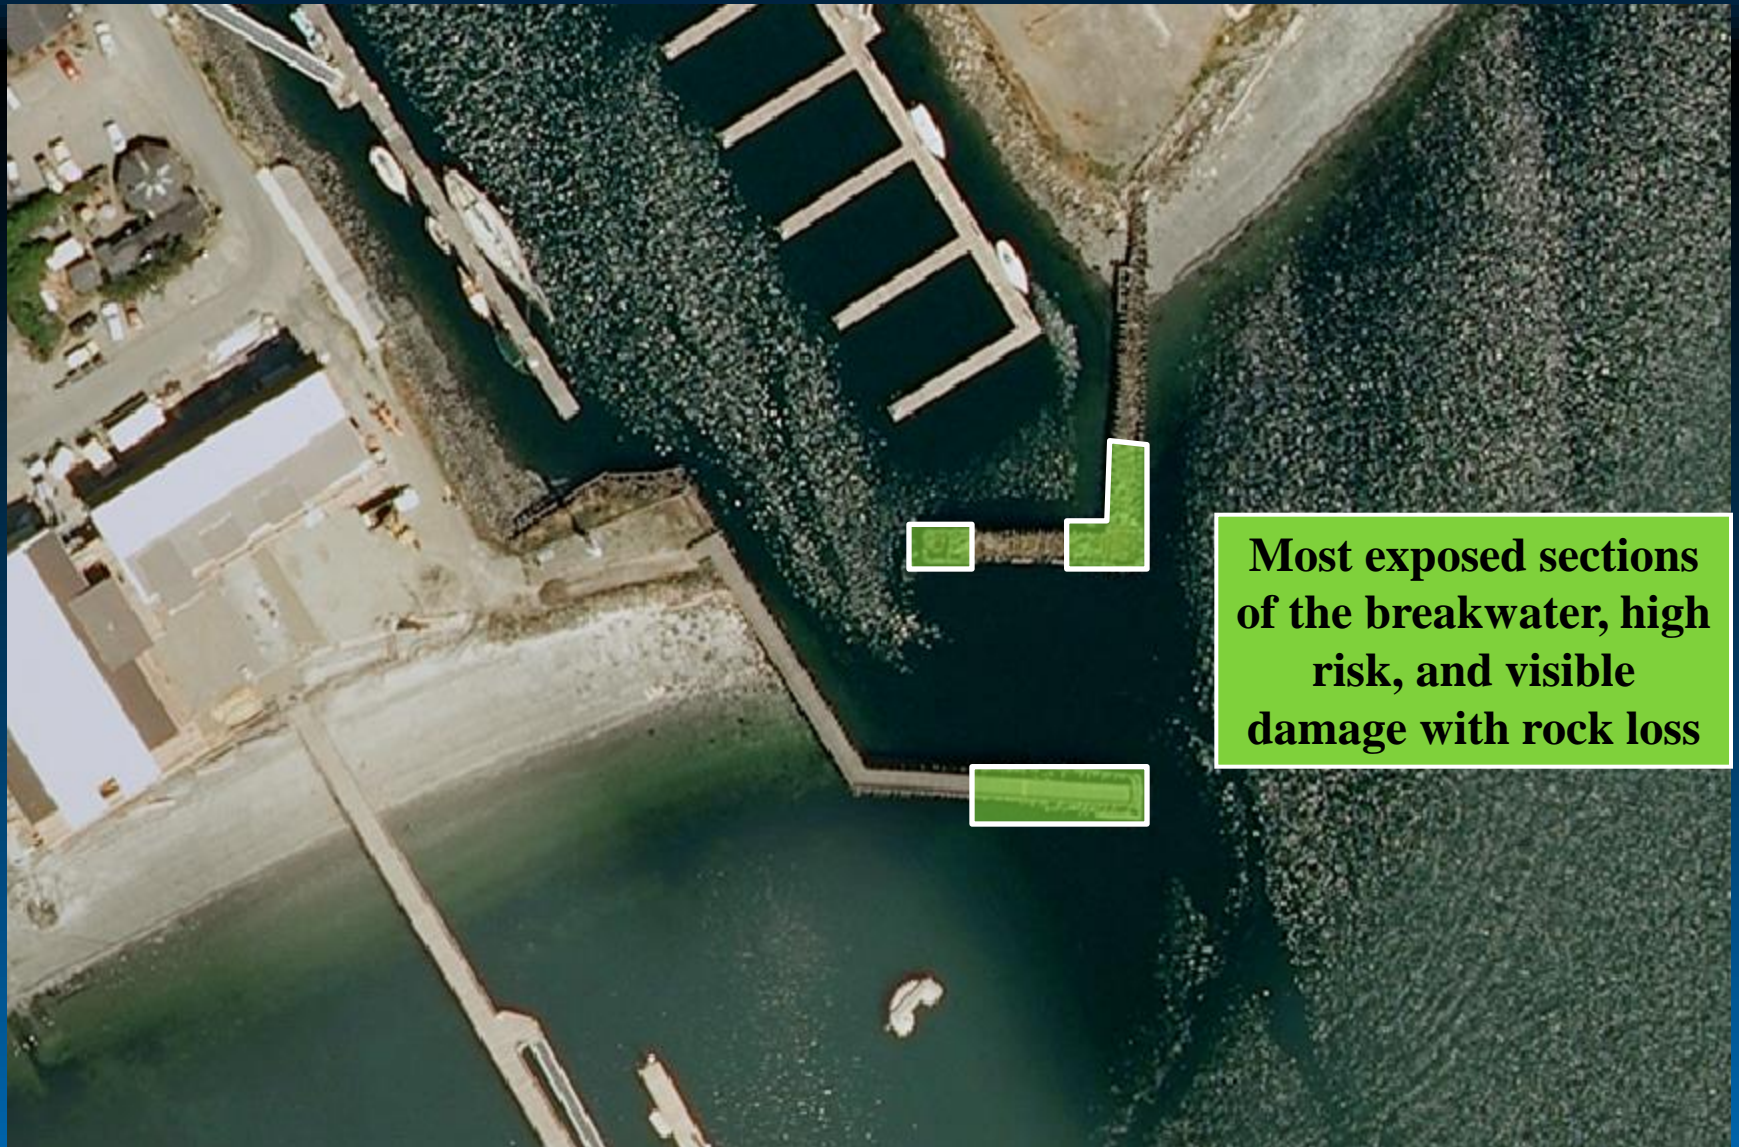
**Most exposed sections
of the breakwater, high
risk, and visible
damage with rock loss**

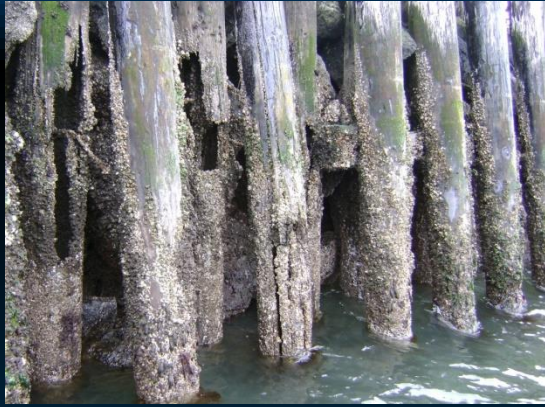
Pile Deterioration

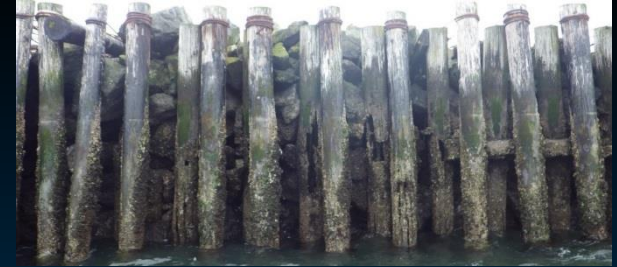
Waler Deterioration

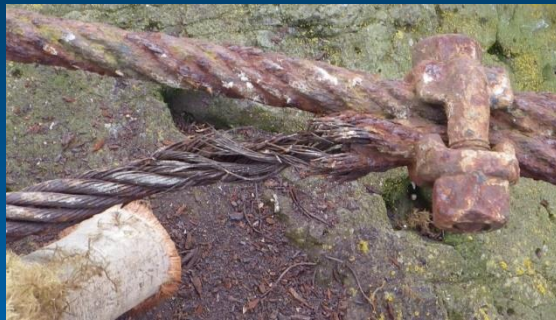
Cable Deterioration

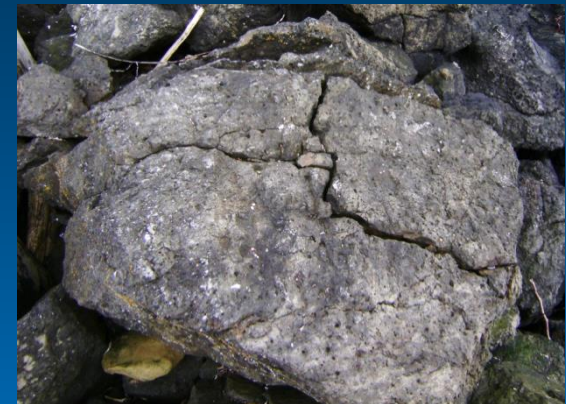
Stone Deterioration
