May 3, 2013

Port of Port Townsend
Post Office Box 1180
Port Townsend, WA 98368
Attn: Mr. Jim Pivarnik

RE: Port Hudson Breakwater, Structural Condition, Port Townsend,
Washington

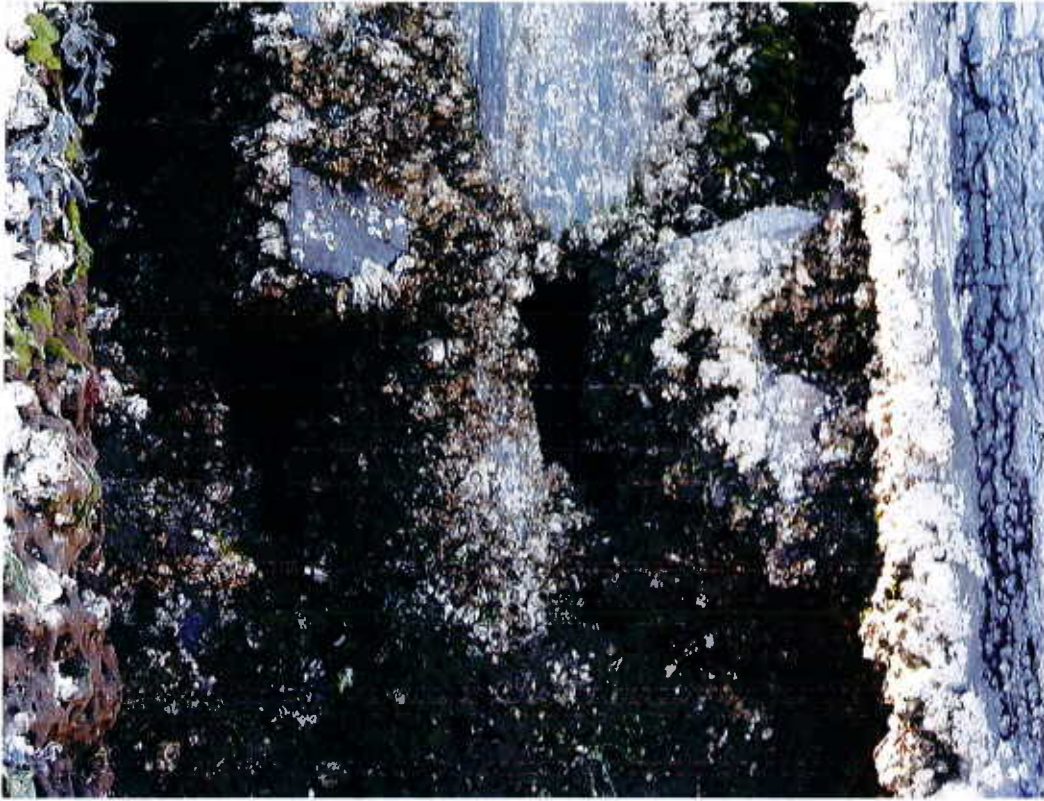
On the northern breakwater, north side, it appears that every original pile is severely deteriorated wherever a bolted connection of the horizontal waler beam was connected to the pile.

Inner pile holes at bolted connections

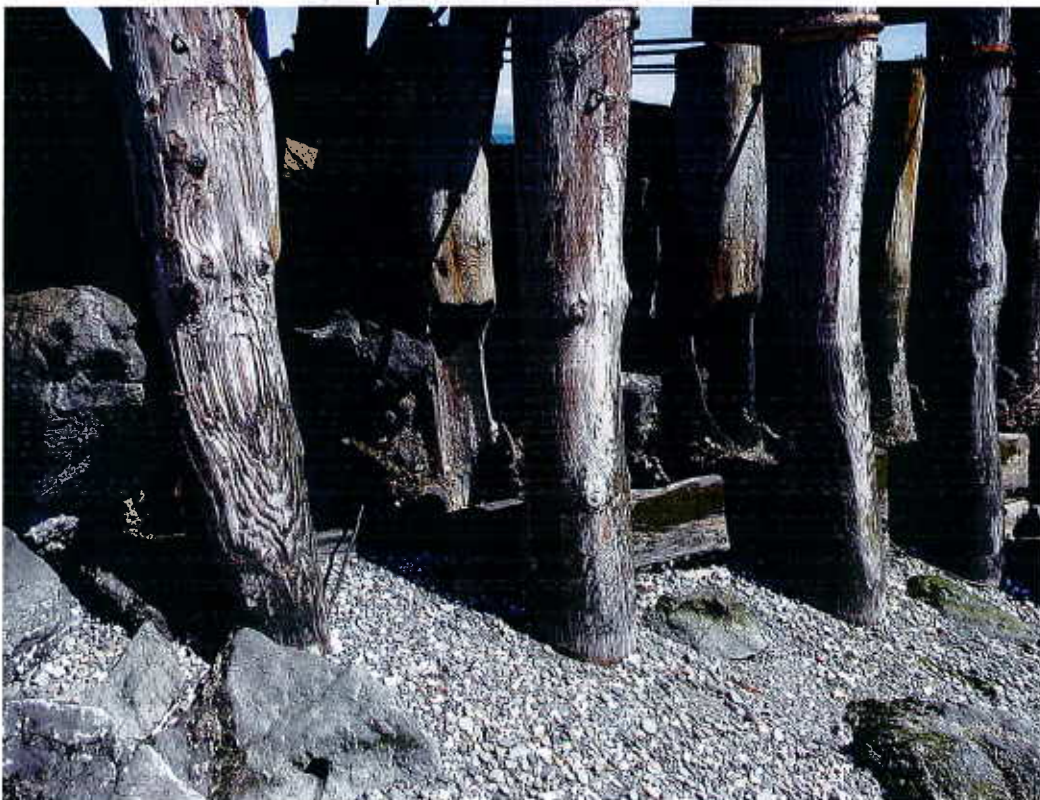
Some of the original interior row of piles are severely deteriorated to the point of offering no structural support. Along the southern breakwater near shore, some of the original piles have 1" thick shells remaining for approximately 8" of the original 36" circumference. The newer piles in the same area have been rubbed and eroded more than likely due to a floating log that was along side the piles for an extended length of time.

Worn piles and minimal original piles

A long term repair option would be to drive new piles in the outer row of piles between the existing piles to add strength to the breakwater. The piles may need to be steel as creosote is generally no longer allowed. The steel piles could be driven with known lengths allowing them to be galvanized and have brackets attached to the piles before driving for connecting brace beams between the new piles.

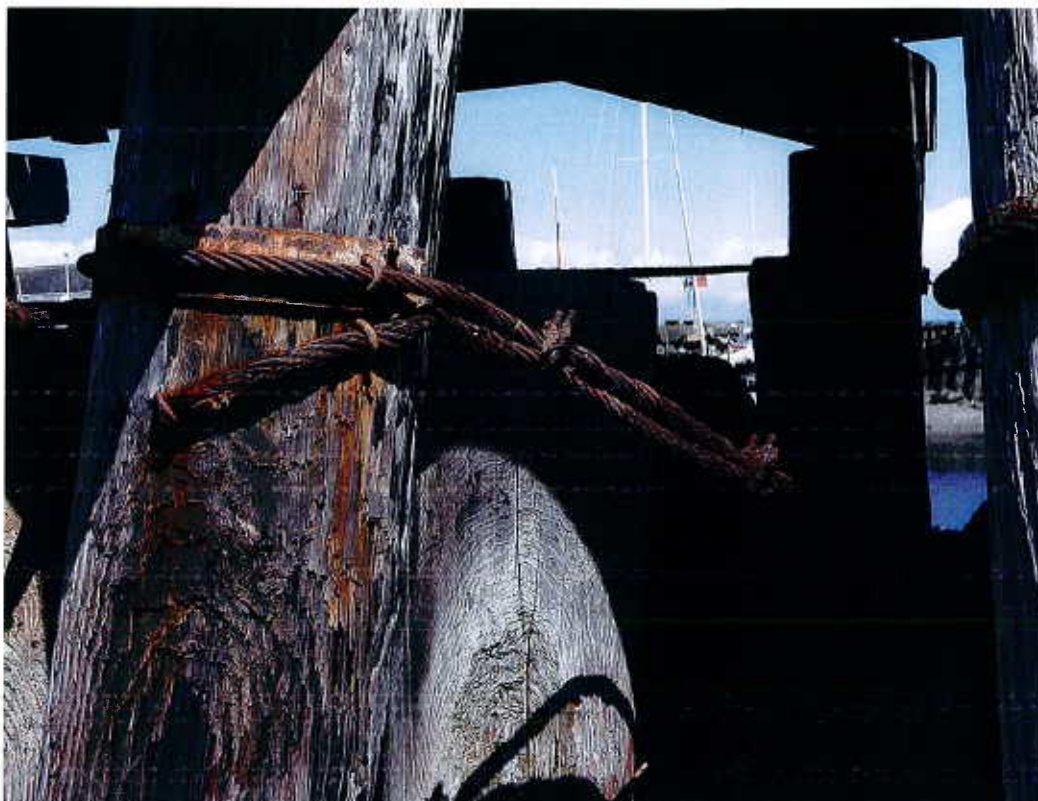
The steel cable ties that were added 18 years ago have severe rust and the individual cable wires are breaking.

Rusting cable ties

A repair to extend the life of the breakwater would be to replace the deteriorating steel cable ties between piles with new ones. This will force the piles to act together in holding the rock fill in.

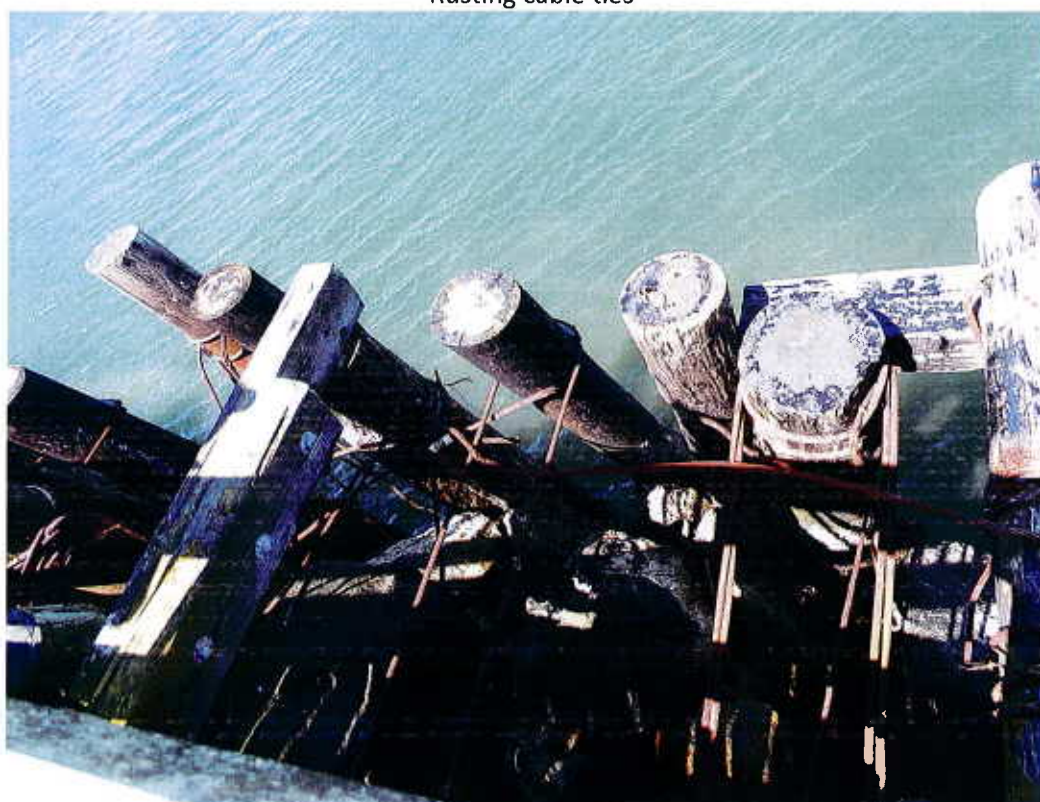
Many rusting cable ties

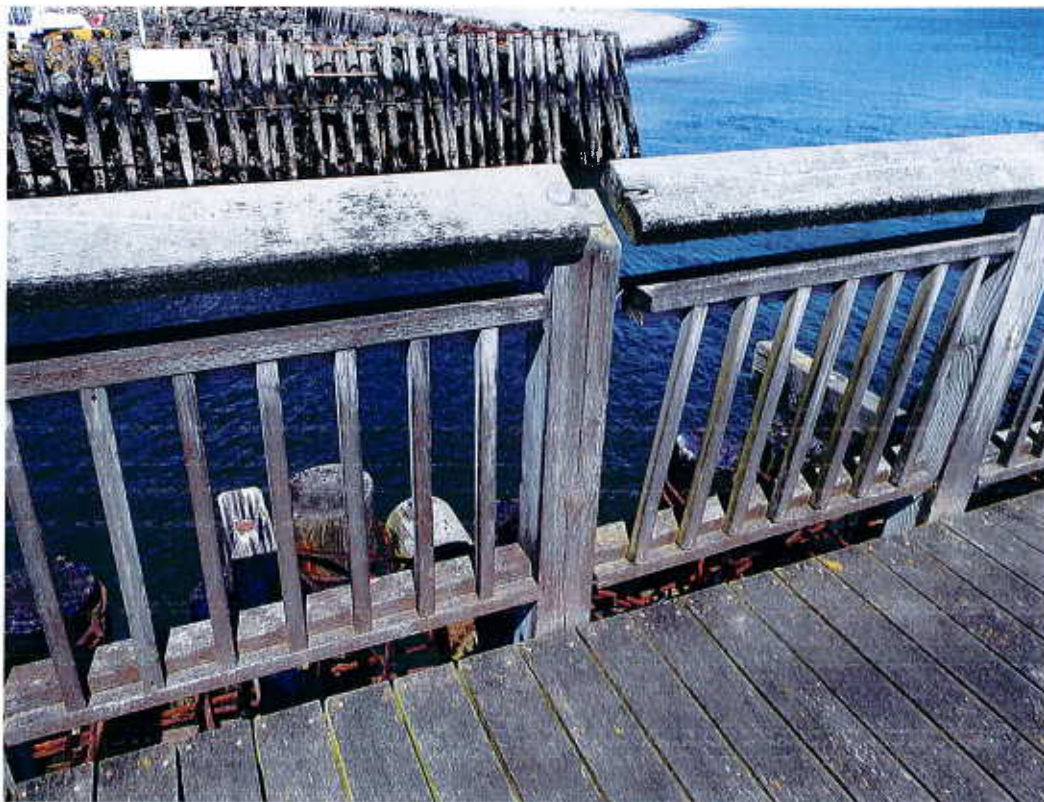
The timber framed walkway on the southern breakwater has shifted from movement of the piles below. The movement has allowed the rail to pull apart from the rail posts tops. The walkway is uneven and twisted over its' length.

Rail shift at southern breakwater walkway

The first repairs would be to re-establish the integrity of the walkway rail system. The rail posts and top rails should be repaired to a safe condition.

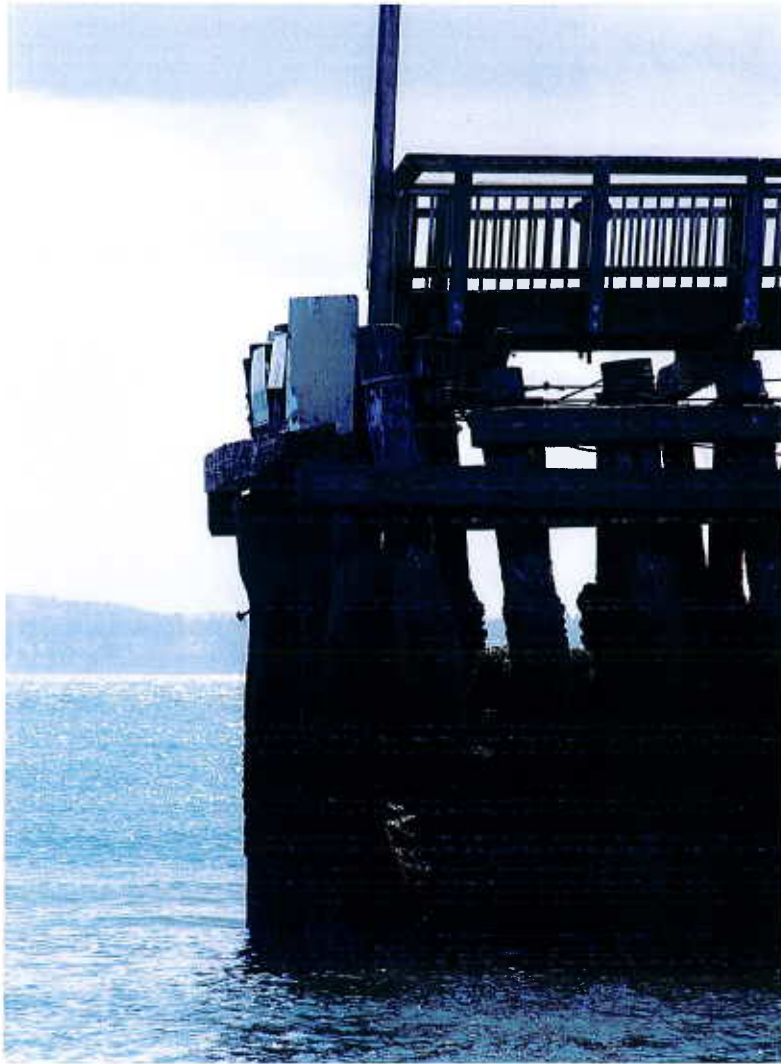
At the far end of the southern breakwater, some of the newer piles have shifted to allow the large rocks to fall out of the breakwater. The boat harbor side of the

Shifted piles at southern breakwater end

At the end of the southern breakwater where the piles have shifted, new horizontal timbers should be added to provide members that can hold the large rock in place. New large rocks should be added to replace the ones that have fallen through the gaps.

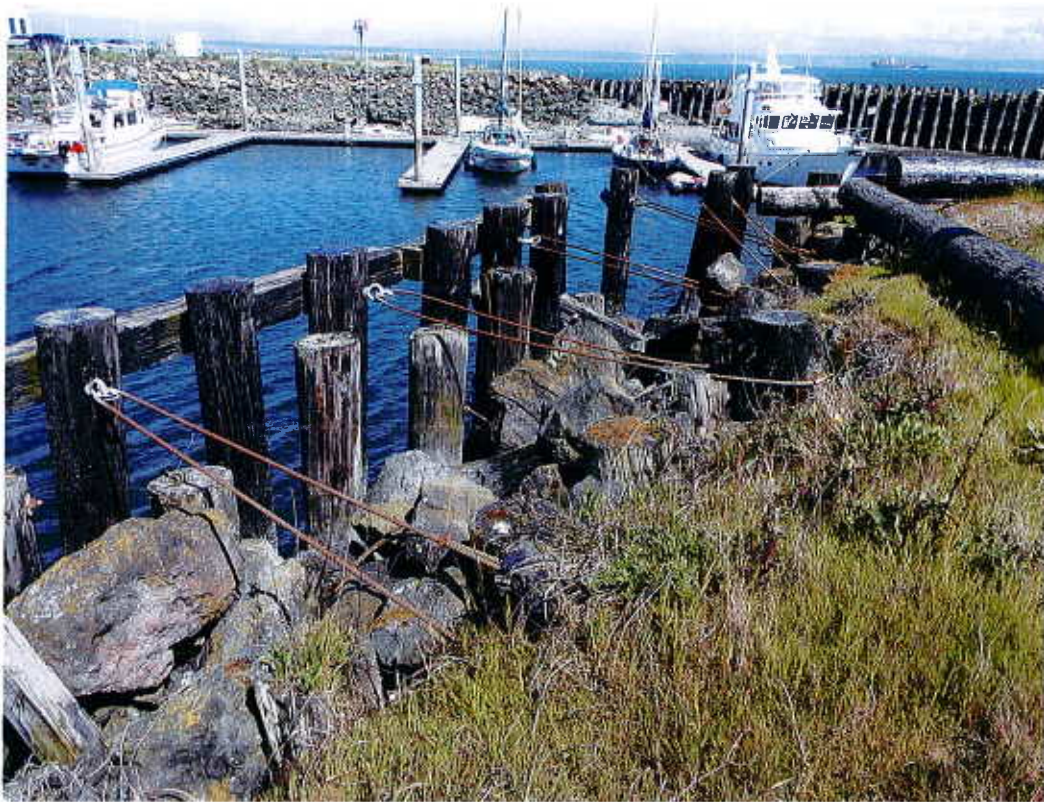
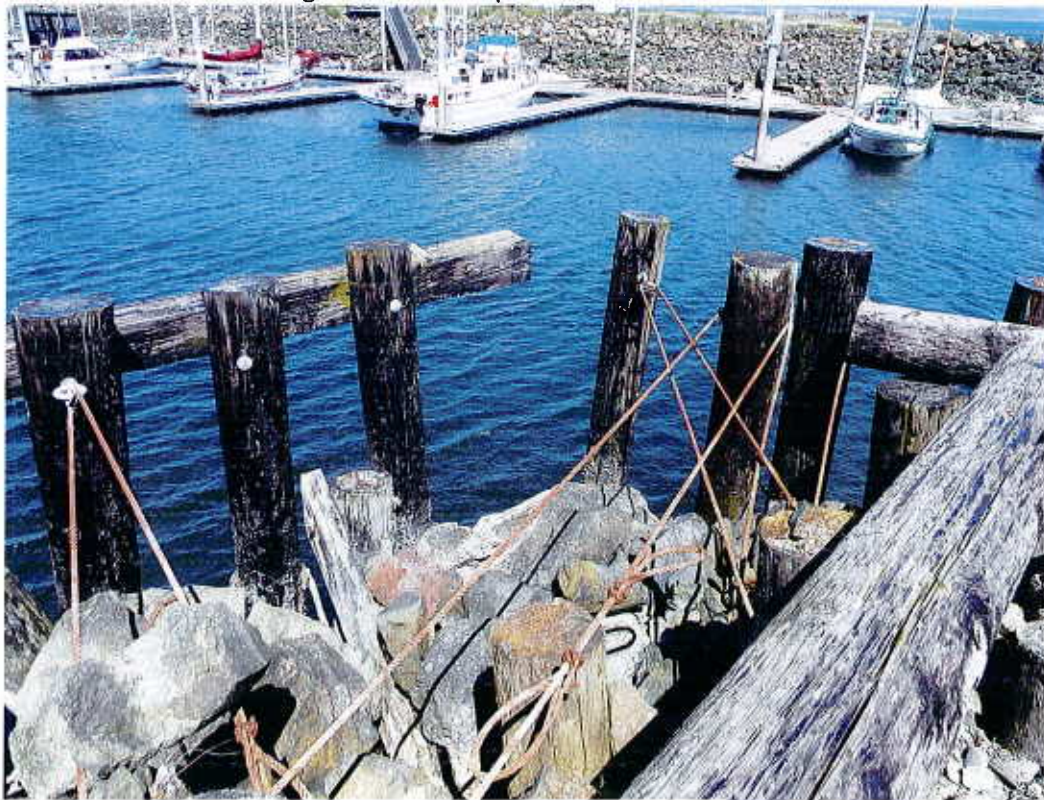
southern breakwater at the beach appears that it has been over-topped by waves that have shifted piles and allowed the rock to fall out.

Missing rock & shifted piles at southern breakwater

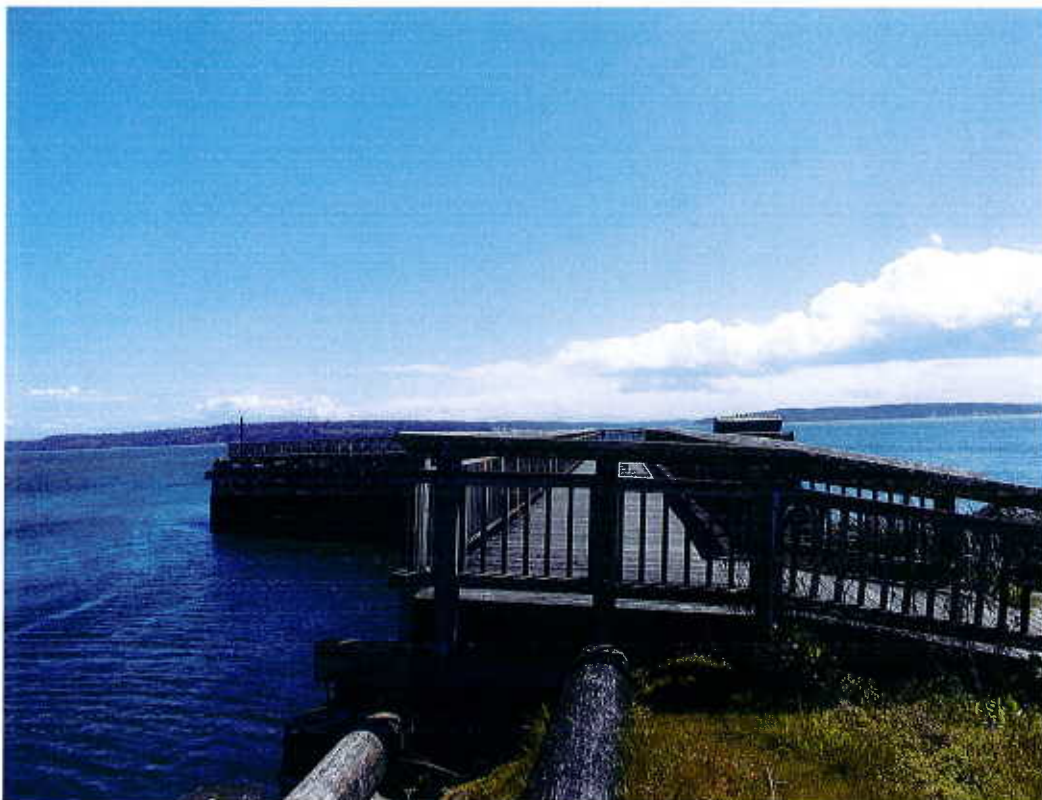
Tilt of walkway

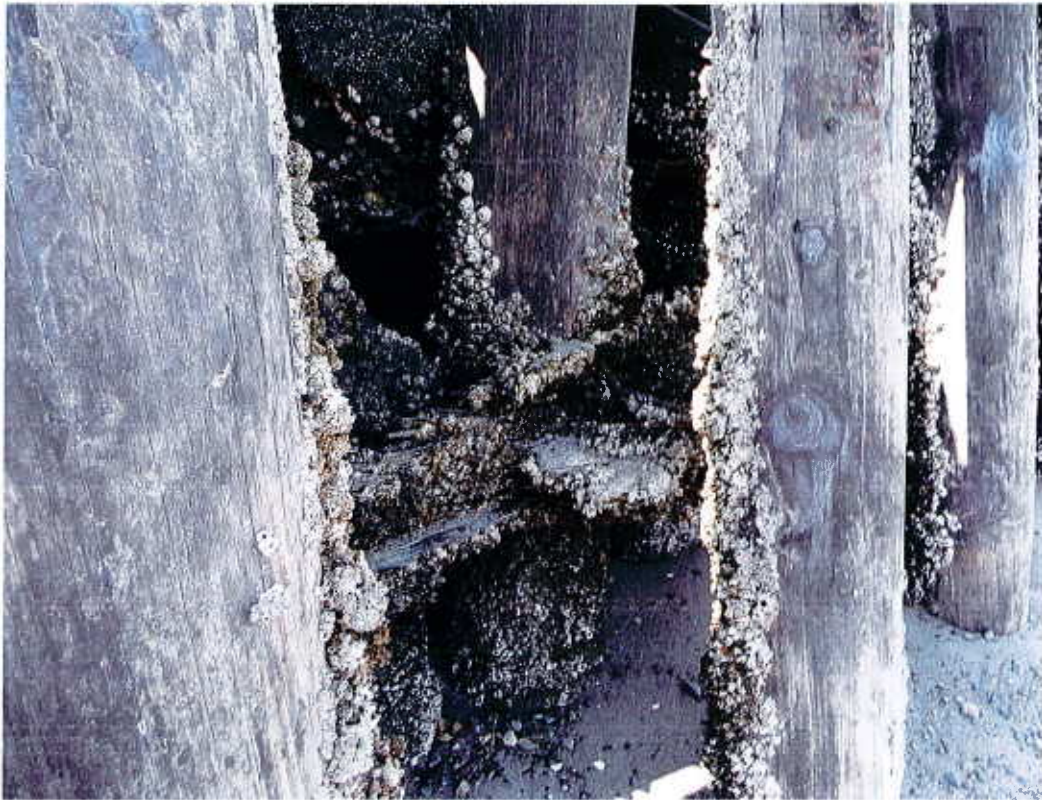
The horizontal waler beam in many places is non-existent. The waler beam has actually rotted to nothing.

Rotted waler at northern breakwater

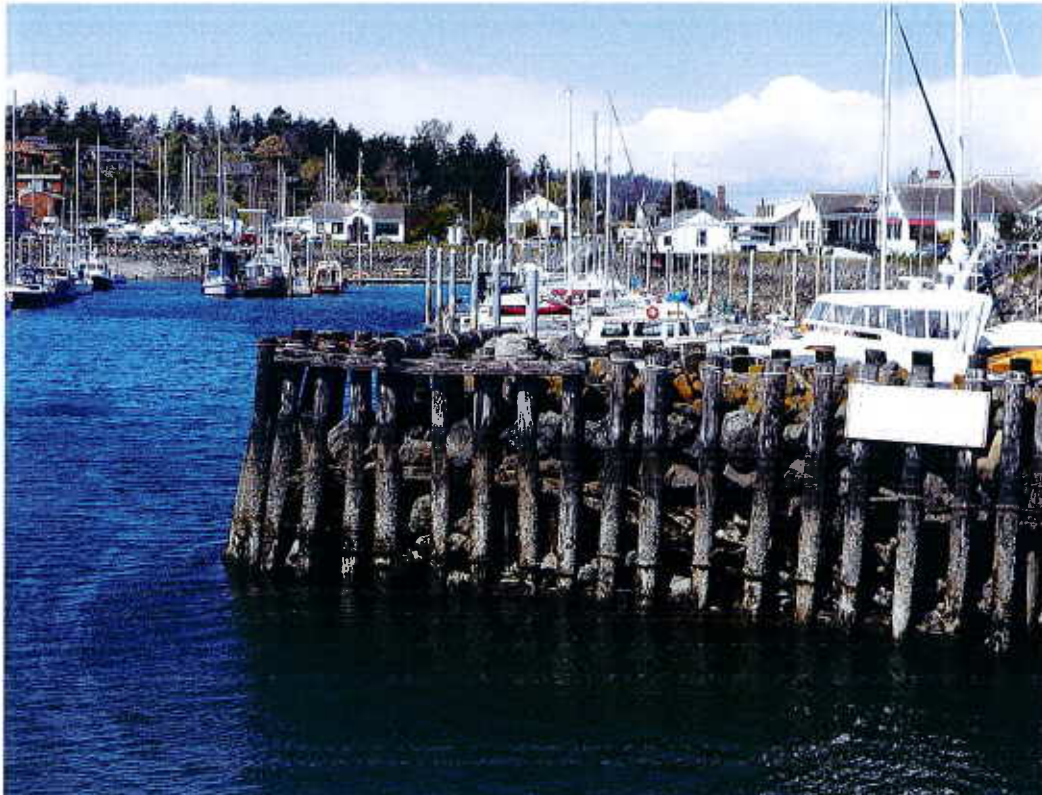
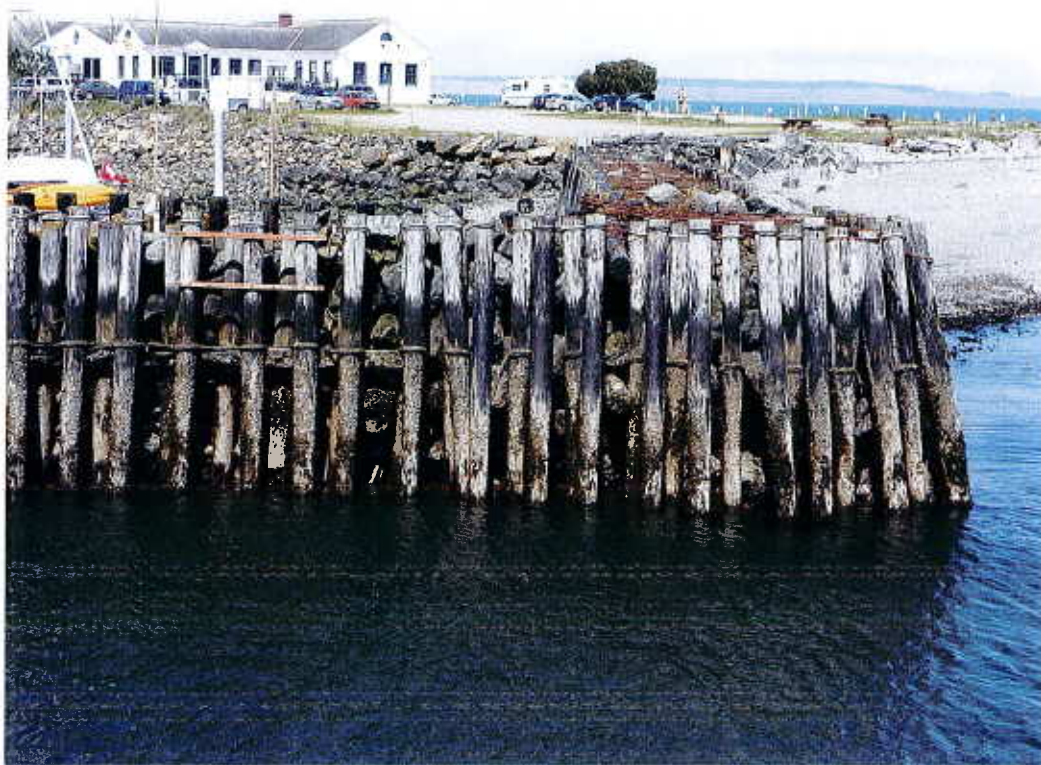
Northern breakwater with rotted horizontal waler
