Point Hudson

Breakwater Improvement Project

Selected Alternative Feb 12th, 2020

Introduction & Assessment

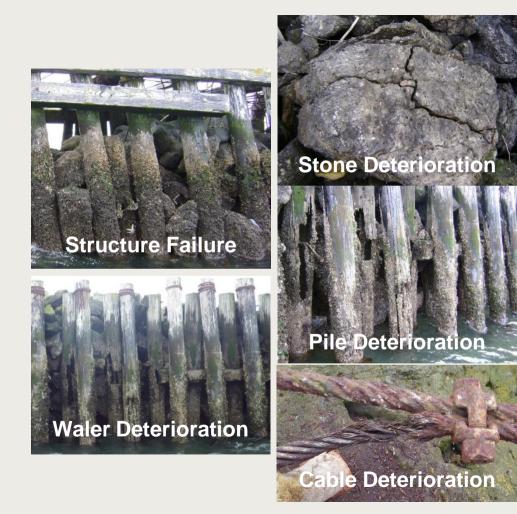
Timber piles, walers, cable tiebacks, and armor rock are at or beyond useful life. Stability of the overall structural system is compromised.

- The most advanced structural deterioration was observed at the end of the south breakwater.
- Voids in the riprap reduce the system's wave protection capability.
