Point Hudson

Breakwater Improvement Project

Selected Alternative
Feb 12th, 2020

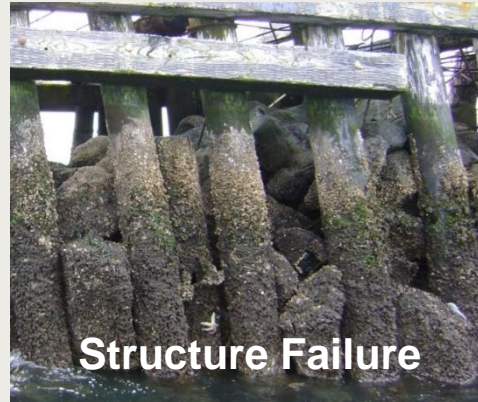
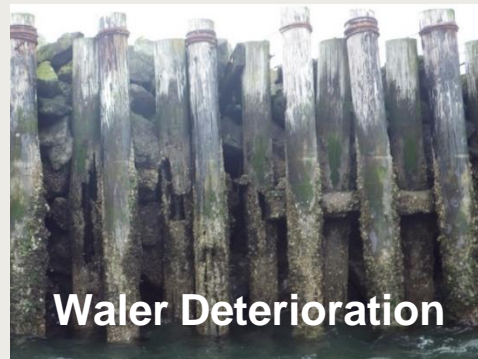
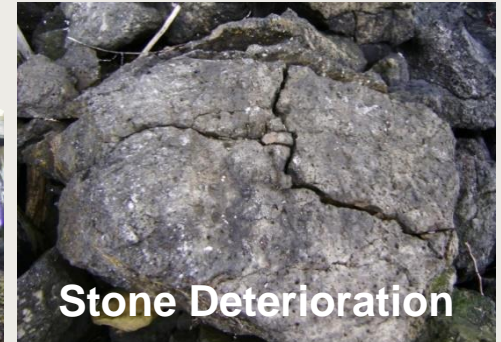
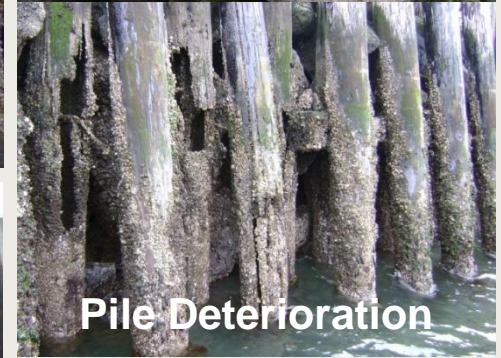
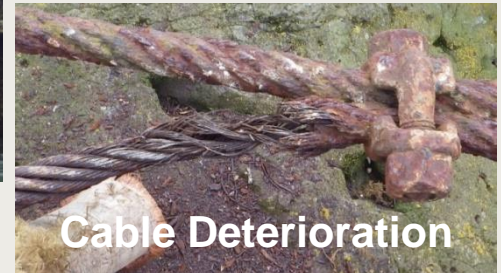
Timber piles, walers, cable tiebacks, and armor rock are at or beyond useful life. Stability of the overall structural system is compromised.

- The most advanced structural deterioration was observed at the end of the south breakwater.
- Voids in the riprap reduce the system's wave protection capability.
