## GEOMORPHIC ASSESSMENT OF CHIMACUM CREEK

North Olympic Salmon Coalition  
205 W Patison St. b,  
Port Hadlock, WA 98339  
360.379.8051

1900 N. Northlake Way, Suite 211  
Seattle, WA 98103

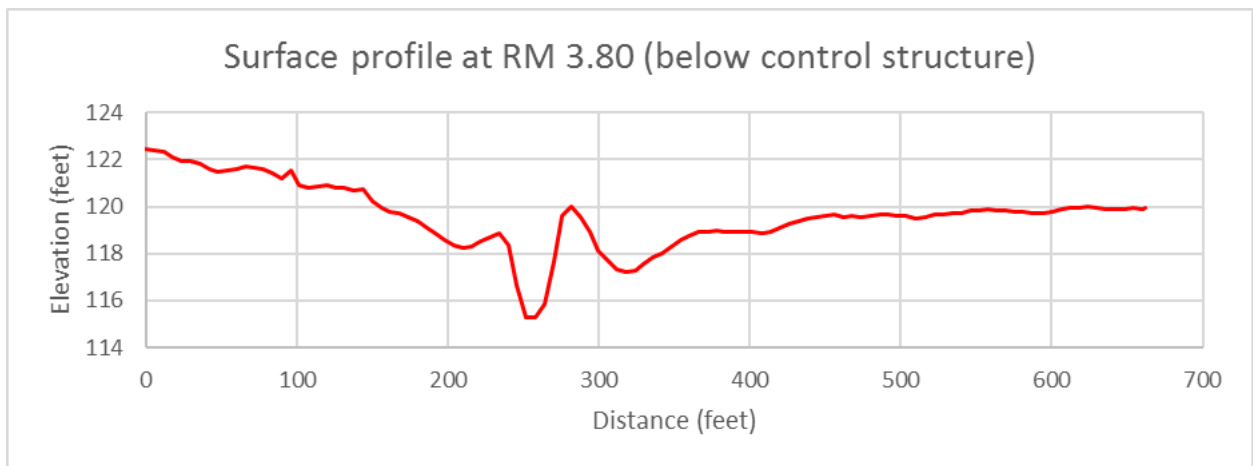
**Figure 6.** Elevation profile (looking downstream) across main stem Chimacum Creek at RM 3.8, illustrating channel incision (channel is located at approximately 250' across the transect) and relict meander bend (at approximately 310'). Note that profile is vertically exaggerated. See Figure 13 for location of transect.

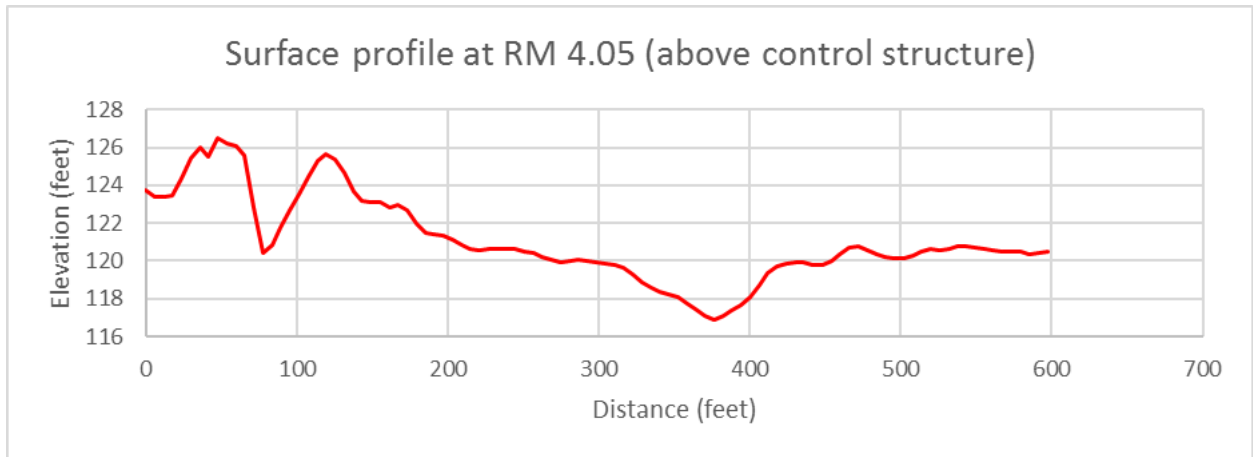
**Figure 7. Elevation profile (looking downstream) across main stem Chimacum Creek at RM 4.05, illustrating elevation of channel (ditch, located at approximately 75' across the transect) relative to lower, relict meander bend evident in the REM map (at approximately 375' across the transect). Note that profile is vertically exaggerated. See Figure 13 for location of transect.**

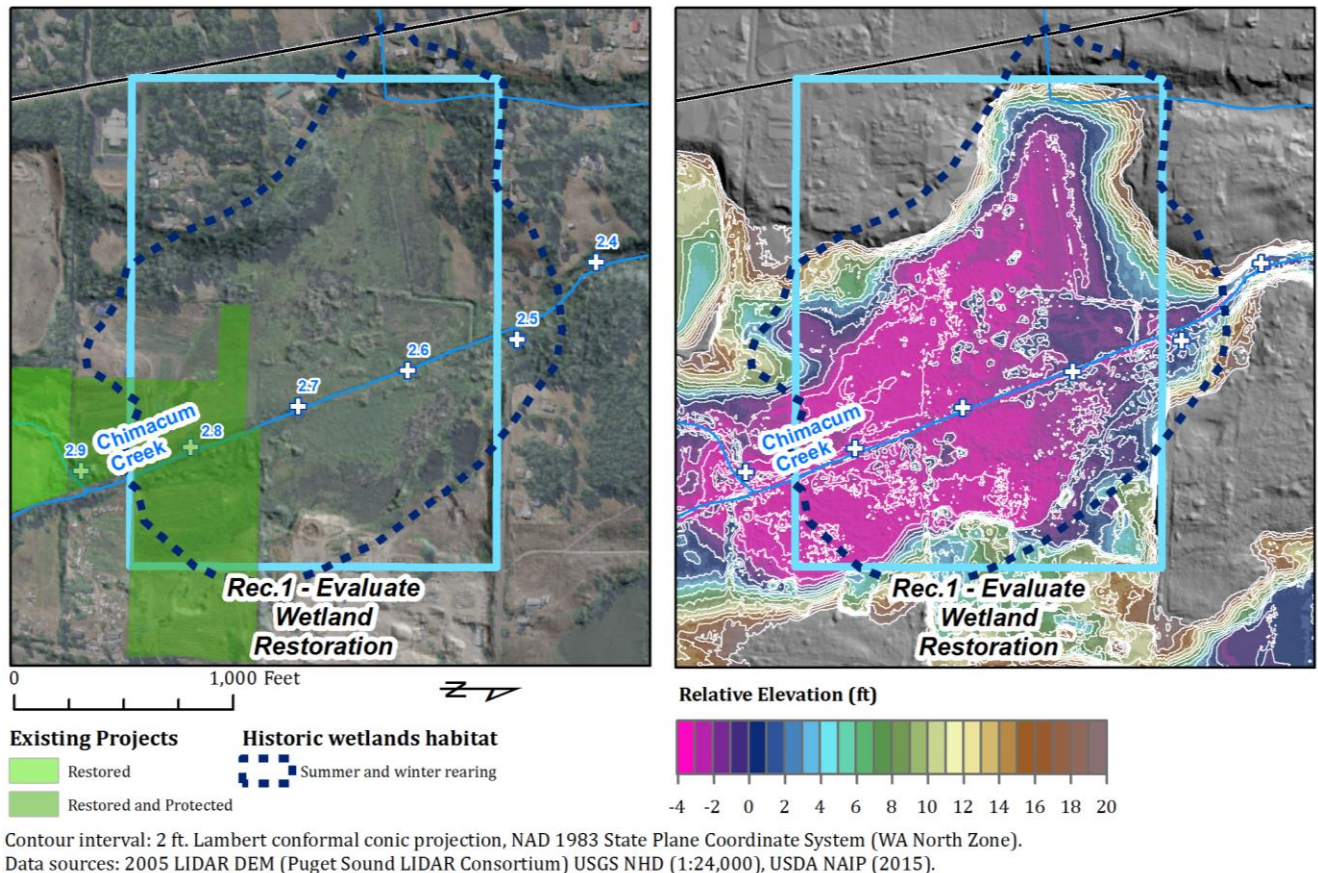
We additionally identified one location (RM 2.6) downstream of the confluence that appears from aerial imagery to be undeveloped wetland. However, zoning records indicate a mix of zoning for residential houses, agricultural open space and vacant land. We recommend an investigation of the zoning and ownership status of this land and possible protection as designated wetland.

Figure 10. Location near RM 2.6 where we recommend assessment of river and wetland function and zoning, for possible protection.

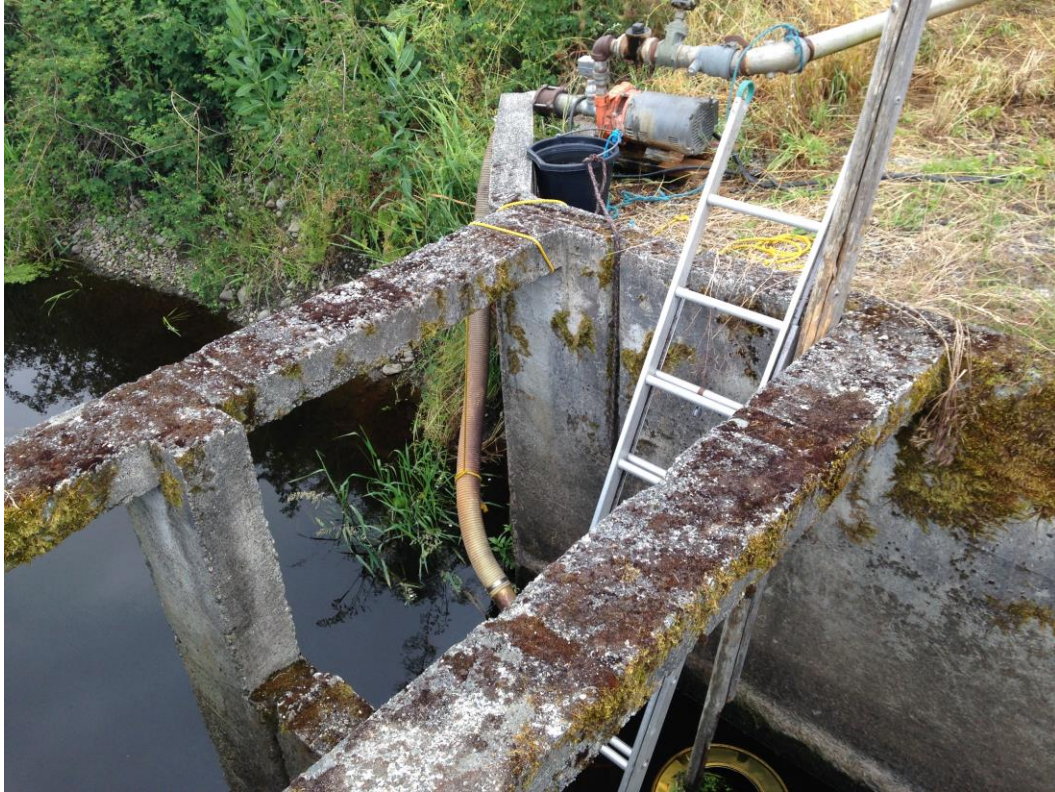
Figure 11. Field photograph of irrigation control structure near RM 4.0, facing left bank.

- ▶ An irrigation control structure was observed at RM 4.0. The operation of this structure represents a major data gap because of the hydraulic control that impoundment of flow exerts of the river. We hypothesize that channel incision surrounding this structure is related to its presence and operation, but the timing and nature of its operation are unknown. Additionally, any other control structures in the valley and their operations should be identified if possible.

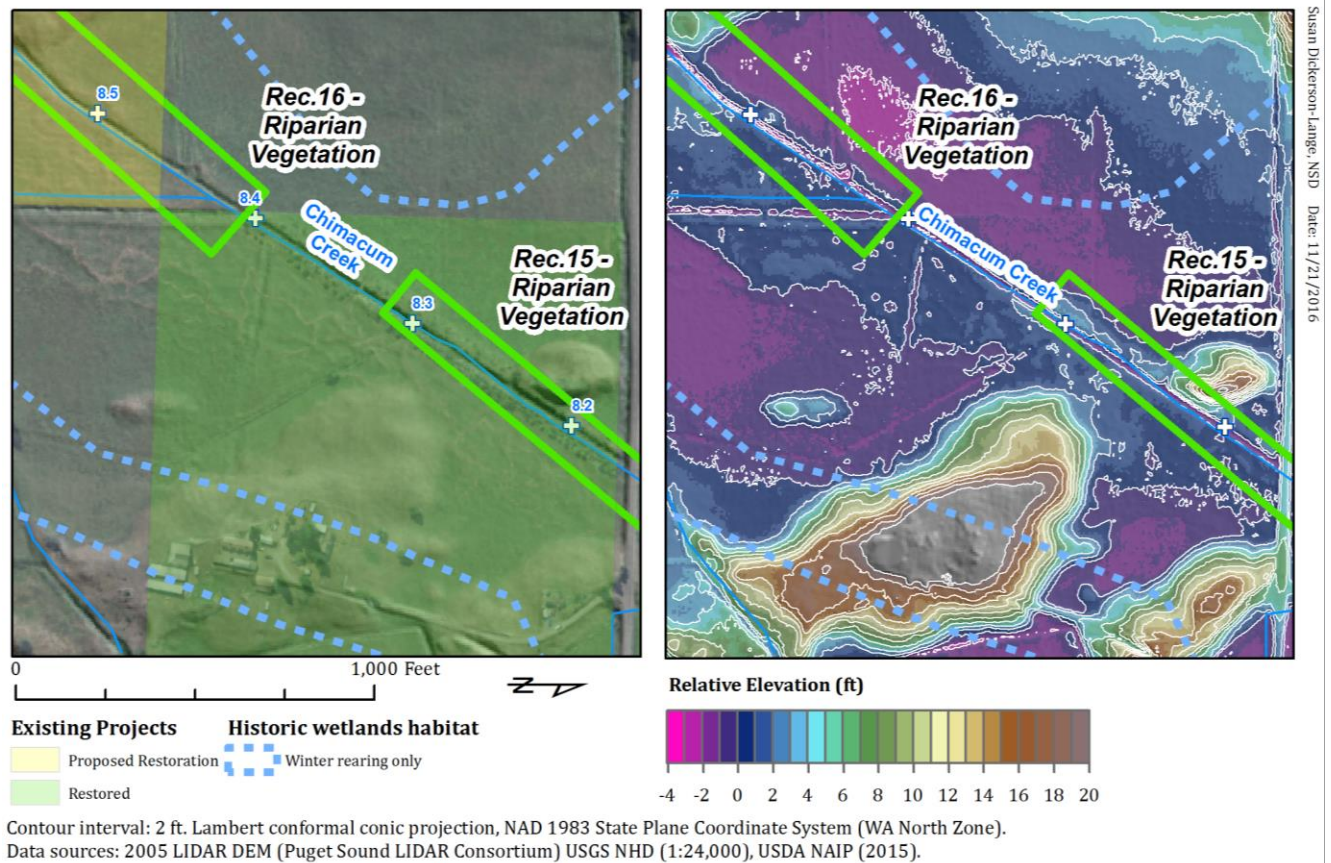
We identified approximately 28 miles of unvegetated ditches in the Chimacum Creek stream network from analysis of aerial imagery (USDA, 2015). The flow direction (tributary versus distributary) and approximate magnitudes of these ditches represent a major data gap. Where unvegetated ditches are acting as tributaries, they may be contributing to impaired water quality by conveying high temperature water that has been heated by direct sunlight. Conversely, distributary channels may be lowering flow in the main channel and additionally contributing to high water temperatures (Figure 8). We recommend that the network of ditches be mapped and assessed for water quality, flow direction, and flow magnitude. At a minimum, riparian buffers should be established along these tributaries, and possibilities for tributary ditch consolidation should be assessed (Figure 12).

**Figure 12.** Hillshade map (left) and relative elevation map (right) for location near RM 8.2-8.3 where we recommend establishing (Rec. 16) or protecting (Rec. 15) riparian buffers. Additionally, note the unvegetated ditch that joins Chimacum Creek at RM 8.4; we recommend hydrologic assessment of the ditch network and establish of riparian buffers around tributary ditches that contribute substantial inflow.

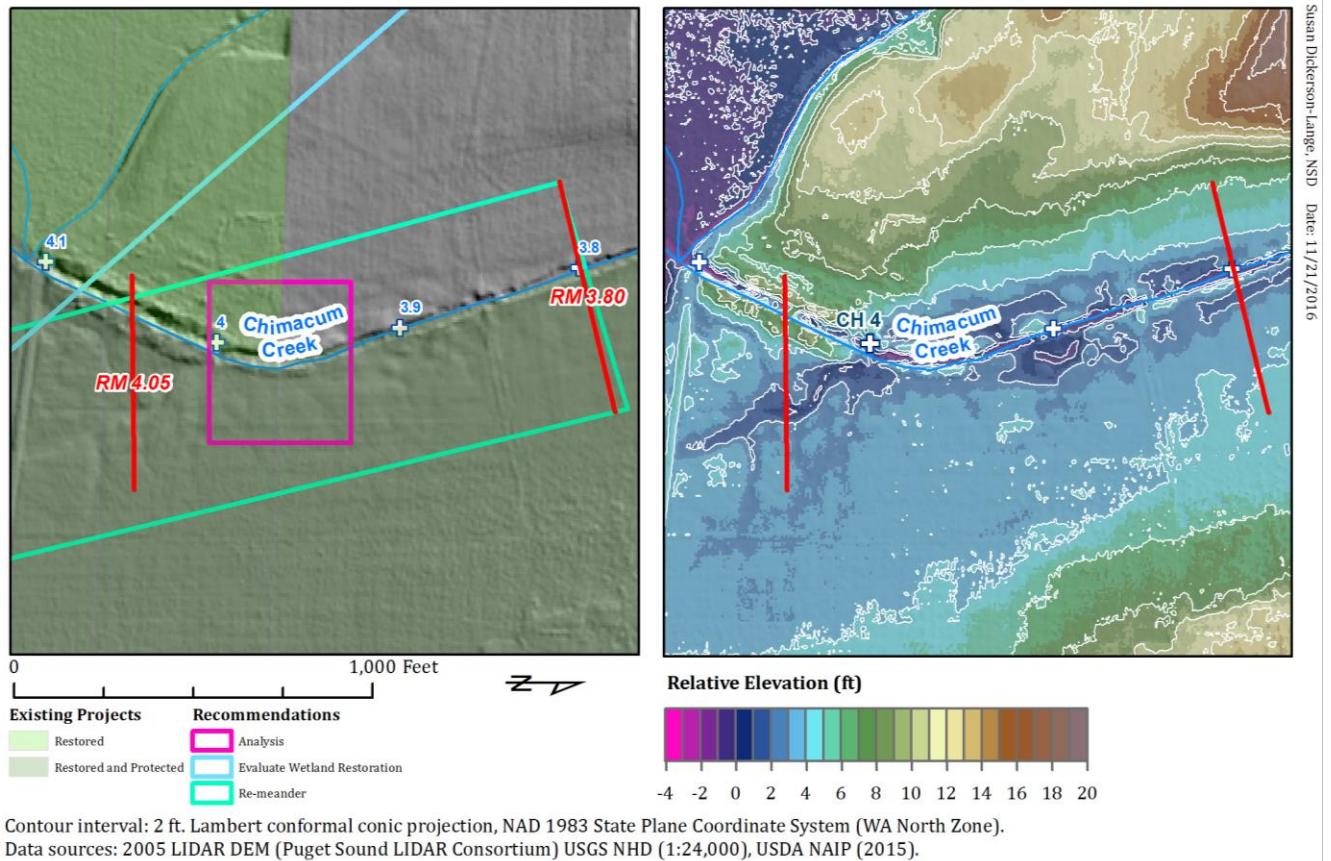
**Figure 13. Hillshade map (left) and relative elevation map (right) of location near RM 3.8-4.1 where we recommend analysis related to the operation of a control structure located near RM 4.0, and possible restoration to improve channel complexity. Elevation profiles for the two transects indicated as red lines, are shown in Figures 6 and 7.**
