Point Hudson

Breakwater Improvement Project

Marine Resource Committee Meeting
March 2021

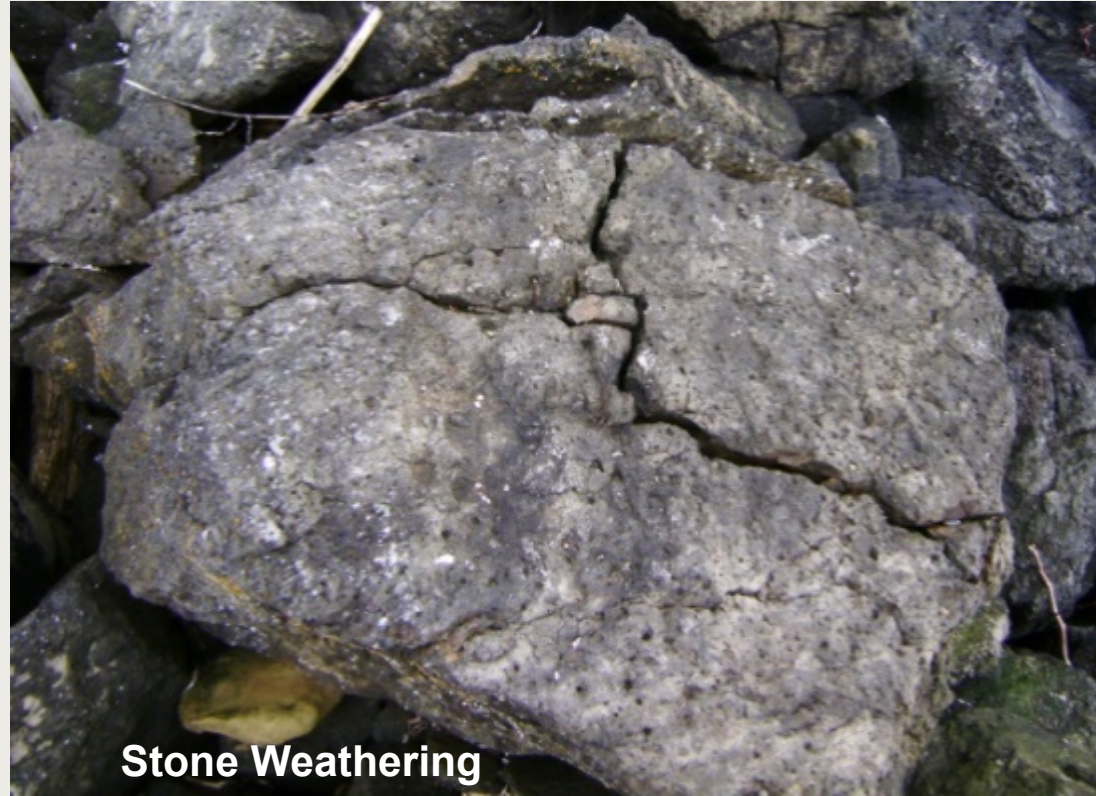
Existing Condition

Timber piles, walers, cable tiebacks, and armor rock are at or beyond useful life. Stability of the overall structural system is compromised.

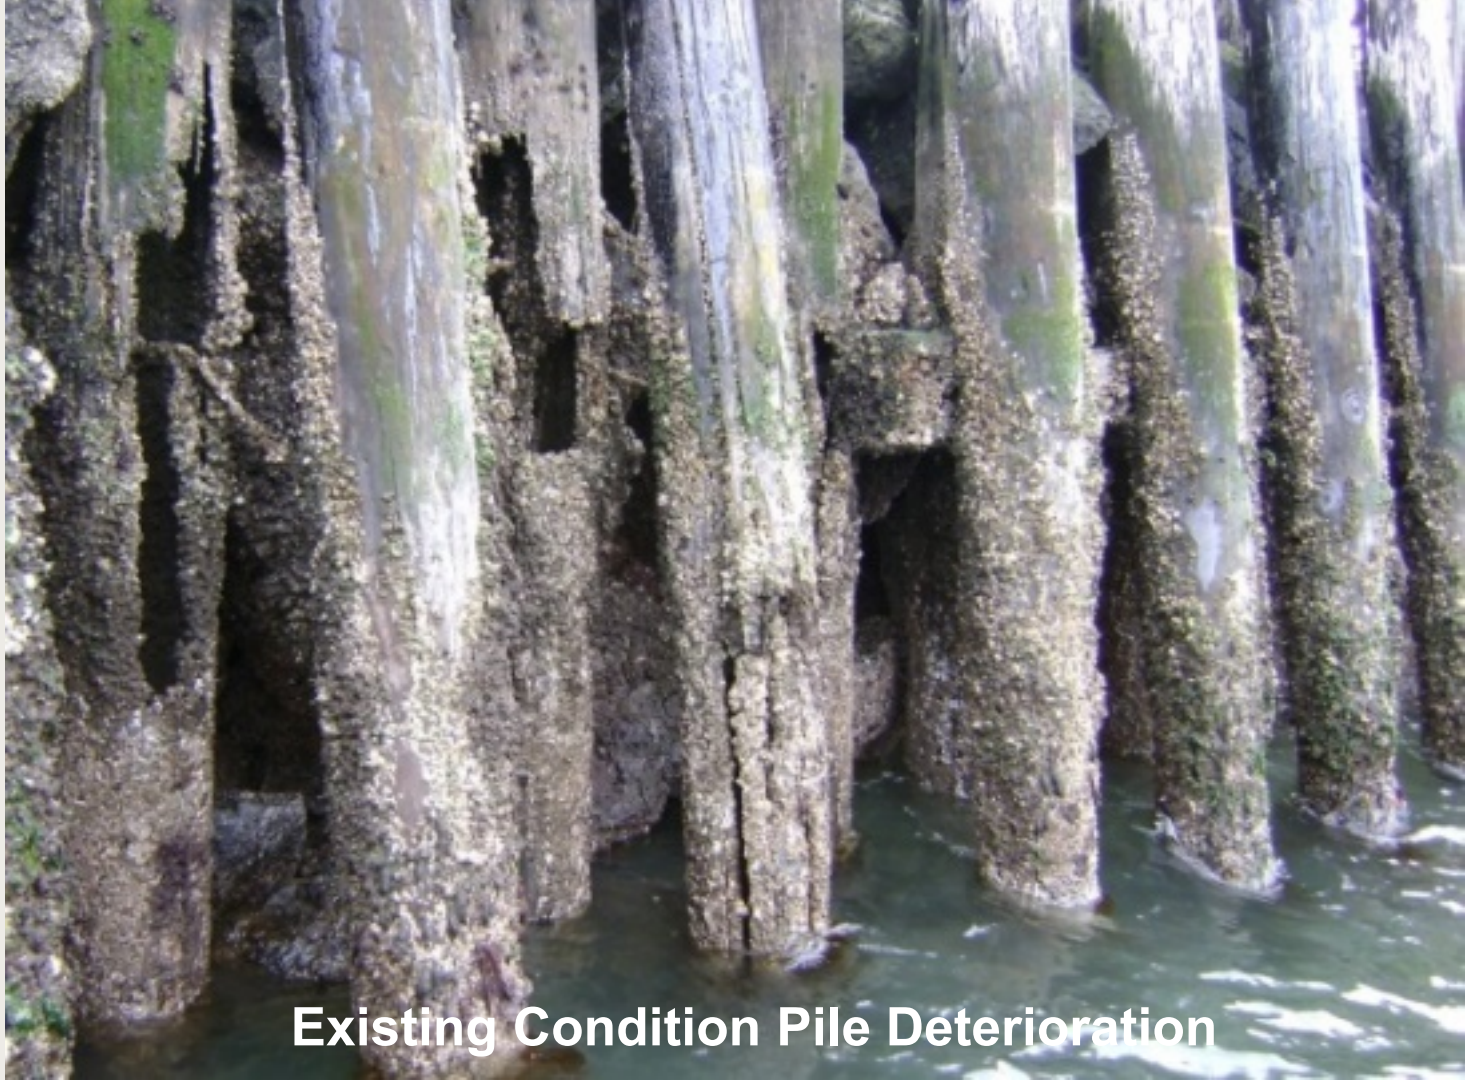
Cable Corrosion

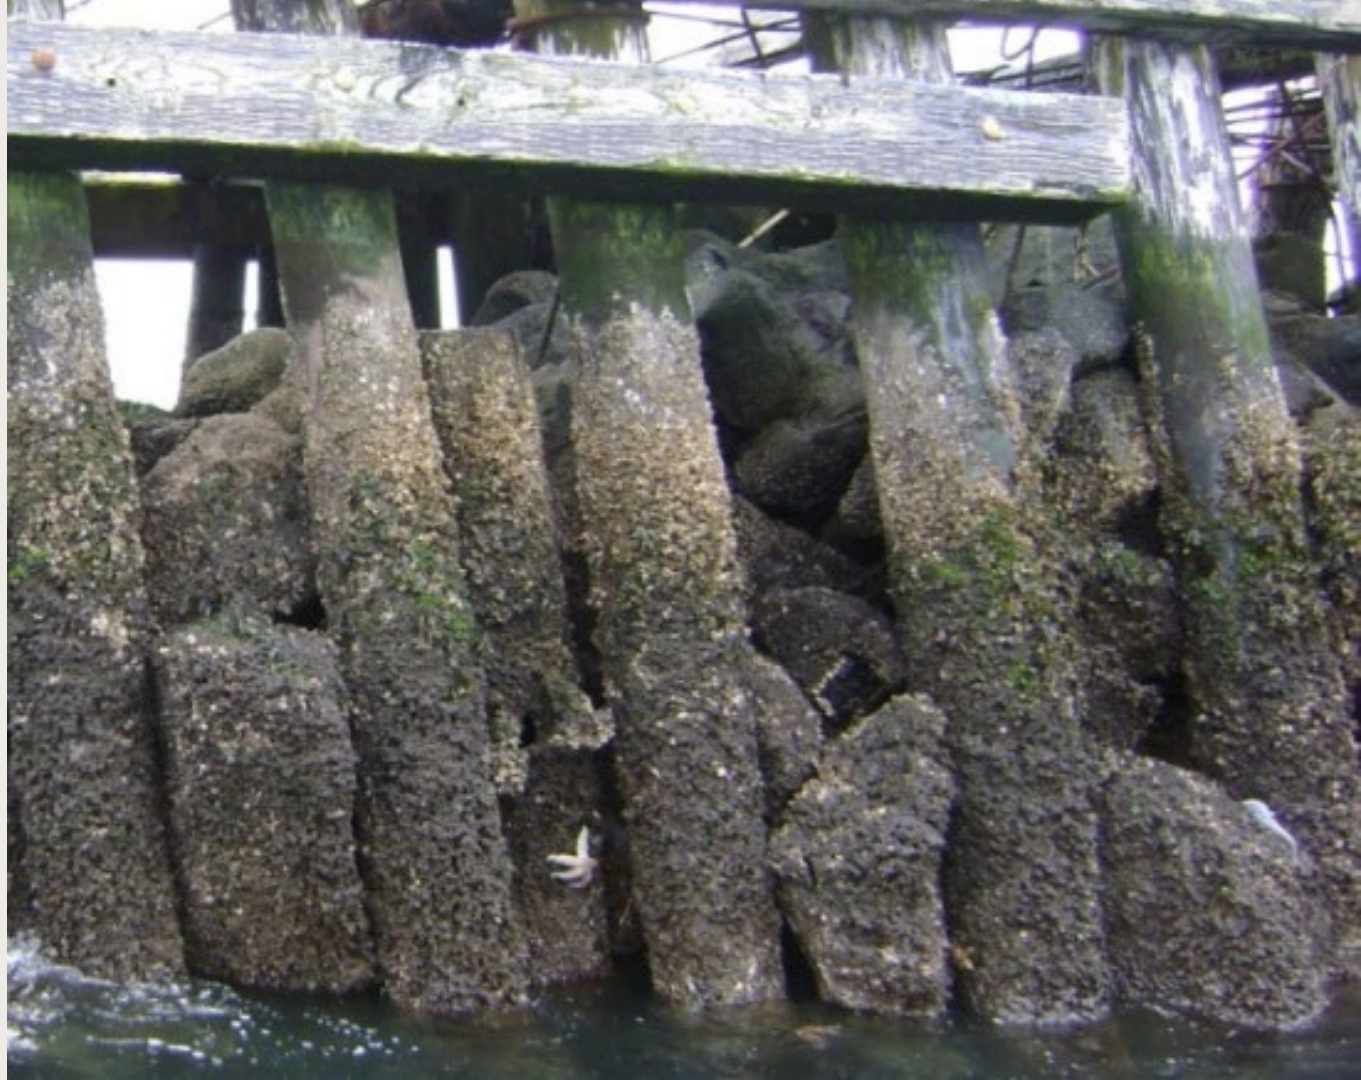
Existing Condition Pile Deterioration

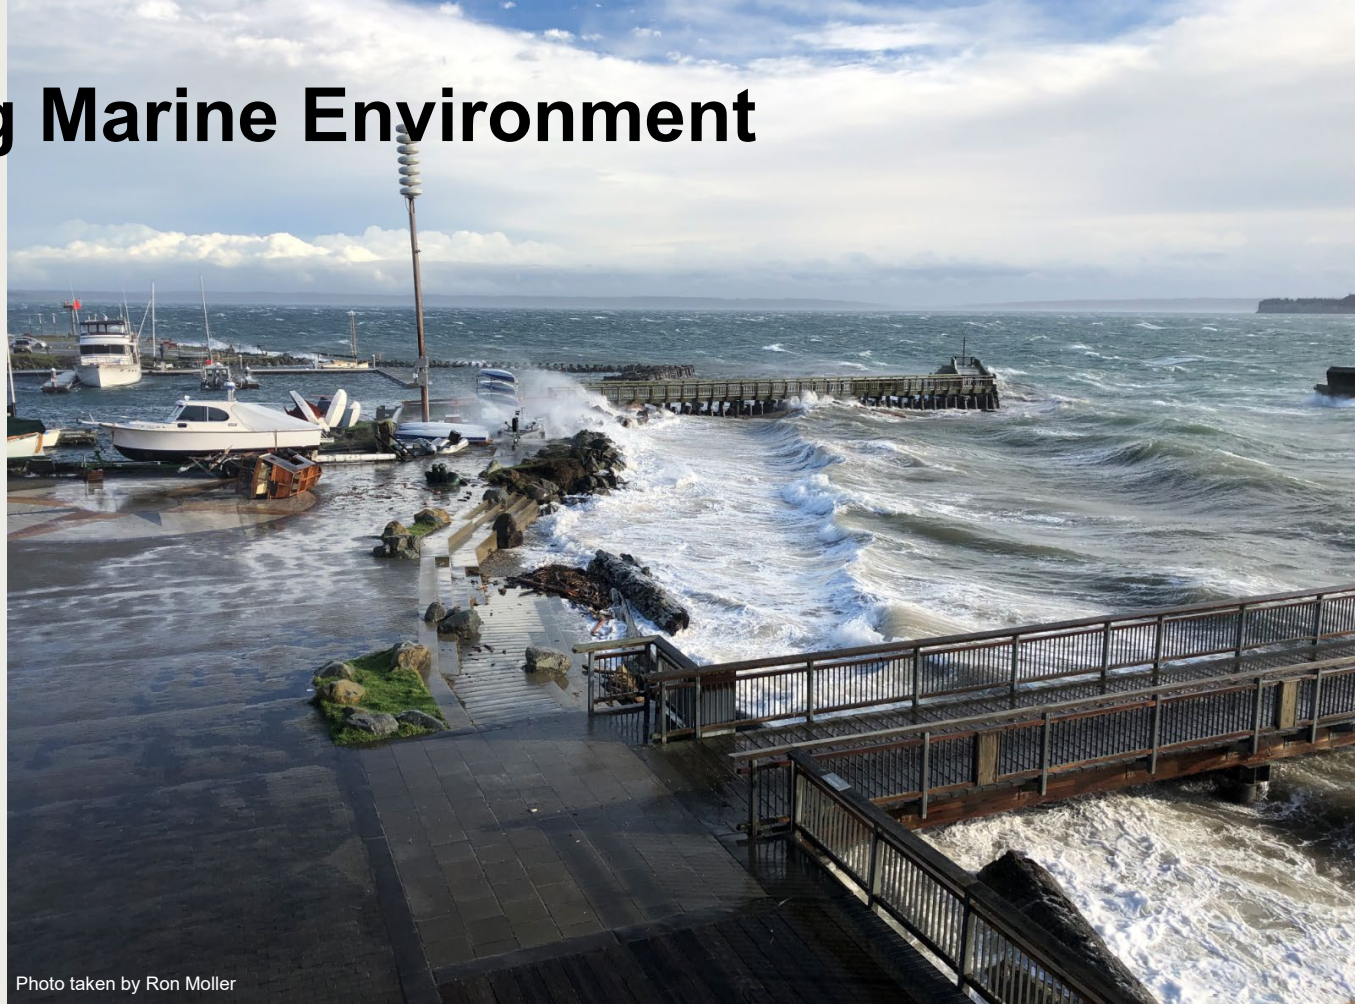
Photo taken by Ron Moller

- A 2018 storm damaged the breakwaters, breaking pile tops, severing cable ties and further eroding the armor rock core

A December 2018 storm sweeps over the jetties and into the Point Hudson Marina.

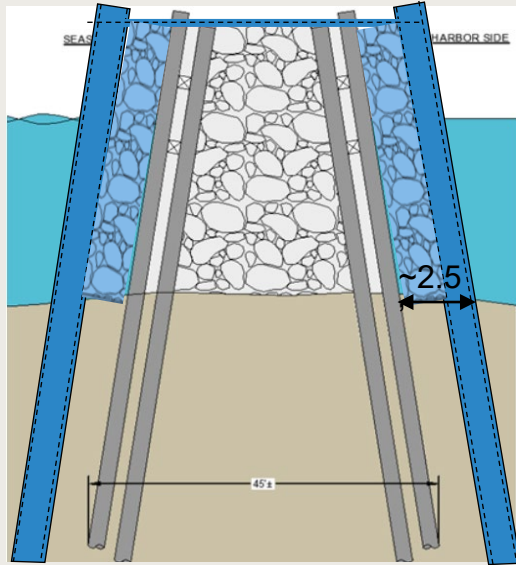
- Existing structure remains except for a few select creosote timber piles removed for permitting.
- Piles driven in a batter outside of existing structure, expand footprint by 2.5 ft each side with mesh lagging.
- Reduces demo costs but increases offsite mitigation costs.

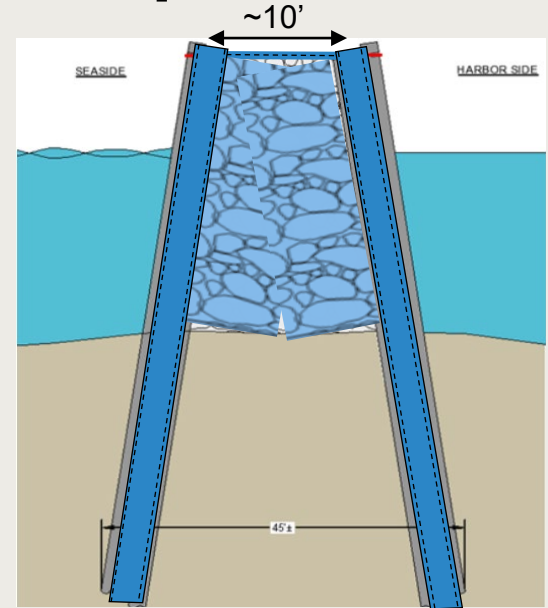
- Existing structure is completely removed including piles and rock.
- Piles driven batter with new rock installed between the rows of piling.
- Seeks to be self mitigating because of the reduction in footprint and creosote removal.

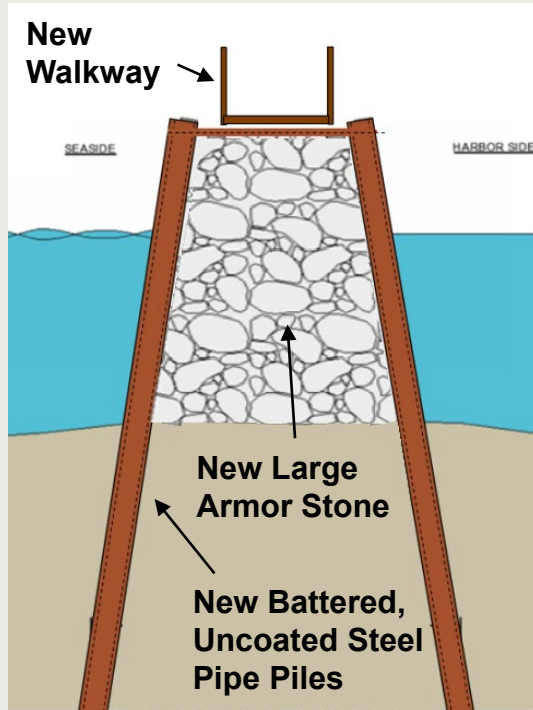
Section A - A

Selected Cross-Section and Elevation

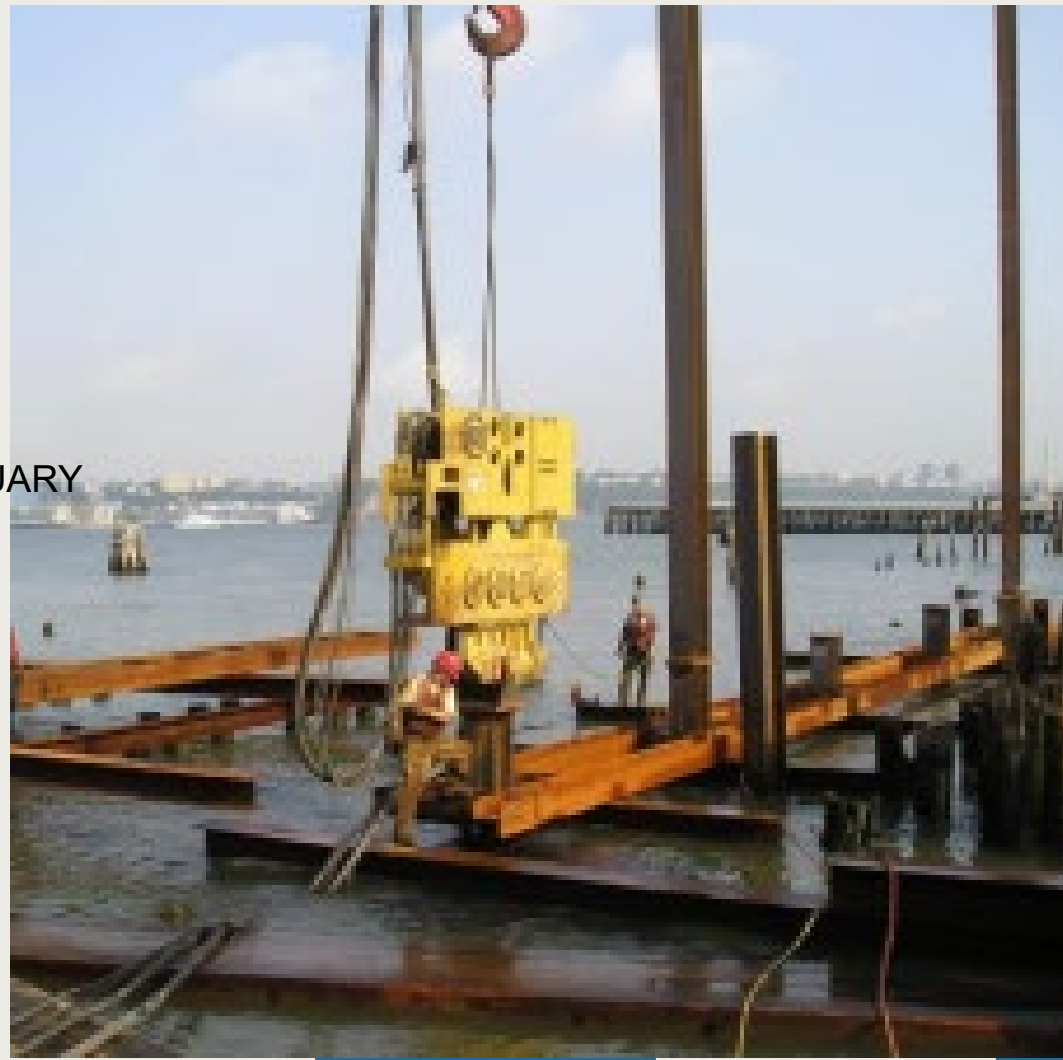
Construction Timeline of North Breakwater (Water access typical crane and barge)

Demo - 5 weeks
356 wood piles
5,428 cy

Rebuild - 12.5 to 14 wk
5,035 cy of Fill
197 new piles

Five Months of in-water
Work without delay
