2-5-24 Photos Reed Canarygrass blockages, Chimacum Cr.

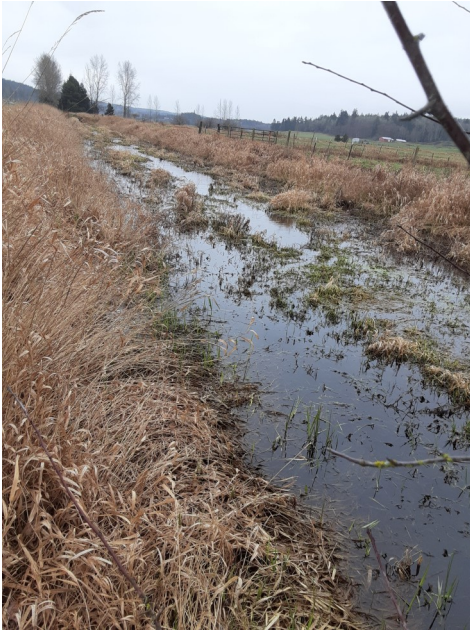
View upstream from Red Dog Farm

Based on the low amounts of rainfall this winter I've been surprised how flooded the Short Farm is. Usually it's only this flooded after a high rainfall storm event. I walked between Red Dog Farm and the bridge on Shaw farm expecting to find a beaver dam causing the flooding. No beaver dams found but a LOT of reed canarygrass in the channel causing the flooding. These photos taken 2-5-24 between Red Dog farm and Short Farm show some areas where canarygrass is restricting flow in the channel. Where trees provide enough shade the canarygrass is suppressed.

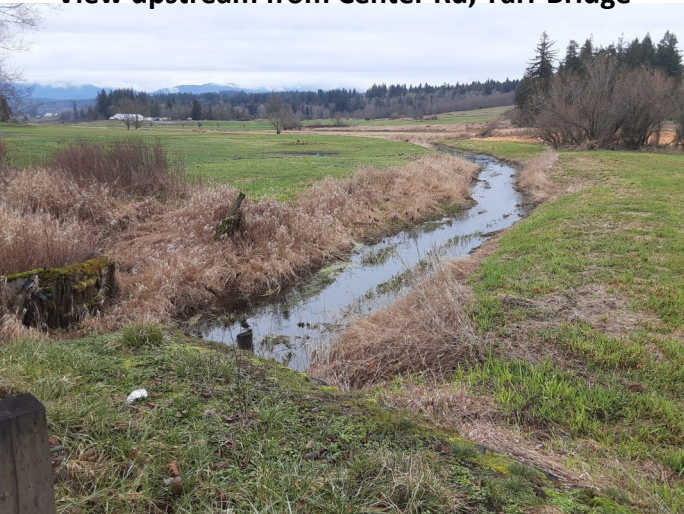
View upstream from Center Rd, Yarr Bridge

The reach upstream of Center Rd on Mozaic (Yarr) farm would be equally as flooded if the amount of rainfall was the cause of flooding at Short's. Al Latham
