PHASE I ENVIRONMENTAL SITE ASSESSMENT

JEFFERSON COUNTY TAX PARCELS #901262002, 901262003, 901233010, 901233011, 901224001, 901233002, 901233005 AND 901233008 CHIMACUM, WA 98325

February 19, 2014 Project No: 0214-03

JEFFERSON LAND TRUST 1033 LAWRENCE STREET PORT TOWNSEND, WA 98368

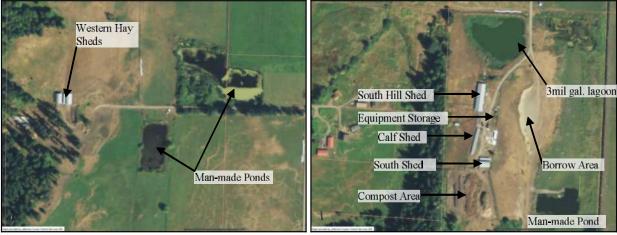
Figure 3.0: Property Detail Map (northeastern developments including Lee's Truck Service, top; eastern developments, middle; northwestern developments, bottom left; southwestern developments, bottom right)

(circa 1900), a 4,000 sqft equipment storage shed (circa 1950's) and a 4,500 sqft material storage shed (soil and compost mixtures) (circa 1982), a ~3 million gallon manure lagoon, a ~4,000 sqft open air calf shed constructed in 1990, a ~2,200 sqft loafing/hay shed with scales known as the Center Valley Shed (circa 1960's), a ~6,500 sqft covered storage shed built in the 1980s, a ~3,500 sqft barn structure known as the South Shed built in the 1960's, a ~2 acre compost area, a ~0.8 acre borrow area, a ~0.32 acre area used for equipment storage, two ~2,500 sqft loafing/storage sheds known as the "western hay sheds" (circa 1960s), a 60ft domestic well (1991), a ~100ft irrigation well (circa 1950's), two concrete bunker silos, two manmade ponds, an old chicken coop, two single family residential structures constructed in the late 1800s/early 1900s and the 1960s (house near Center Road), a ~1,500 sqft storage shed (circa 1970s) utilized by a landscaping business, a single wide mobile home, a ~1,500 sqft storage shed known as the "lumber shed", a small shed that formerly held the filter system for a former swimming pool, two single wide mobile homes, a 1,000 gallon and a 3,000 gallon waste oil above ground storage tanks (ASTs), two 1,000 gallon diesel/gas ASTs, three ~500 gallon motor oil/gear oil/transmission oil ASTs, two 10,000 gallon irrigation water ASTs, one unused/never installed 1,000 gallon AST and multiple concrete bunker silos. The facility is supplied with power by Jefferson County PUD and domestic water is provided by a private well. See the chart below and the photograph Appendix for additional details.

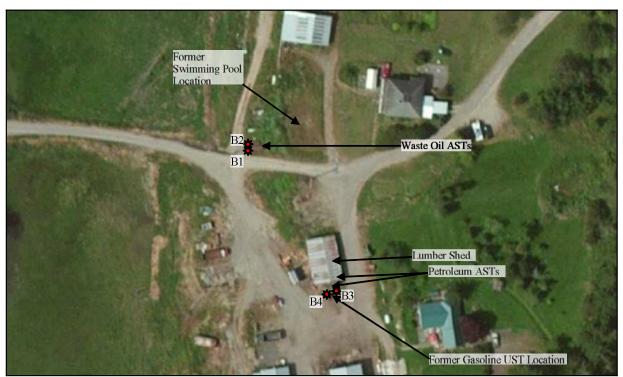
Figure 4.0: Soil Investigation Detail Map

To assess the significance of the oil stained soil below the waste oil ASTs and the lack of sampling in the former gasoline UST location, on January 20, 2014, Roger Short removed the area of surface staining beneath the waste oil tanks and ADESA collected soil samples from 1-2 feet below the ground surface (B1 & B2). The samples were submitted for laboratory analysis. The soil samples were non-detect for diesel/oil range petroleum hydrocarbons, benzene, toluene, ethyl benzene and xylenes. The results confirm that the surface staining was of minor significance and represents a de minimis condition and not a recognized environmental condition in relationship to this report. Also on January 20, 2014, a test pit investigation was performed in the location of the previously removed gasoline UST. Two soil samples (B3 & B4) were collected from 6-7 feet below the ground surface, beneath the former location of the bottom of the UST, and submitted for laboratory analysis. Both of the samples were non-detect for gasoline range petroleum hydrocarbons and BTEX, and no indications of petroleum impacts were observed within the test pit. Based on the results of the soil analysis, the former gasoline UST does not represent a recognized environmental condition. Laboratory Documentation is provided in Appendix E of this report and a photograph log of the investigation is presented in Appendix C.

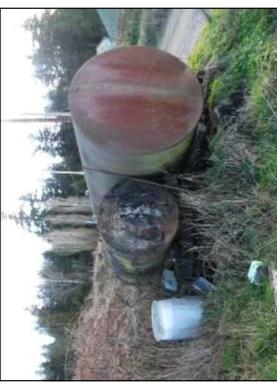
Waste oil tanks used to hold oil for the waste oil burning water heater in northeast area of the Property

During the initial site inspection performed by ADESA on December 18, 2013, oil/petroleum staining was observed beneath the western end of the 1,000 gallon and 3,000 gallon waste oil above ground storage tanks (ASTs) in the northeastern portion of the Property. The tanks are situated to the southwest of the storage shed rented to a landscaping company near the former location of a swimming pool. The two tanks held waste oil that was used to fire a waste oil burning heater associated with the swimming pool. Also during the inspection of the Property, Mr. Short identified the location of a former 1,000 gallon gasoline underground storage tank that he removed from the Property approximately 20 years ago; no samples were collected at the time of the removal.

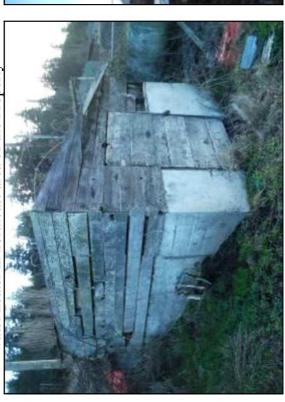
Former pool filter equipment room in northeast area of the Property

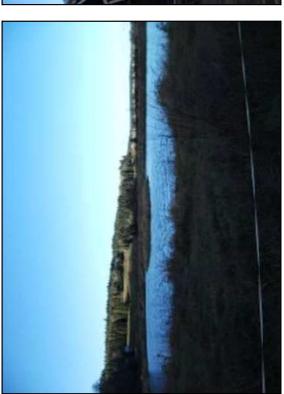
~3million gallon manure lagoon

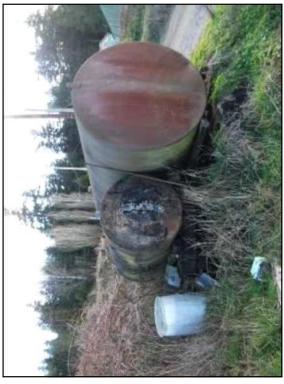
Waste oil ASTs associated with former oil burning water heater for swimming pool

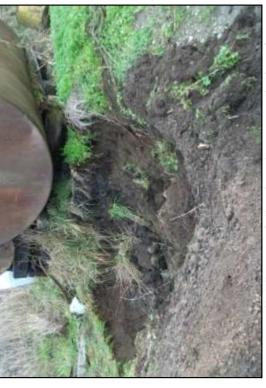
Waste oil AST area following the removal of surface staining and sampling

To assess the significance of the oil stained soil below the waste oil ASTs and the lack of sampling in the former gasoline UST location, on January 20, 2014, Roger Short removed the area of surface staining beneath the waste oil tanks and ADESA collected soil samples from 1-2 feet below the ground surface (B1 & B2). The samples were submitted for laboratory analysis. The soil samples were non-detect for diesel/oil range petroleum hydrocarbons, benzene, toluene, ethyl benzene and xylenes. The results confirm that the surface staining was of minor significance and represents a de minimis condition and not a recognized environmental condition in relationship to this report. Also on January 20, a test pit investigation was performed in the location of the previously removed gasoline UST. Two soil samples (B3 & B4) were collected from 6-7 feet below the ground surface, beneath the former location of the bottom of the UST, and submitted for laboratory analysis. Both of the samples were non-detect for gasoline range petroleum hydrocarbons and BTEX, and no indications of petroleum impacts

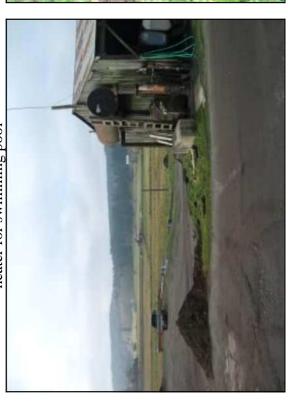
Test pit at the location of the former gasoline UST, south of the "lumber shed"

were observed within the test pit. Based on the results of the soil analysis, the former gasoline UST does not represent a recognized environmental condition.
