POINT HUDSON

Intensive Level Survey Documentation and Illustrated Historic Context Statement

ARTIFACTS CONSULTING, INC.

SEPTEMBER 2020

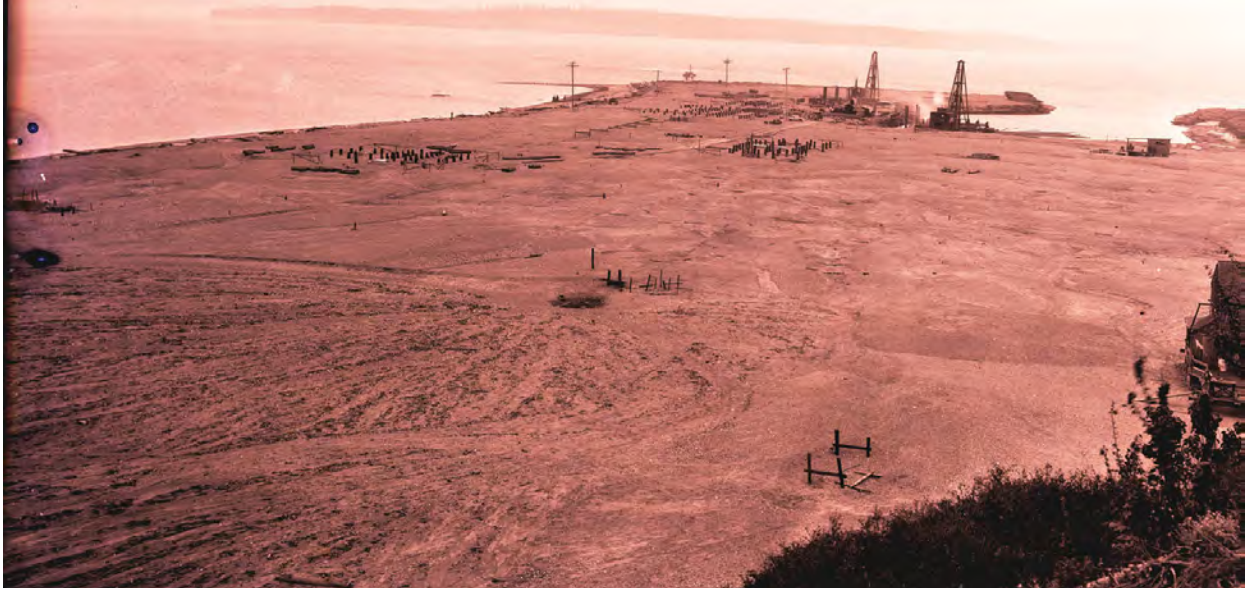
August 1934 view looking south at Point Hudson, showing foundation piles for future buildings and dredging of the marina. Source: Jefferson County Historical Society, image ID 1995.379.7 *PENDING PERMISSIONS*

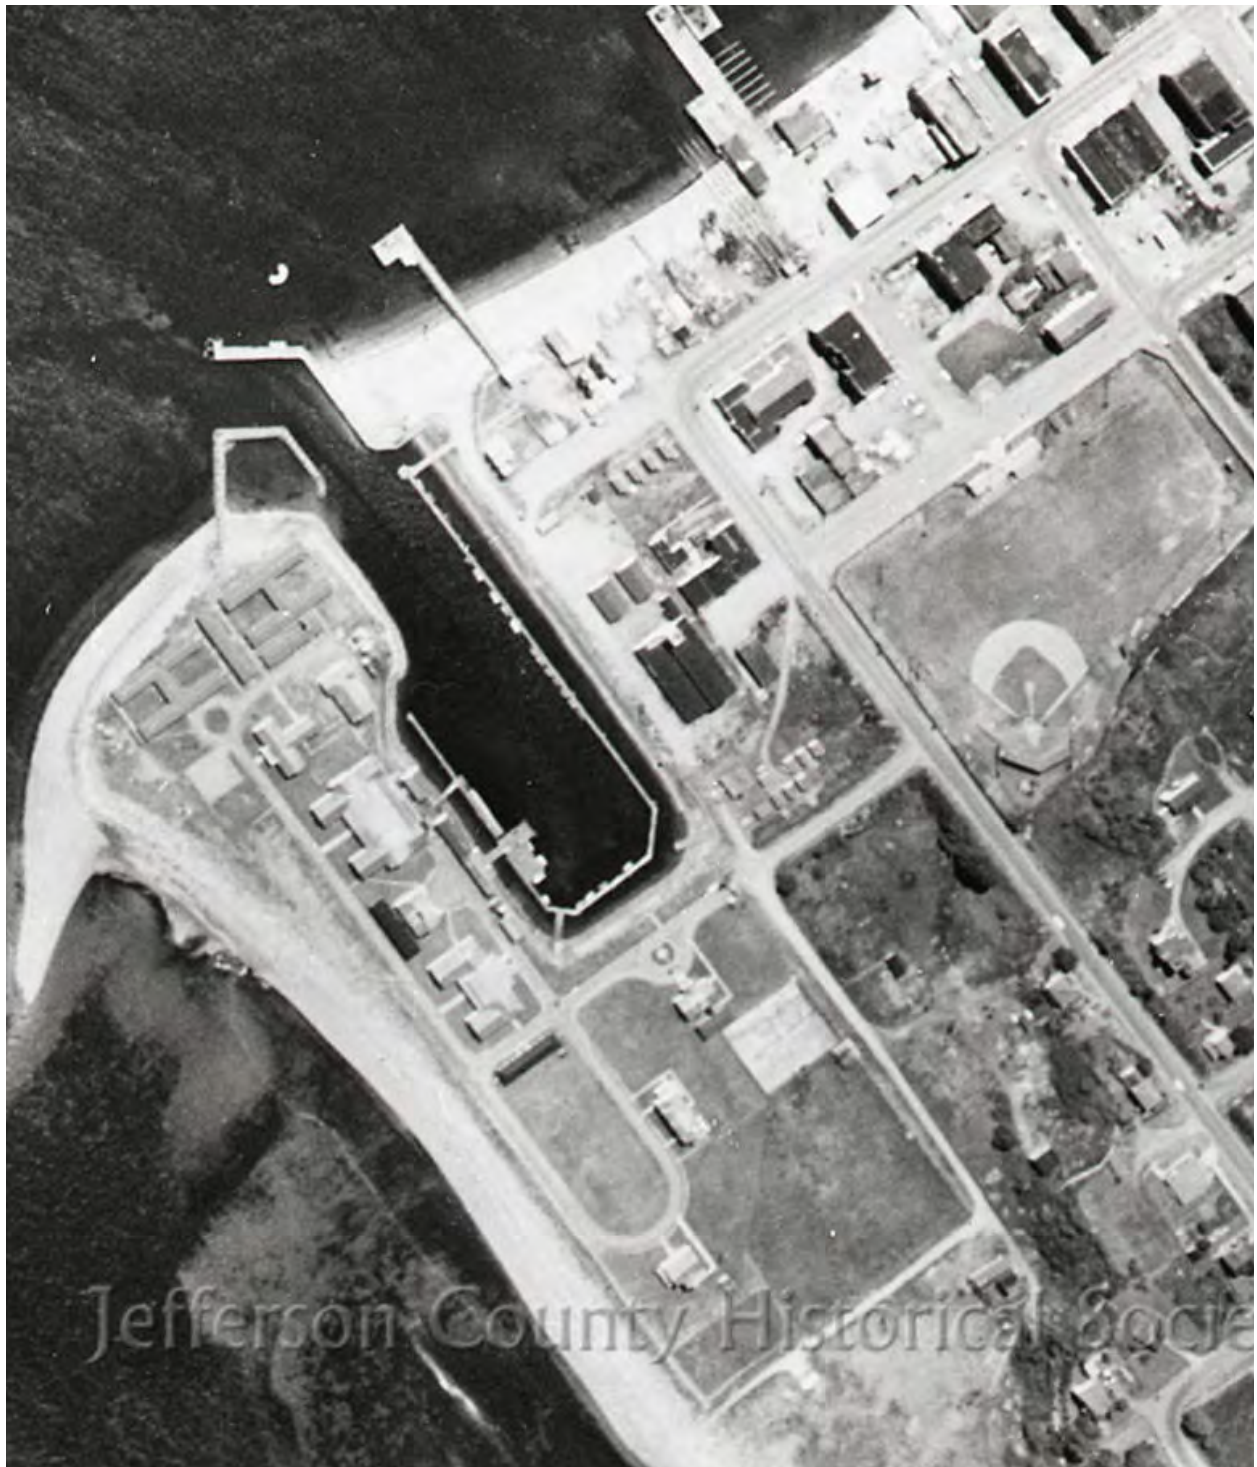
Undated aerial image of Point Hudson. This image shows more buildings than are present today. It presumably dates to the 1940s, when the Coast Guard and Navy added temporary structures during WWII. Source: Jefferson County Historical Society. Image ID 1984.28.1. *PERMISSIONS PENDING*

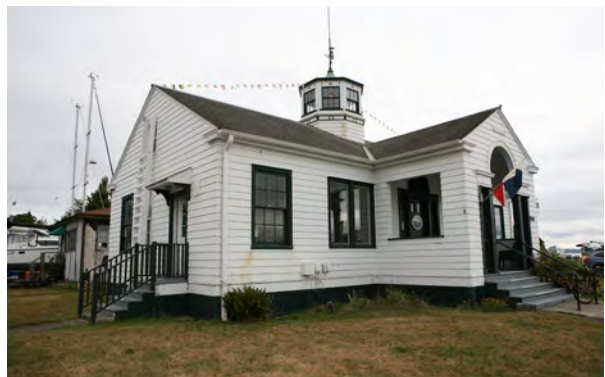
Left: 1953 view of Cupola building, SW corner, courtesy of Jefferson County Historical Society (image 2005.77.274).
Right: 2020 view of Cupola building, SW corner.

The exterior siding of the main building is in relatively good condition. The roof shingles are most likely at the end of their life cycle and should be replaced. Most of the windows are original with the exception of the fixed, single tall lites in the south facade. A detailed window survey was not part of the scope but no major damage was noted from the exterior. The shutters and hardware present in 1953 pictures have been removed.

A north addition is attached via a hyphen. The addition is in poor condition. It appears to have been built in the early 1940s during the Coast Guard/Navy occupancy. It is of typical wartime, temporary construction. Concrete pier footings support the light wood frame structure. The siding is presently plywood with "tarpaper" over portions of it. It has wood windows with single pane glass. There are no downspouts. The roofing is three-tab asphalt shingles.

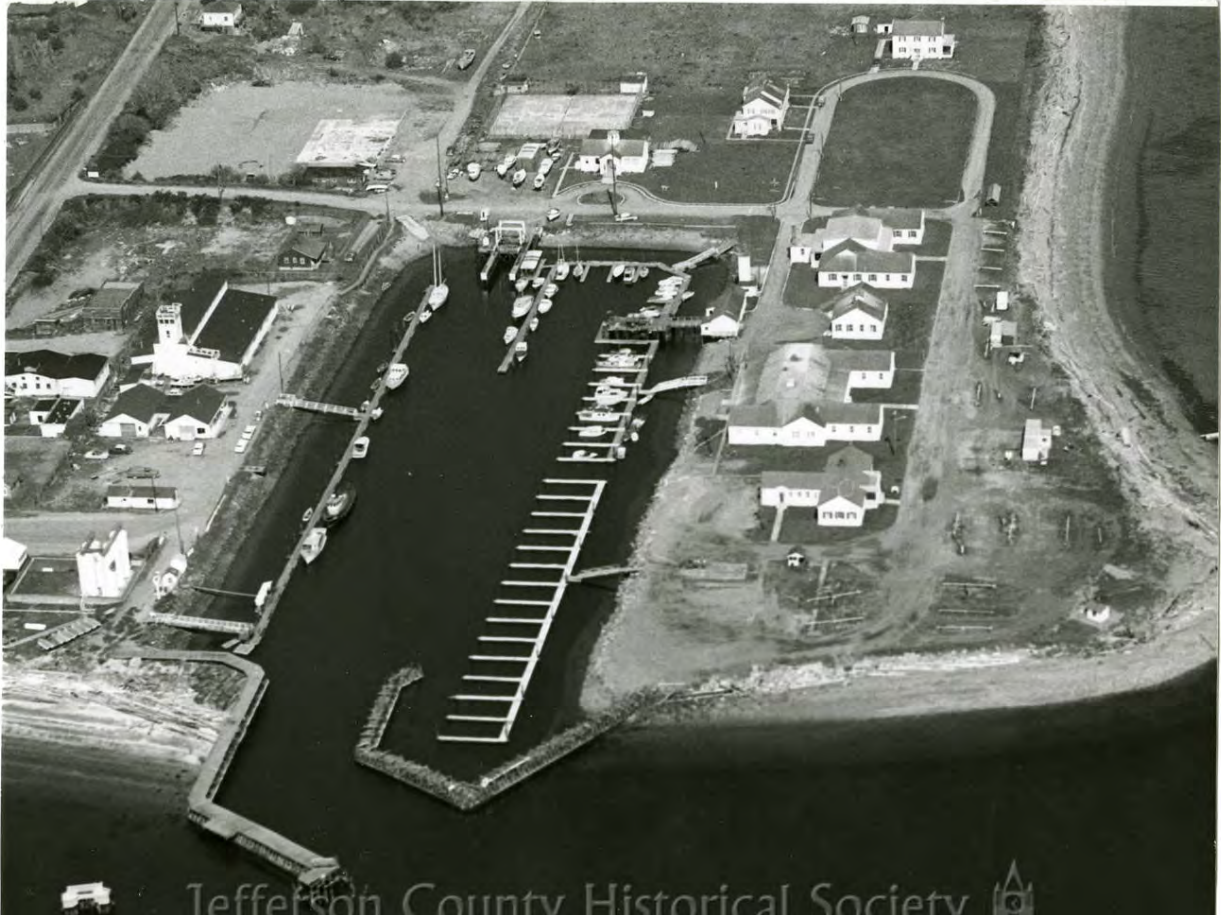
Above: Post-1960 aerial image of Point Hudson. This image shows the wartime buildings removed. Source: Jefferson County Historical Society. Image ID 2004.117.100. *PERMISSIONS PENDING*

Below: Circa 1958 view of Point Hudson, taken by Joseph Bailey. Source: Jefferson County Historical Society. Image ID 2005.77.87. *PERMISSIONS PENDING*

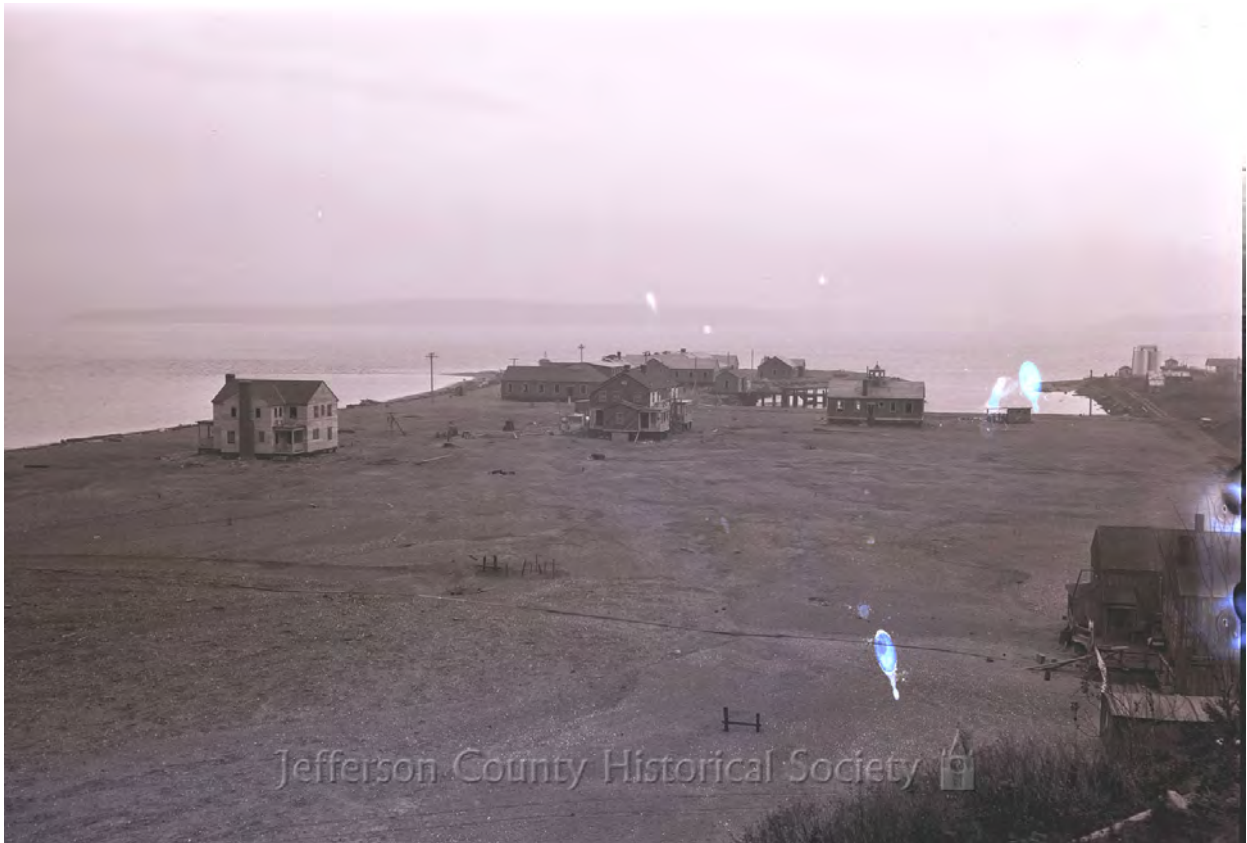
October 1934 view of quarantine station under construction, looking south. Courtesy of the Jefferson County Historical Society, image ID 1995.379.10. *PENDING PERMISSIONS*

In 1934, the Puget Sound Bridge and Dredging Company converted a former lagoon into a small harbor, deepening and widening the basin. The tailings from the dredging operation appear to have been used to raise and level the site. While dredging was still under way, construction of the quarantine station buildings began. All of those buildings were constructed over wood pilings. Using pilings instead of concrete foundations may have been due to the possible settlement of dredged fill material. The pilings were heavily coated with creosote. Once the pilings were in place, the supporting beams were set and bolted to the pilings. Floor joists were attached to the beams using joist hangers. The entire under-structure of the buildings was coated with creosote. The three 1940s naval buildings, on the west side of the marina basin, do not sit on pilings; rather, they have continuous concrete foundations.

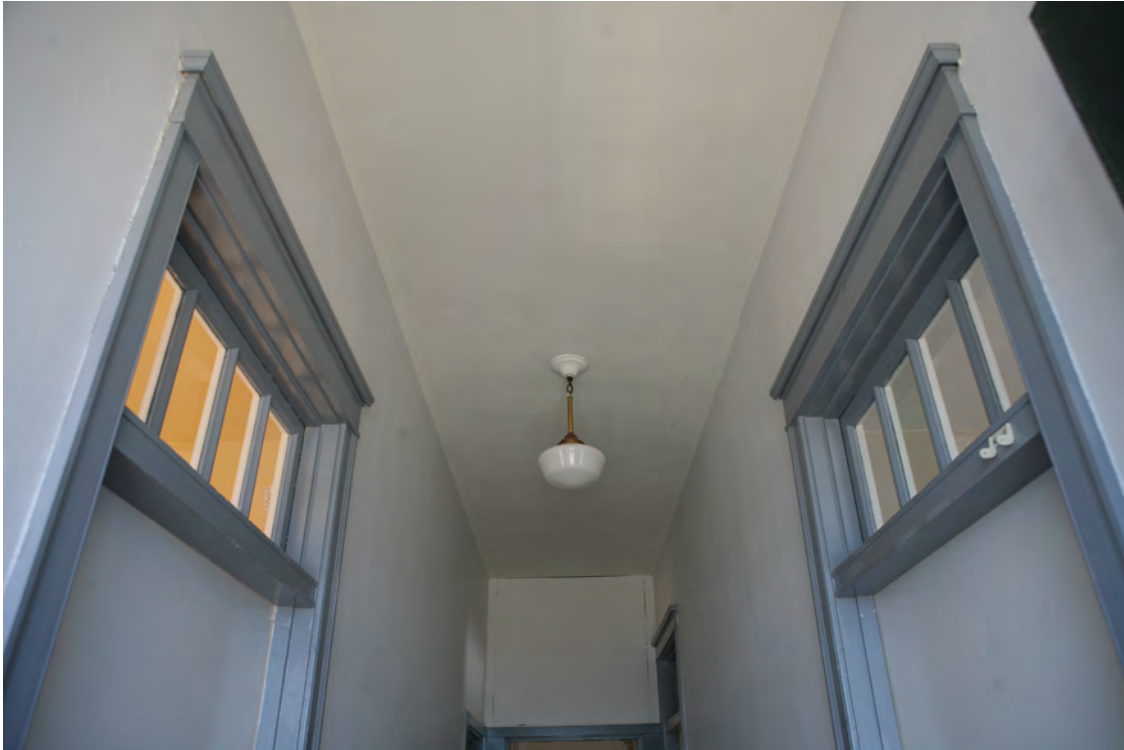
Interior detail view of relites over doorways and trim, Main Building, July 2020.

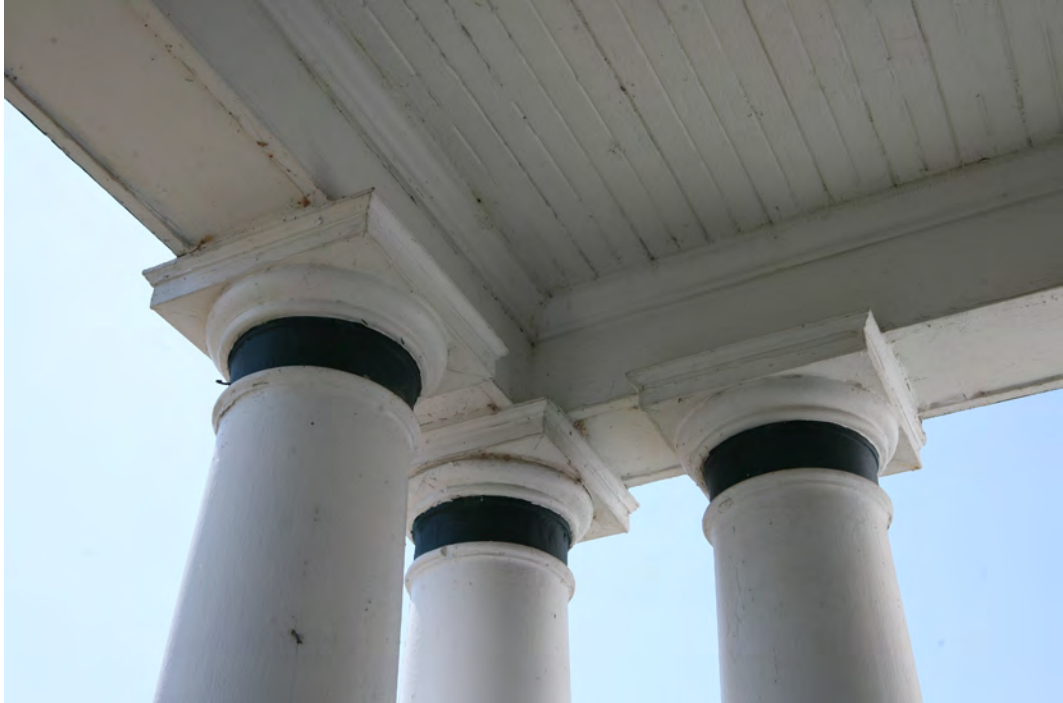
Detail view, porch of the Commander's Bed and Breakfast, July 2020.

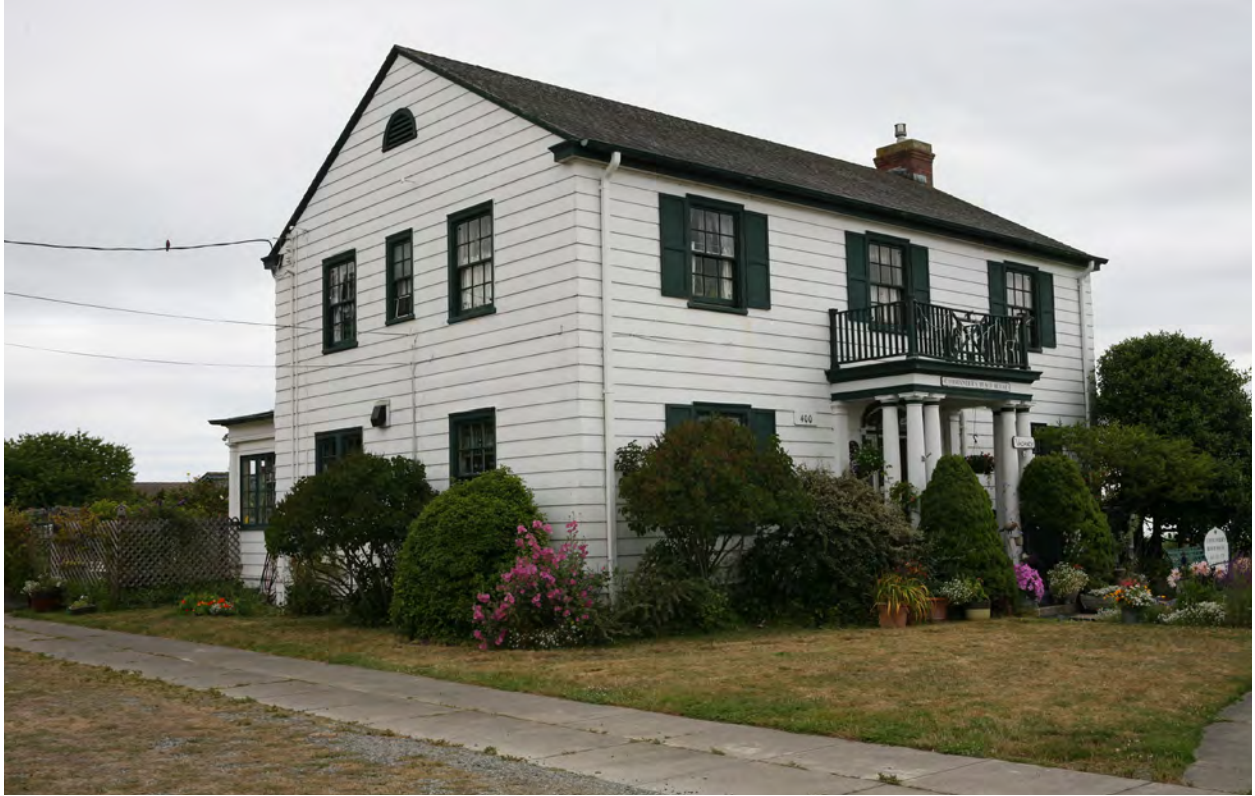
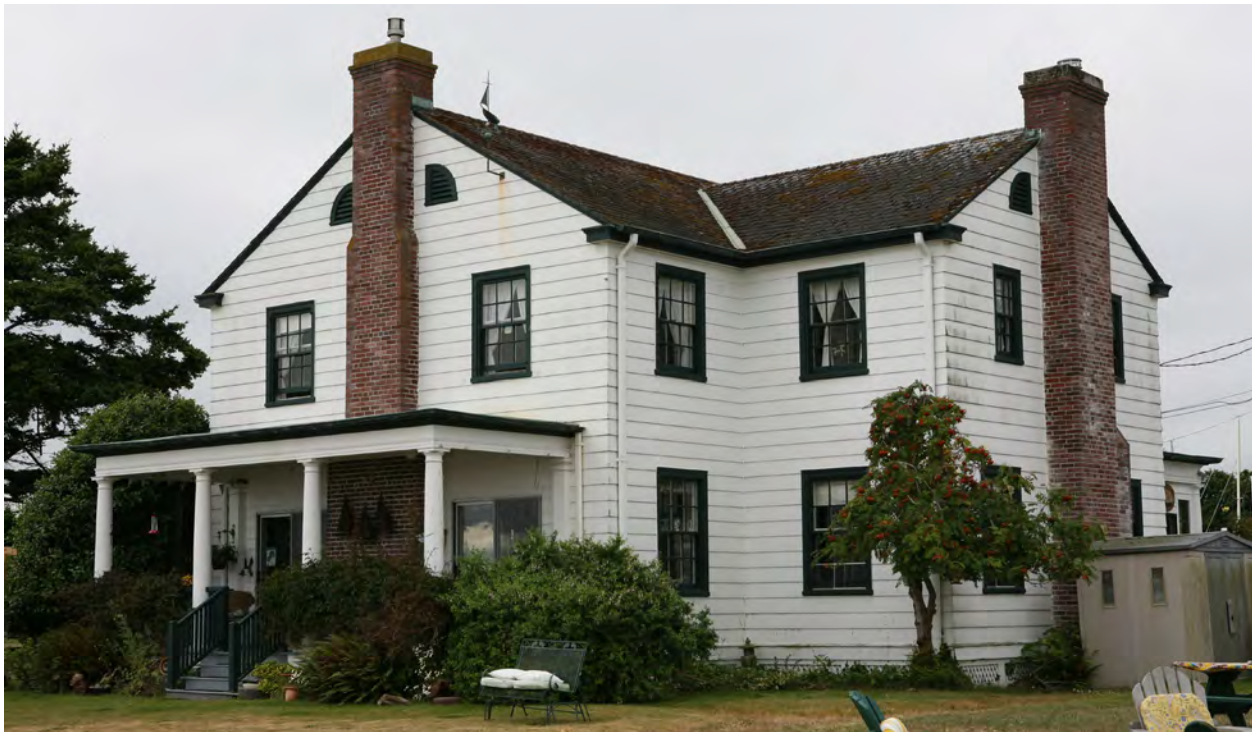
Top: SW corner of bed & breakfast, July 2020. Bottom: NE corner of bed & breakfast, July 2020.

This Colonial Revival style home is a two-story wood structure built in 1934-35 for the Medical Officer-in-Charge of the quarantine station. It is a platform framed house set on a foundation of driven piles and dimensional timbers. The footprint is T-shaped. The side gable roof form has a lower cross gable in the rear (north) slope. The roofing is asbestos-cement shingles. Two exterior brick chimneys are centered in the east and north facades. The main entrance is centered in the front (south) facade, emphasized with a flat roofed portico, round porch columns with capitols, and a fanlight transom. A flat roofed attached porch is located on the east facade. Most windows are original wood framed, 6-over-6 hung sashes. Fixed wooden shutters are extant on the south facade only.

Current condition and needs: The building appears to be in good condition. There do not appear to be any settlement problems. From that, we can imply that the piling and floor structures are in good condition (access to the crawl space was not possible). The creosote smell was less than in the Duplex, but the bed and breakfast operators mentioned it is a problem for some guests. The smell may have been less noticeable during our visit because the building had open windows and doors, thus the change of air reduces the creosote odor.

The exterior envelope siding is in relatively good condition. The addition of sliding glass doors off the living room to the side porch and removal of the shutter dogs (the shutters are permanently fastened and no longer operate) are among the few alterations evident. We were unable to access the attic and inspect the roof structure. However, judging from the other buildings on site we assume the structure and sheathing is similar. If the roof structure is the same as on the other buildings, it is robust. The roof shingles, however, are most likely at the end of their life cycle and should be replaced. Most of the windows are original. A detailed window survey was not part of the scope but no major damage was noted from the exterior.

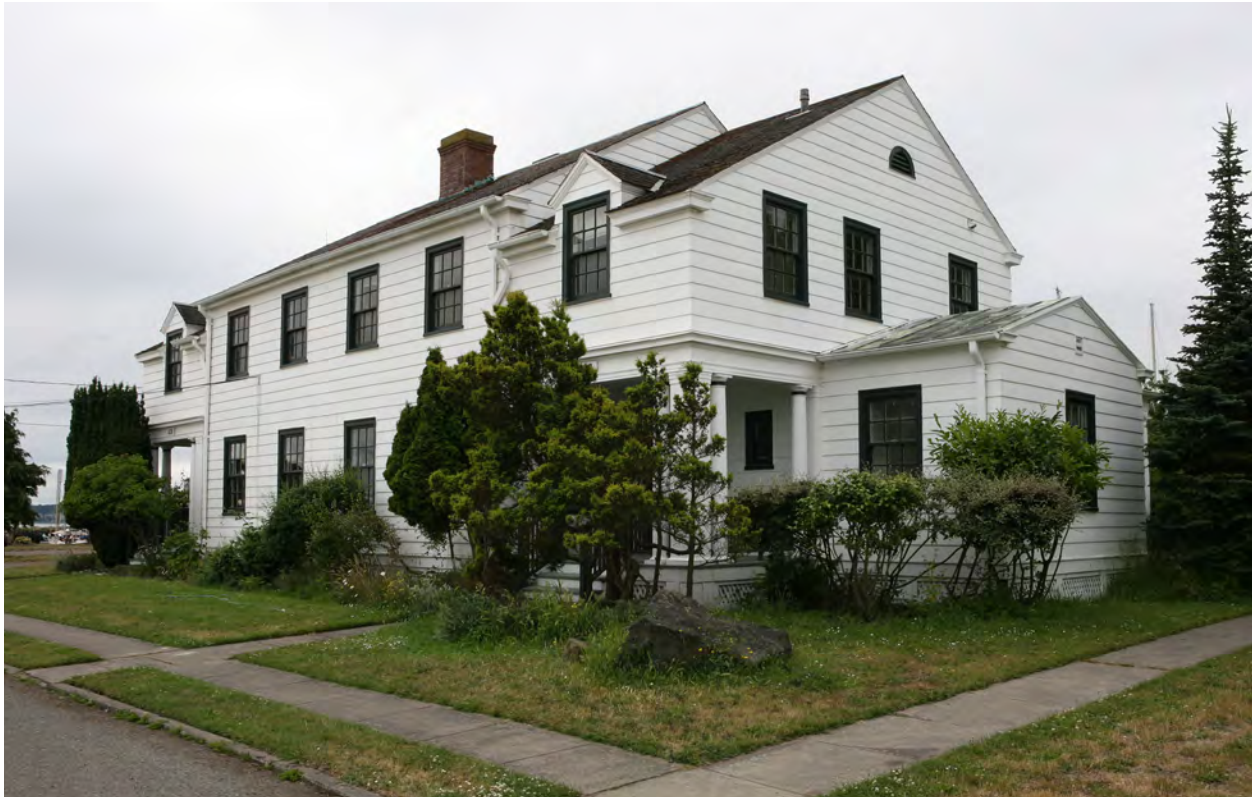
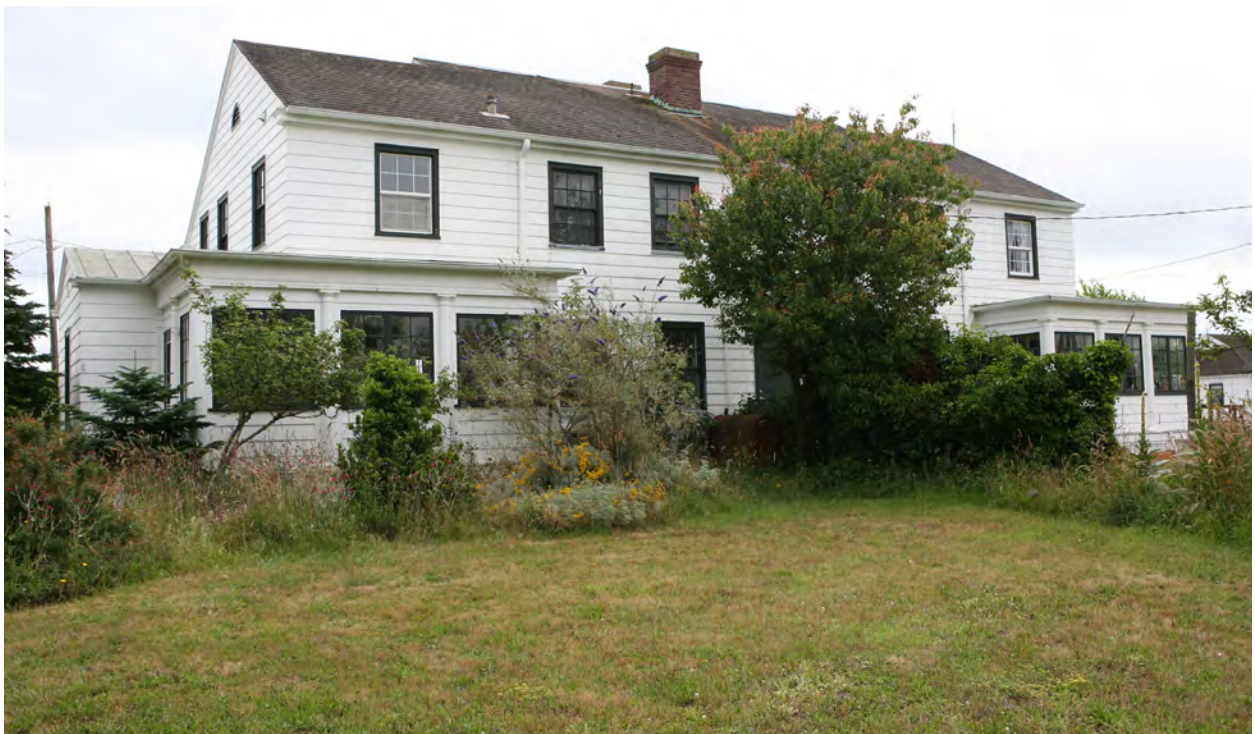
Duplex

Top: NE corner of Duplex, July 2020. Bottom: NW corner of Duplex, July 2020.

This Colonial Revival style, residential building is a symmetrical, two-story duplex house built in 1934-35 for the quarantine station at Point Hudson. It is a wood platform frame structure set on a foundation of driven piles and dimensional timbers. The footprint is primarily rectangular with small protrusions at the north and south ends and the two rear (west) corners. The main entrances are via recessed porches in the east facade. A side gable roof features two interior brick chimneys at the center of the plan and two gabled wall dormers. The roofing is asbestos-cement shingles on the main portion of the building and old standing seam metal on the north and south protrusions. Most windows are original wood framed, 6-over-6 hung sashes.

Current condition and needs: The building appears to be in good condition. There do not appear to be any settlement problems. From that, we can imply that the piling and floor structures are in good condition (access to the crawl space was not possible). There was a strong smell of creosote particularly in the unoccupied half of the building. This portion of the building has been closed off and there has been little air exchange, which could account for the strong odor.

The exterior siding is in relatively good condition. Few changes have been made to the exterior except the removal of all the widow shutters and associated hardware. We were unable to access the attic and inspect the roof structure. However, judging from the other buildings on site we assume the structure and sheathing is similar. If the roof structure is the same as on the other buildings, it is robust. The roofing is at the end of life cycle and should be replaced. There are a few replacement window sashes (see rear/west facade). A detailed window survey was not part of the scope but no major damage was noted from the exterior.

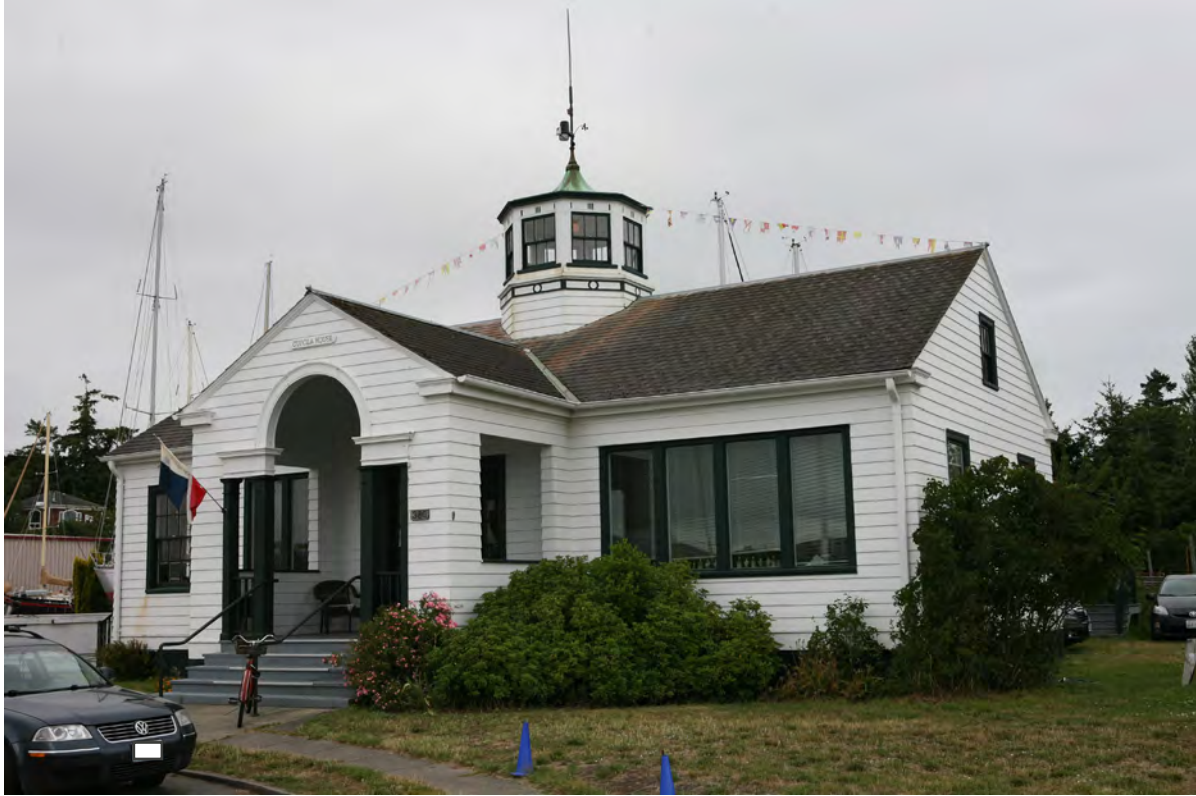
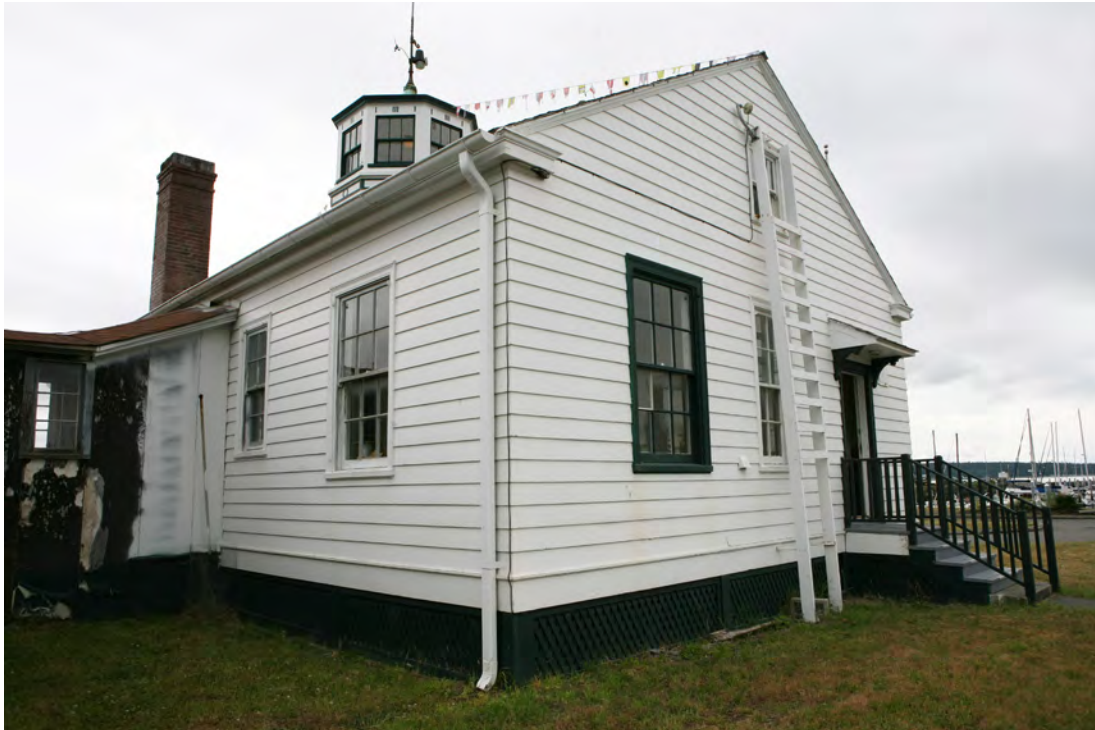
Cupola Building

Top: SE corner of Cupola Building, July 2020. Bottom: NW corner of same, July 2020.

This Colonial Revival style building is a single-story, wood platform framed structure built in 1934-35 for the Point Hudson Quarantine Station. It is set on a foundation of driven piles and dimensional timbers. The original footprint is rectangular. The side gable roof form has an octagonal, central cupola that provides daylight to the attic. The roofing is asbestos-cement shingles with copper flashing. The main entrance is centered in the front (south) facade, emphasized with a front gable roofed, partially enclosed portico. The front doorway features sidelites, a fan shaped element above, and Classical ornament such as swags and reeding; the assembly gives the impression of a Palladian window. Most windows are original wood framed, 6-over-6 hung sashes; the cupola has original 3-over-3 hung sashes.

The exterior underlayment sheathing was laid out in a diagonal pattern rather than the conventional horizontal manner. From historic photos, this appears to be tongue and groove. Wood lap siding completes the exterior wall envelope. The roof is built of 2x8 about 16 inches on center covered with tongue and groove sheathing. The structure and sheathing appear to be in very good condition, as is the cupola itself.

Current condition and needs: The building appears to be in good condition. There are no evident settlement problems. With a limited survey of the crawl space, it appears that the pilings and floor structure are in good condition. The creosote smell was noticeable but mitigated by a portable air purifier in the east office. The interior is in good condition and much of the original millwork, hardware and even some fixtures are still present.

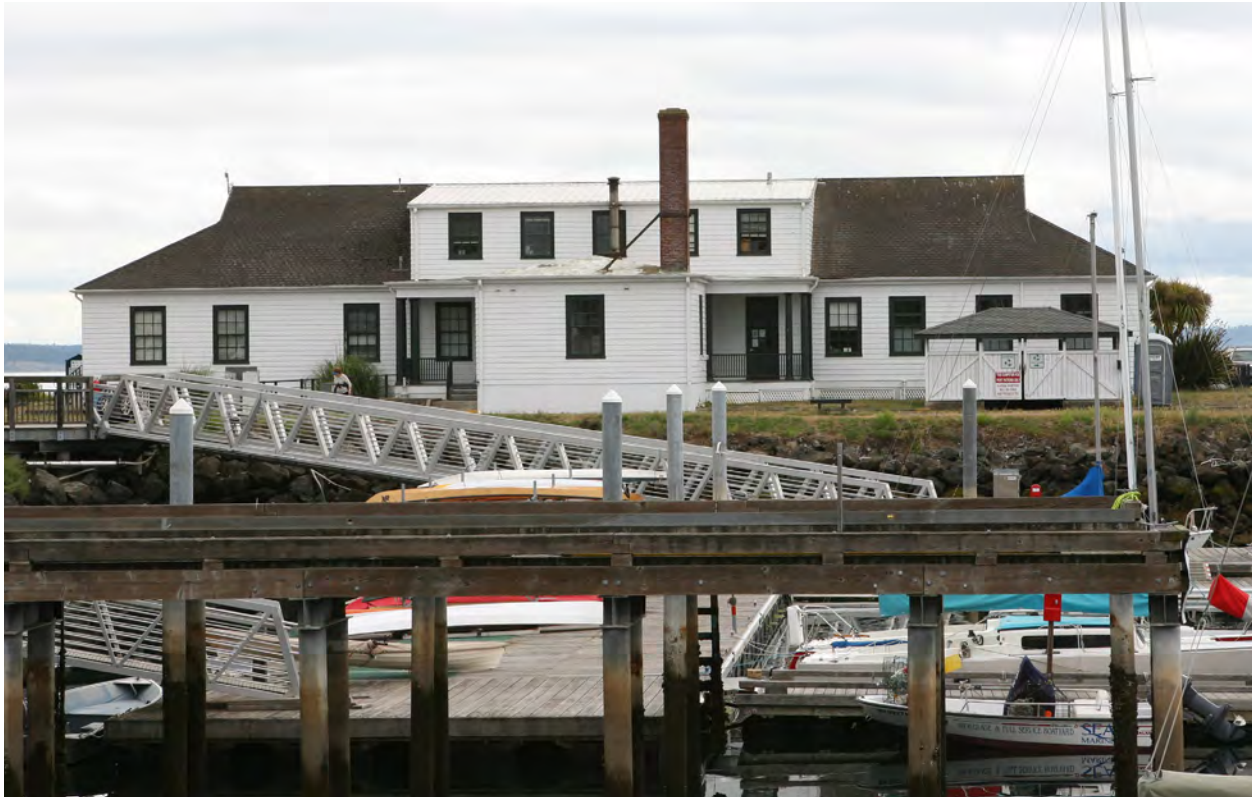
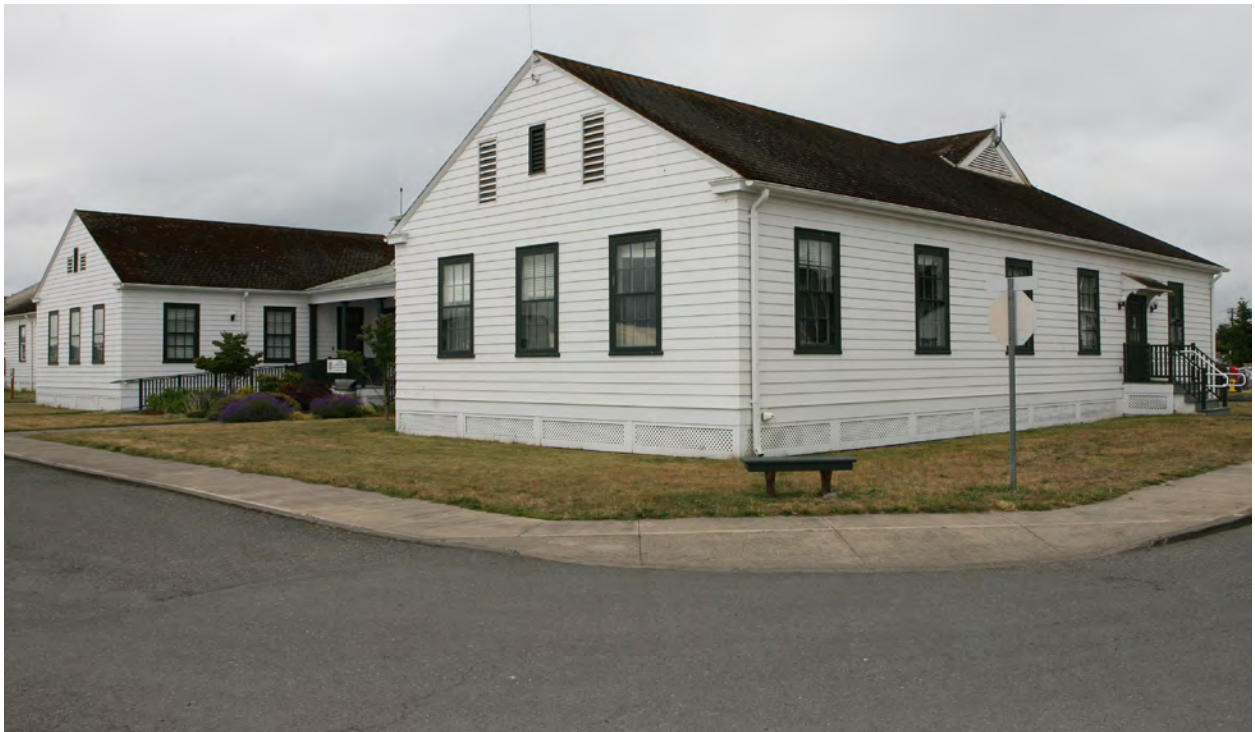
Top: West facade of Hospital, July 2020. Bottom: NE corner of same, July 2020.

This Colonial Revival style building is a 1.5-story, wood platform framed structure built in 1934-35 as the Detention Hospital for the Point Hudson Quarantine Station. It is set on a foundation of driven piles and dimensional timbers. The footprint is U-shaped around a courtyard on the east; a small laundry facility projects from the west facade. There are hip and gable roof forms on the main building plus a flat roof over the laundry addition. The east and west roof slopes each have a broad, shed roofed dormer. Roofing is primarily asbestos-cement shingles; the lower half of the east slope features large metal shingles, laid flush; the metal has a patina resembling copper, but close examination was not possible. The main entrance is centered in the front (east) porch, emphasized with sidelites and transom. Most windows are wood framed, 6-over-6 hung sashes.

Current condition and needs: The building appears to be in good condition. There do not appear to be any settlement problems. From that, we can imply that the piling and floor structures are in good condition (access to the crawl space was not possible). There was no noticeable creosote odor; the building has recently had a new HVAC system installed to address the previous odor issues.

The exterior siding is in relatively good condition. Few changes have been made to the exterior except the removal of all the widow shutters and associated hardware. We were unable to access the attic and inspect the roof structure. However, judging from the other buildings on site we assume the structure and sheathing is similar. If the roof structure is the same as on the other buildings, it is robust. The asbestos-cement shingle roofing is at the end of life cycle and should be replaced. There are a few replacement window sashes but they all match the historic examples in terms of profile and operation. A detailed window survey was not part of the scope but no major damage was noted from the exterior.

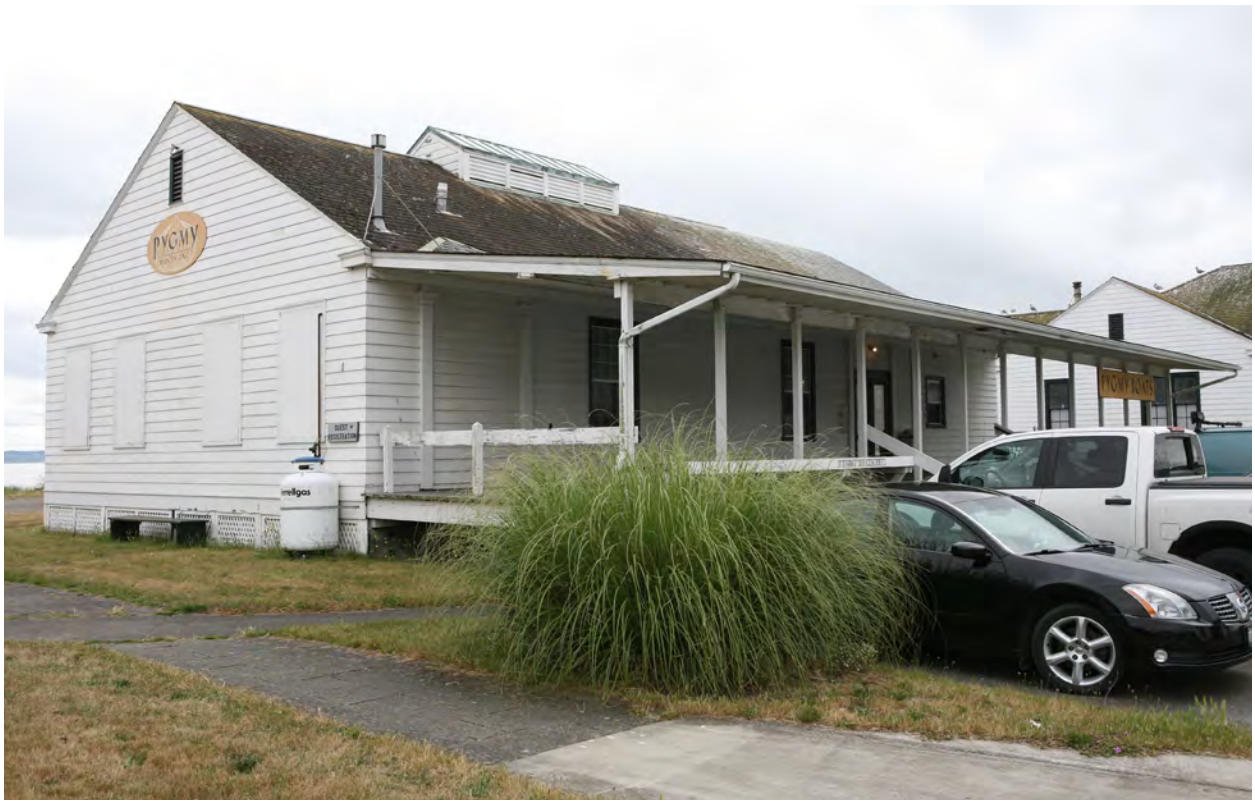
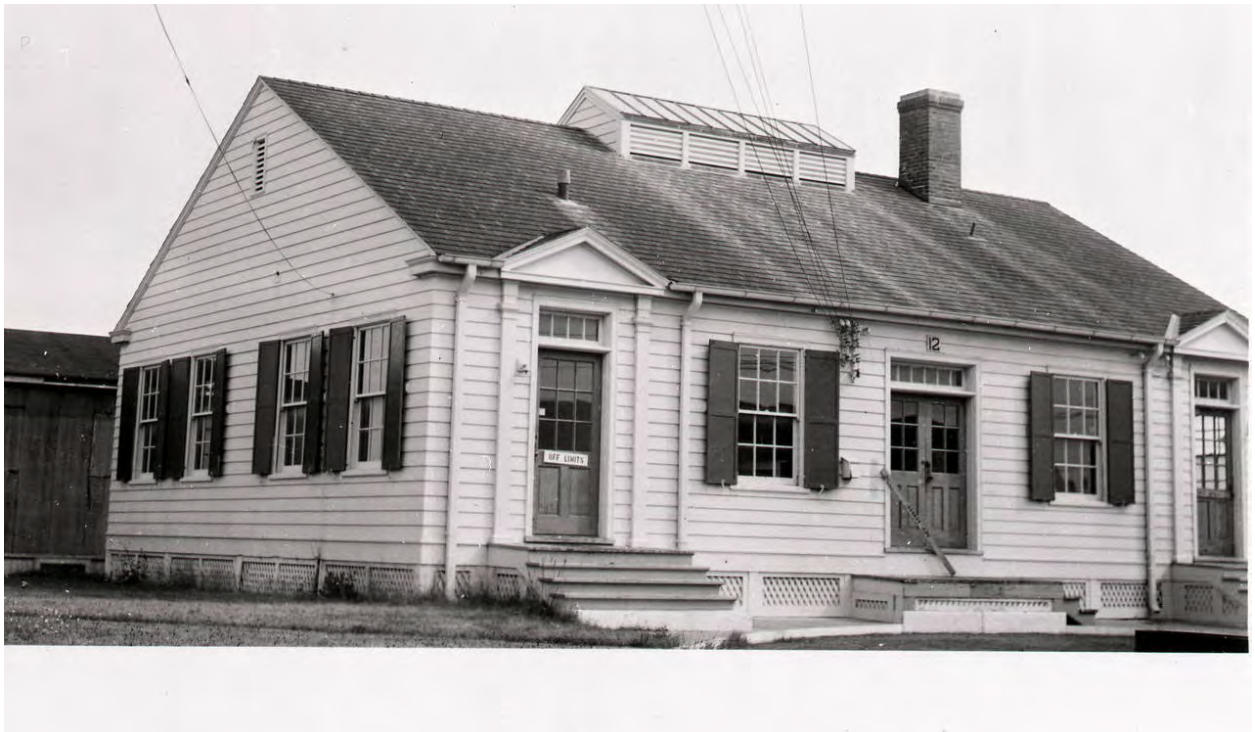
Pygmy Kayaks (vacant)

Top: NW corner, July 2020. Bottom: NW corner in ca1953, courtesy of Jefferson County Historical Society, image 2005.77.271. *PERMISSIONS PENDING*

This Colonial Revival style building is a 1.5-story, wood platform framed structure built in 1934-35 as the Disinfecting Building for the Point Hudson Quarantine Station. It is set on a foundation of driven piles and dimensional timbers (note, the south addition has a concrete foundation). The footprint is primarily rectangular with an added full-width wooden porch along the west facade. The main entrances are in the west (front) facade with secondary entrances to the south and east. A side gable roof features a rectangular, louvered cupola along the ridgeline. On the original building portion, the exterior underlayment sheathing was laid out in a diagonal pattern. From historic photos, this appears to be tongue and groove. Wood lap siding completes the exterior wall envelope. The south addition is platform framed, set on a concrete foundation, and the exterior wall underlayment is unknown.

Current condition and needs: This is the most altered building at Point Hudson. Since being surplused in ca1953, the building has been expanded to the south, a brick chimney removed, and the west porch added. Pilaster plinths at the west doorways were removed when the porch deck was built. To accommodate the new porch roof, two decorative pediments were removed. Two of the west doorways were removed. Original wood windows have been replaced with vinyl sashes; windows in the north facade have been covered from the outside with plywood. Shutters and associated hardware have been removed.

This building has the most condition issues at Point Hudson. There is no indication of settlement on the exterior and a limited survey of the floor structure indicated pilings and timbers are in good condition. However, the floor in the original portion of the building is uneven, presumably due to being added to or removed in places. There is a noticeable creosote odor. The covered porch is of questionable construction. Exterior siding is in fair condition. Asbestos-cement shingle roofing is at the end of life cycle and should be replaced. North windows are covered from the exterior and obscured from the interior, so their condition is unknown.

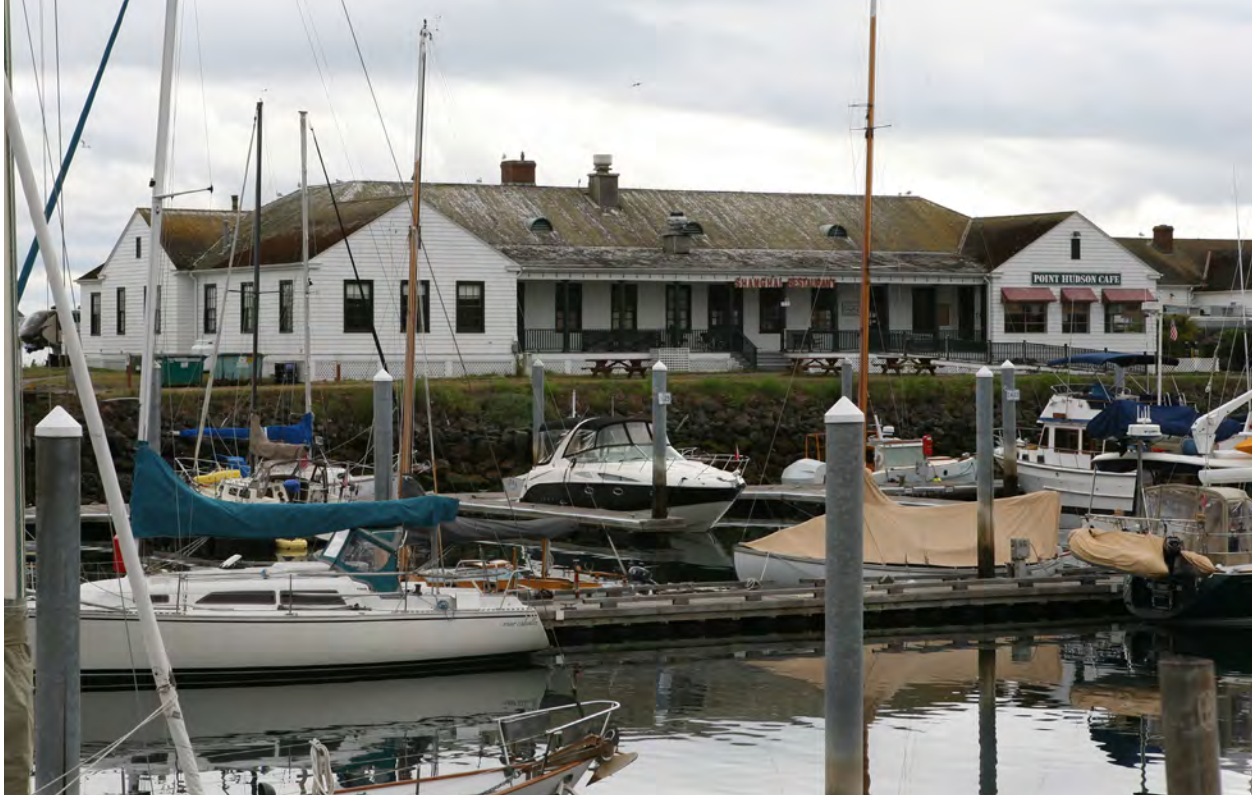
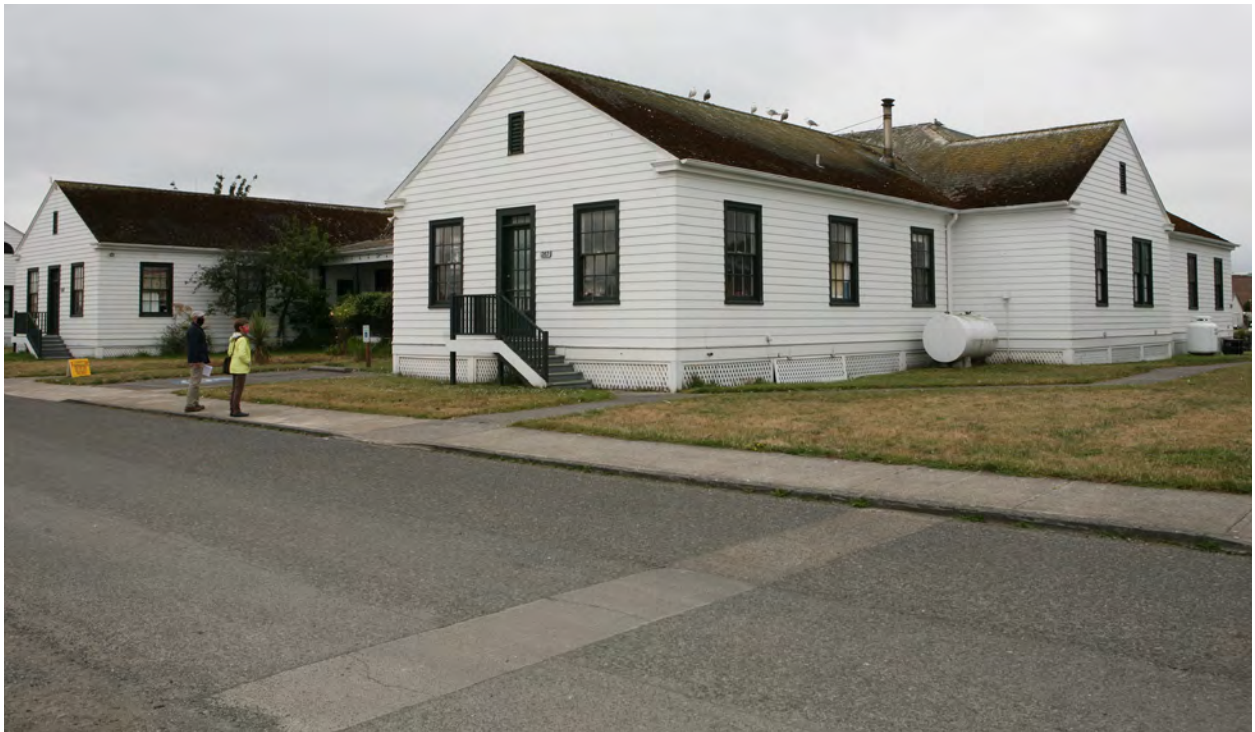
Main Building

Top: NW corner, July 2020. Bottom: NE corner of same, July 2020.

This Colonial Revival style building is a single-story, wood platform framed structure built in 1934-35 as the Detention Barracks for the Point Hudson Quarantine Station. It is set on a foundation of driven piles and dimensional timbers. This is the largest building at Point Hudson. The footprint is U-shaped around a courtyard on the east. There are hip and gable roof forms on the main building. Roofing is primarily asbestos-cement shingles; the west porch roof features large metal shingles, similar to the Hospital roof. The main entrances are in the west and east facades; some entries retain sidelites and/or transoms. Most windows are wood framed, 6-over-6 hung sashes.

Current condition and needs: The building appears to be in relatively good condition. There is no indication of settlement on the exterior, and a limited survey of the floor structure indicated pilings and timbers are in good condition. There was a noticeable creosote odor. The roof structure is in good condition but there are some places where the roof is leaking. The roofing is at the end of life cycle and should be replaced.

The exterior siding is in relatively good condition although there are sections of deterioration (see SW corner). Window shutters and associated hardware have been removed. There are a few replacement, historic metal windows with cloth awnings at the Point Hudson Cafe. There are some fixed lite, non-historic windows in the east facade. At least one exterior door has been replaced. A detailed window survey was not part of the scope but no major damage was noted from the exterior. ADA ramps have been added.
