POINT HUDSON

Intensive Level Survey Documentation and Illustrated Historic Context Statement

ARTIFACTS CONSULTING, INC.

SEPTEMBER 2020

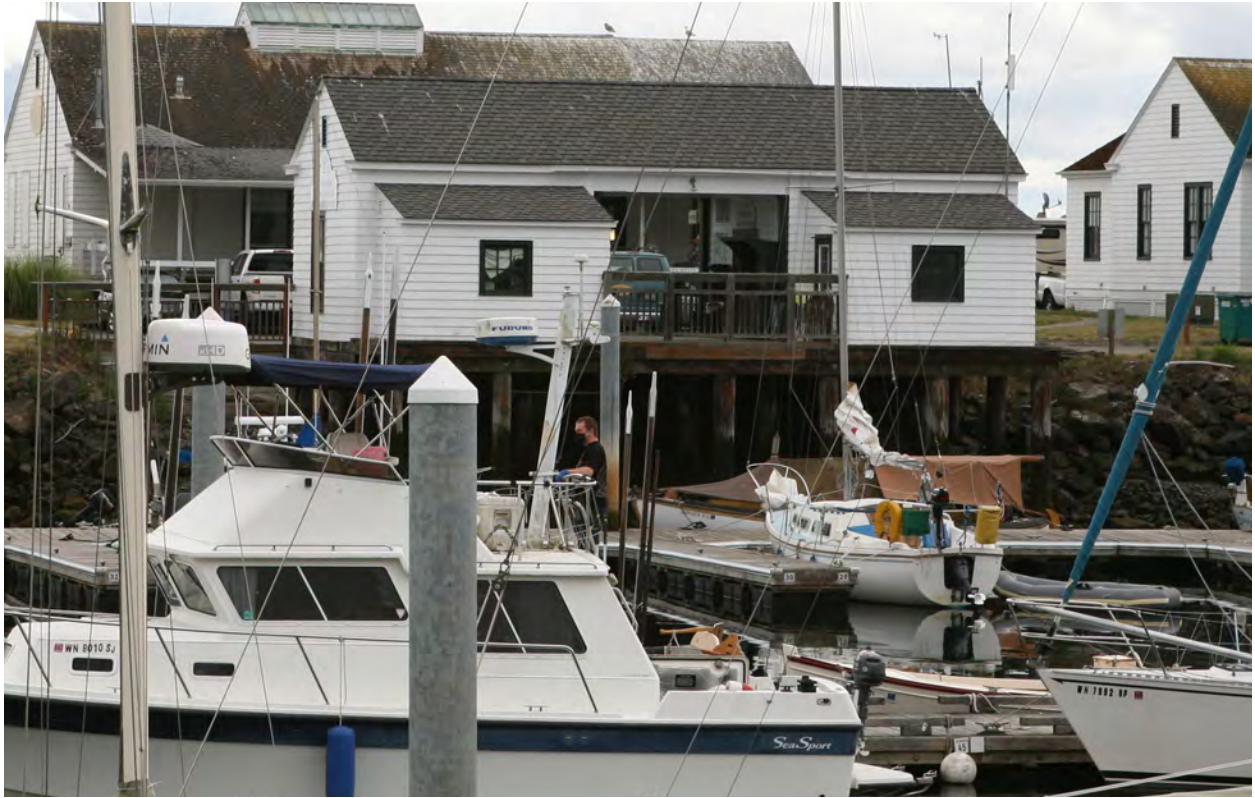
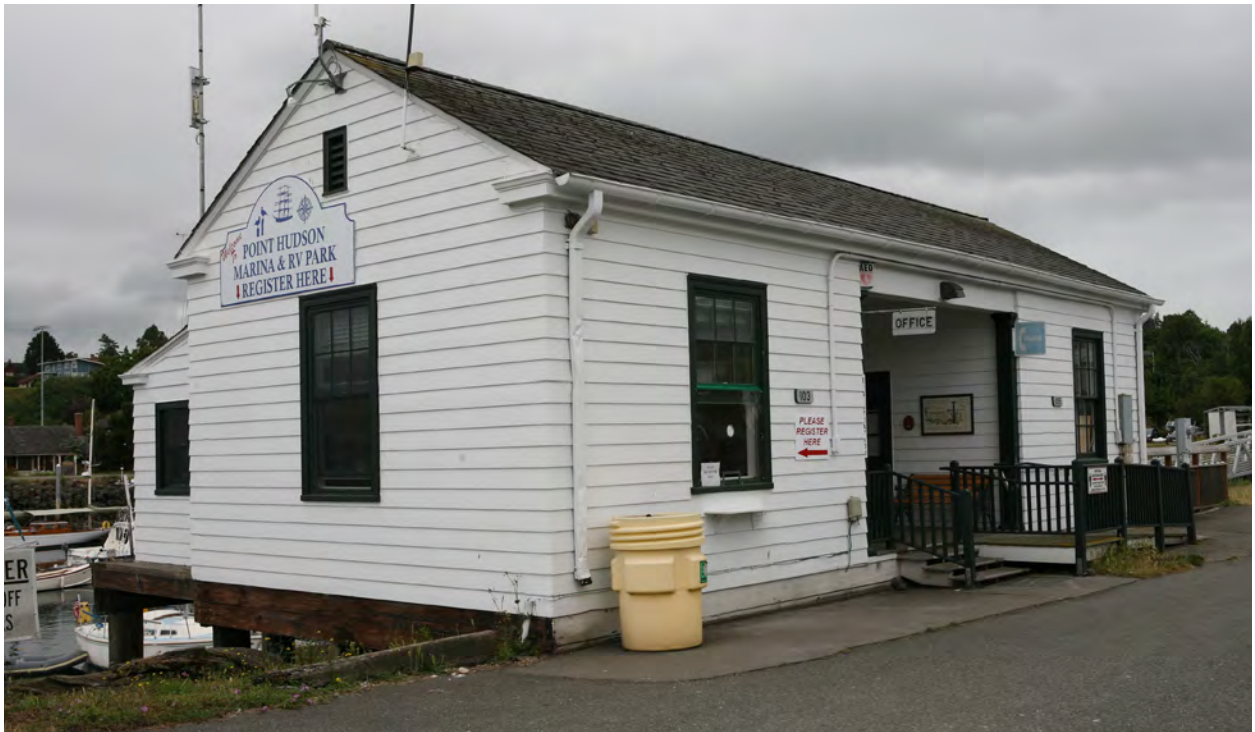
Marina Office

Top: West facade, July 2020. Bottom: SE corner, July 2020.

This Colonial Revival style building is a single-story, wood platform framed structure built in 1934-35 as storage/dock shelter for the Point Hudson Quarantine Station. It is set on a foundation of driven piles and dimensional timbers. This is the smallest building at Point Hudson. The building has a rectangular footprint with a dogtrot plan. That is, the two parts of this building are connected by a continuous roof but separated by an open-air passageway between them. The two parts are nearly identical from the exterior. The gable roof is clad with asphalt/composition shingles and metal flashing. The two halves of the building have entrances off the central passageway. Most windows are wood framed, 6-over-6 hung sashes.

Current condition and needs: The building appears to be in good condition. There is no indication of settlement. Since some of the foundation pilings are in water, they may need replacement sooner than other buildings on site, given their exposure. There did not seem to be the smell of creosote, this maybe because the office is heavily used and it is elevated. The exterior siding and the roofing are in good condition.

There have been multiple significant alterations to this building over time, but the current appearance is in keeping with the overall character of Point Hudson. Based on historic images, the building has changed significantly in size over time, with extensions added and removed. Windows have also been extensively altered since the ca1953 image taken at the time of surplus (Building 14, image 2005.77.294 from JCHS).

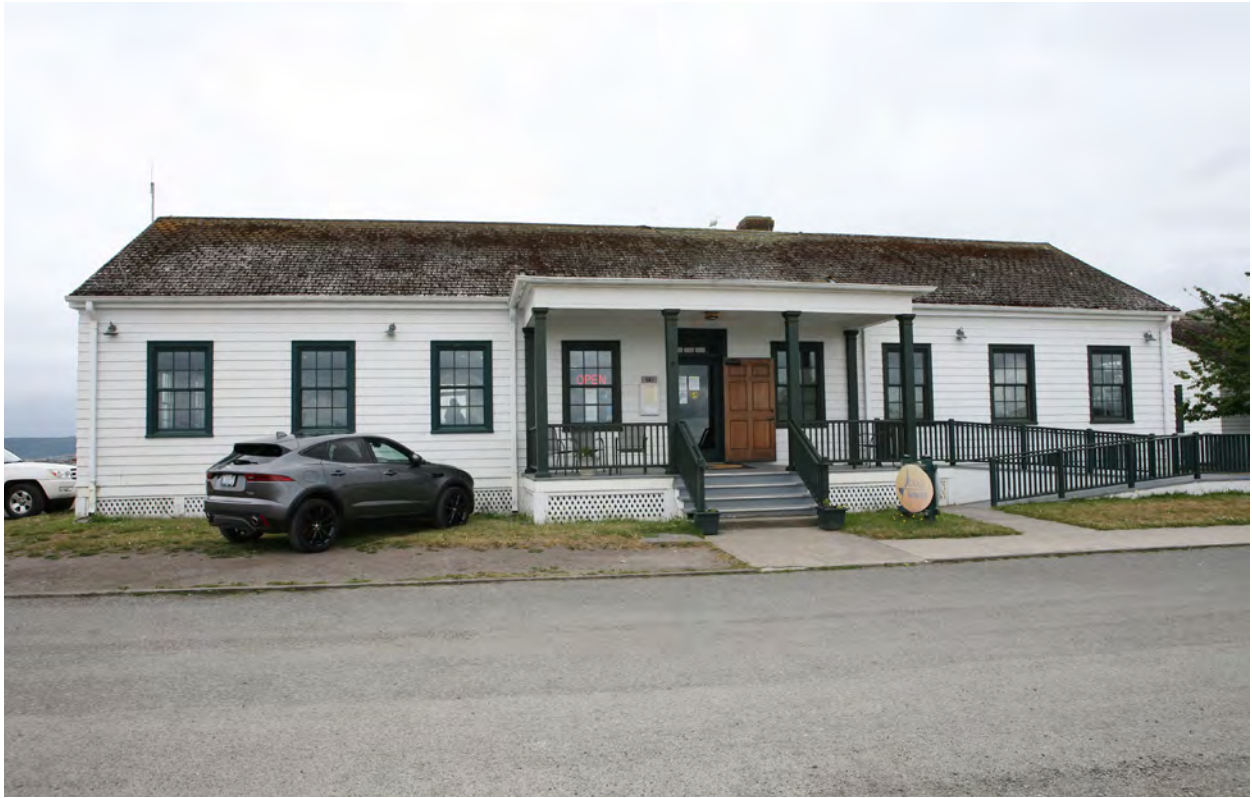
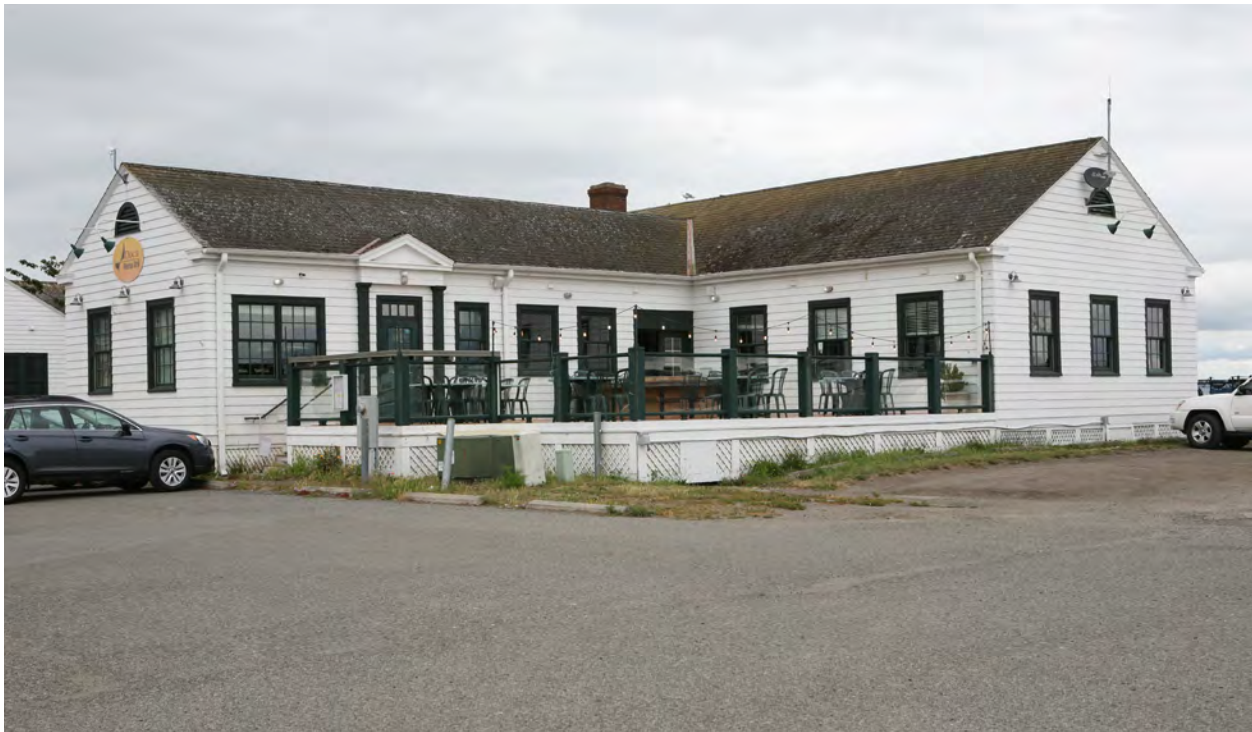
Doc's Marina Grill

Top: East facade, July 2020. Bottom: West and south facades, July 2020.

This Colonial Revival style building is a single-story, wood platform framed structure built in 1934-35 for the Point Hudson Quarantine Station. It is set on a foundation of driven piles and dimensional timbers. The original footprint is T-shaped. The side gable roof form has a lower cross gable to the west. The roofing is asbestos-cement shingles with copper flashing. The main entrance is centered in the front (east) facade at the attached porch. A secondary doorway in the south facade features a pediment overhead. Windows are replacement wood framed, 6-over-6 hung sashes.

The exterior underlayment sheathing was laid out in a diagonal pattern rather than the conventional horizontal manner. From historic photos, this appears to be tongue and groove. Wood lap siding completes the exterior wall envelope. The roof structure is presumably consistent with the other 1935 buildings. From the outside there appears to be no sign of structural failure.

Current condition and needs: The building appears to be in good condition. There are no evident settlement problems. With a limited survey of the crawl space, it appears that the pilings and floor structure are in good condition. This building is the only one where we observed mechanical tie-downs between the pilings and the floor framing -- these were added some time in the recent past. There was no noticeable creosote smell. The interior is in good condition. The floor plan and interior finishes have been extensively altered to accommodate changes in use.

The exterior siding of the main building is in good condition. The roofing is most likely at the end of life cycle and should be replaced. The windows are contemporary double-pane replacement sashes which replicate the originals' operation and profile. A detailed window survey was not part of the scope but no major damage was noted from the exterior. The shutters and hardware present in 1953 pictures have been removed. Some outdoor enclosures have been added for refrigeration units. Kitchen ventilation units are attached to the exterior walls. The dining patio at the southwest corner is a contemporary addition.

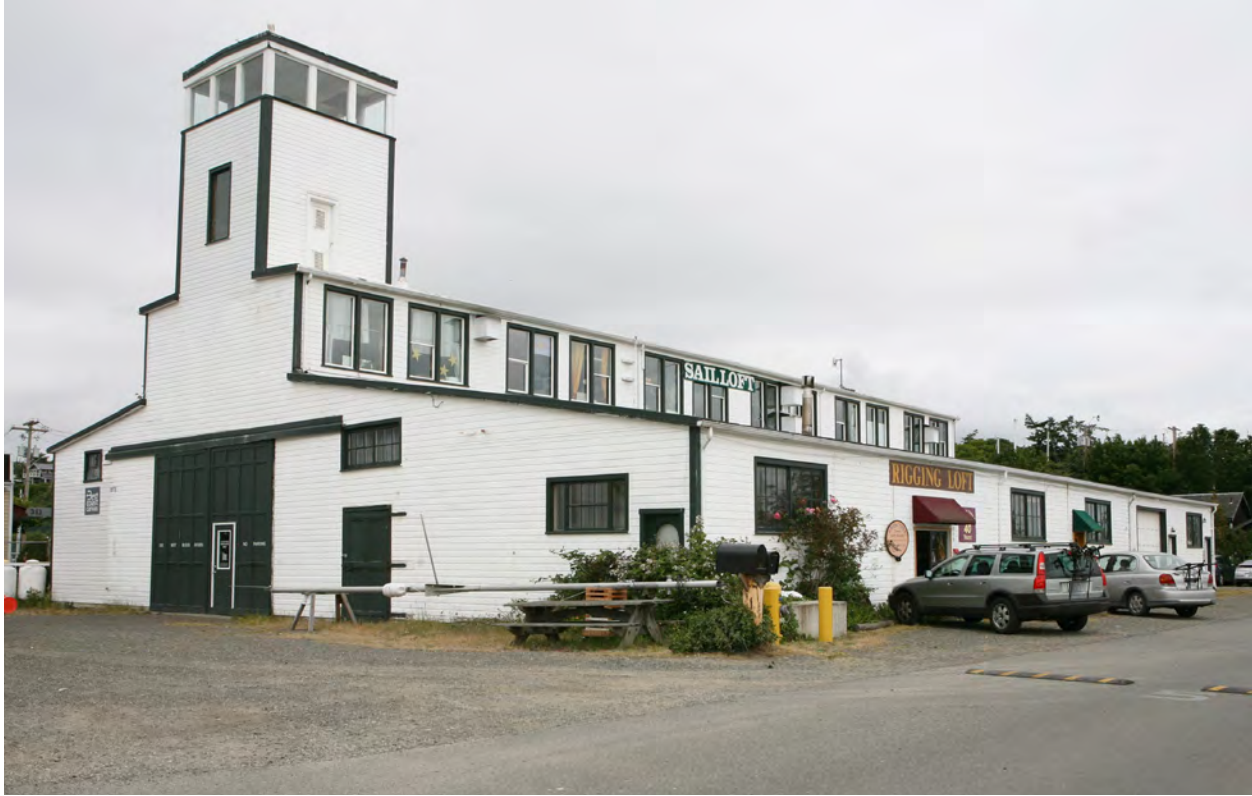
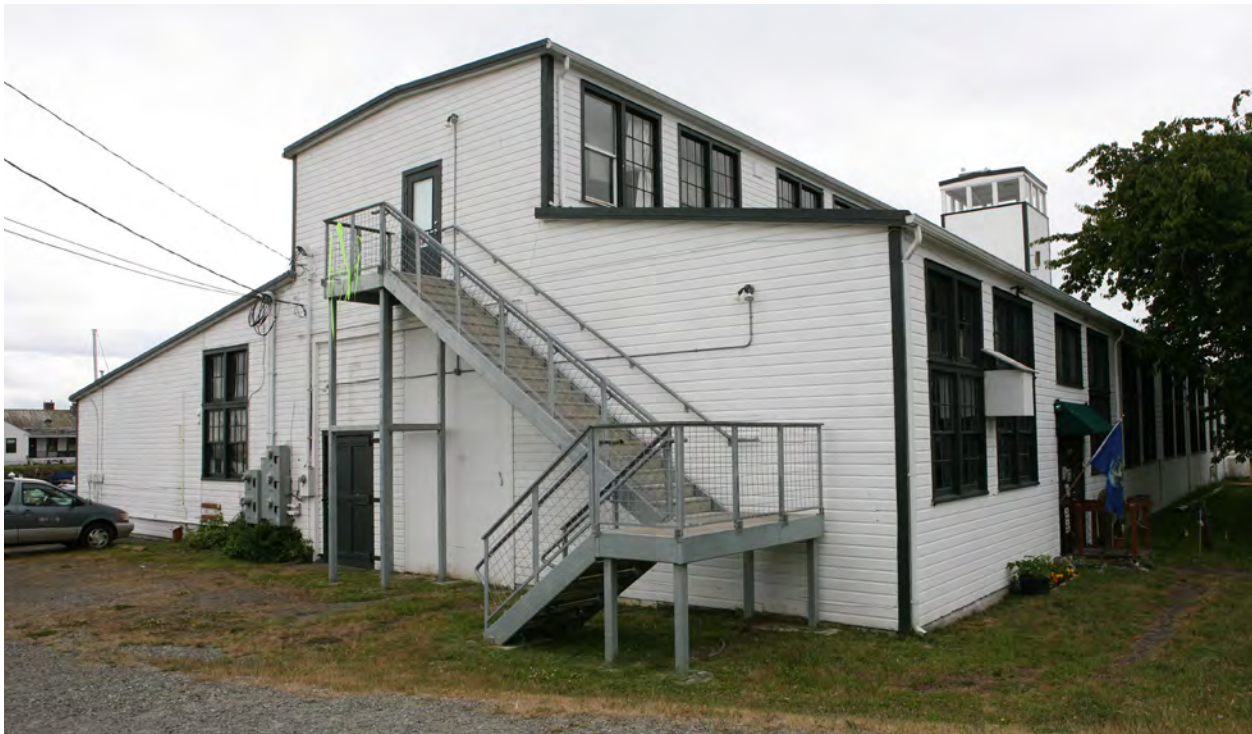
Sail Loft

Top: SE corner, July 2020. Bottom: NW corner, July 2020.

Built in 1941-42, this wood frame building is unique in many ways, not least for its massing. The US Navy constructed this as a Signal Tower with workshop space. It has served as a parachute repair shop, auditorium, indoor basketball court, bowling alley, bike shop, and more. Today, there are multiple private businesses operating there, including a sailmaking business (Port Townsend Sails) that opened there in 1978.

There are a variety of window and door types. Most windows at the main floor are historic wood framed, multi-lite sashes but size and operation ranges from a single 6 lite, small fixed sash to large paired units of transoms above hung 6-over-6 sashes (west facade). The east facade has some unique 6-by-6 sliding wooden sashes. Windows in the monitor and tower have been replaced with contemporary 1-over-1 or single lite fixed sashes. Tall sliding barn doors in the south end access the large central shop space. Single leaf and overhead garage doors are also present. Most doors appear to be contemporary.

Current condition and needs: The building appears to be in good condition. There are no evident settlement problems. There is no crawl space from which to inspect foundation. The floor plan has been altered to accommodate changes in use. A metal exterior stairwell/fire escape for the loft has been added to the north facade.

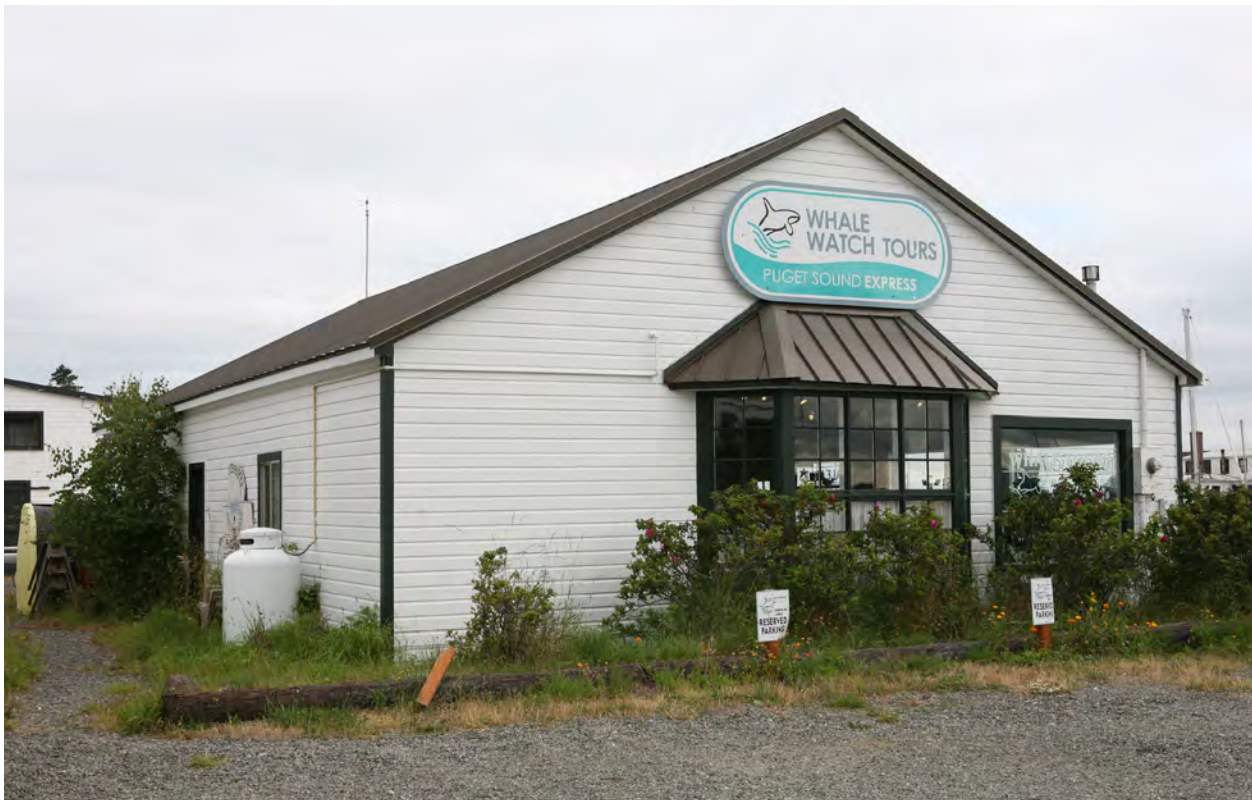
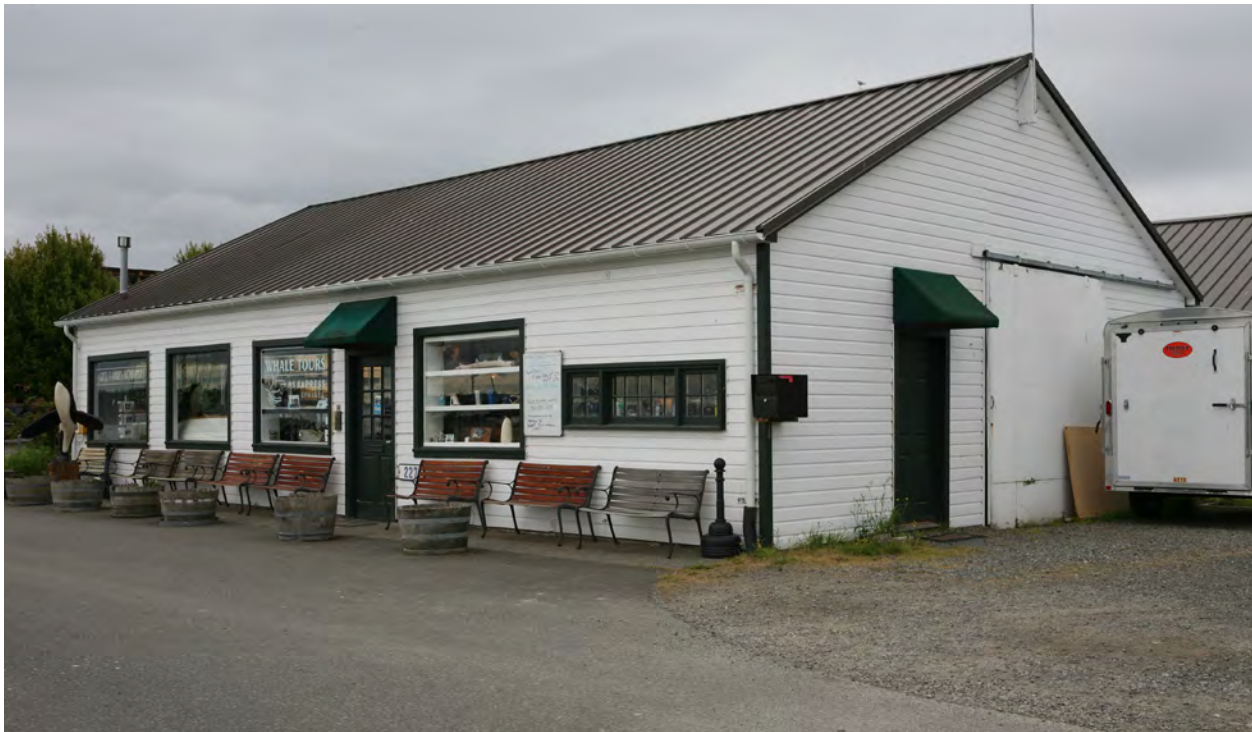
Top: SW corner, July 2020. Bottom: NE corner, July 2020.

The exterior siding and the roofing are in good condition. The windows vary by facade, showing a range of age, materials, operation style, and condition. Some tenants noted maintenance is needed to restore operability. A detailed window survey was not part of the scope but damage/deterioration was noted on various windows.

Built in 1941-42 for the US Navy, this building reportedly served as a carpentry shop. Today, it is occupied by Puget Sound Express Whale Watch Tours for their gift shop and office. The single-story, wood platform frame building has a rectangular plan on a concrete perimeter foundation. Wood drop siding clads the exterior. The gable roof structure is every third joist braced by diagonal supports that fasten down to a lower horizontal cord. Roof sheathing is tongue and groove, which is clad with recently installed standing seam metal roofing.

Current condition and needs: The building appears to be in good condition. There are no evident settlement problems. There is no crawl space from which to inspect foundation. The floor plan has been altered to accommodate changes in use. From comparing current and historic photos, the original window and door openings have been extensively altered. For example, large single pane windows have been added as well as a bay window; former freight doors have been removed. The exterior siding and the roofing are in good condition. A detailed window survey was not part of the scope but no major damage/deterioration was noted.

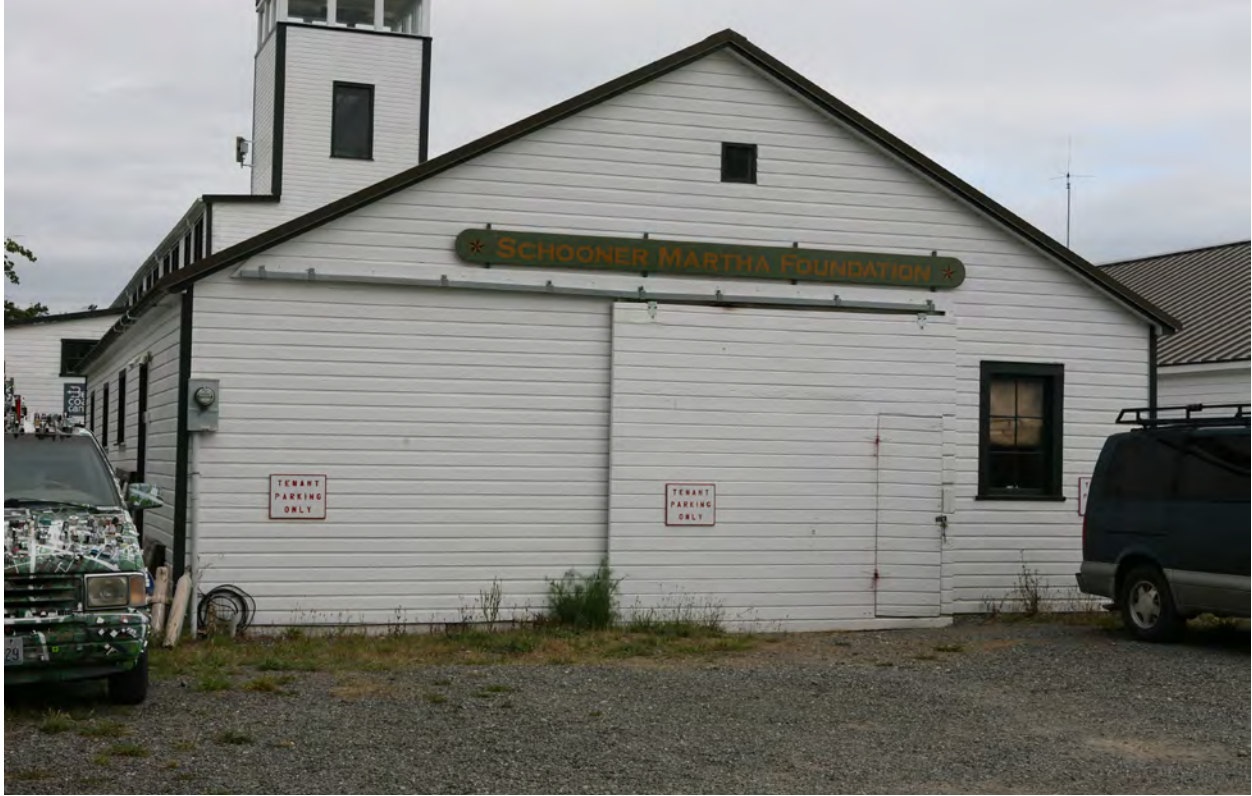
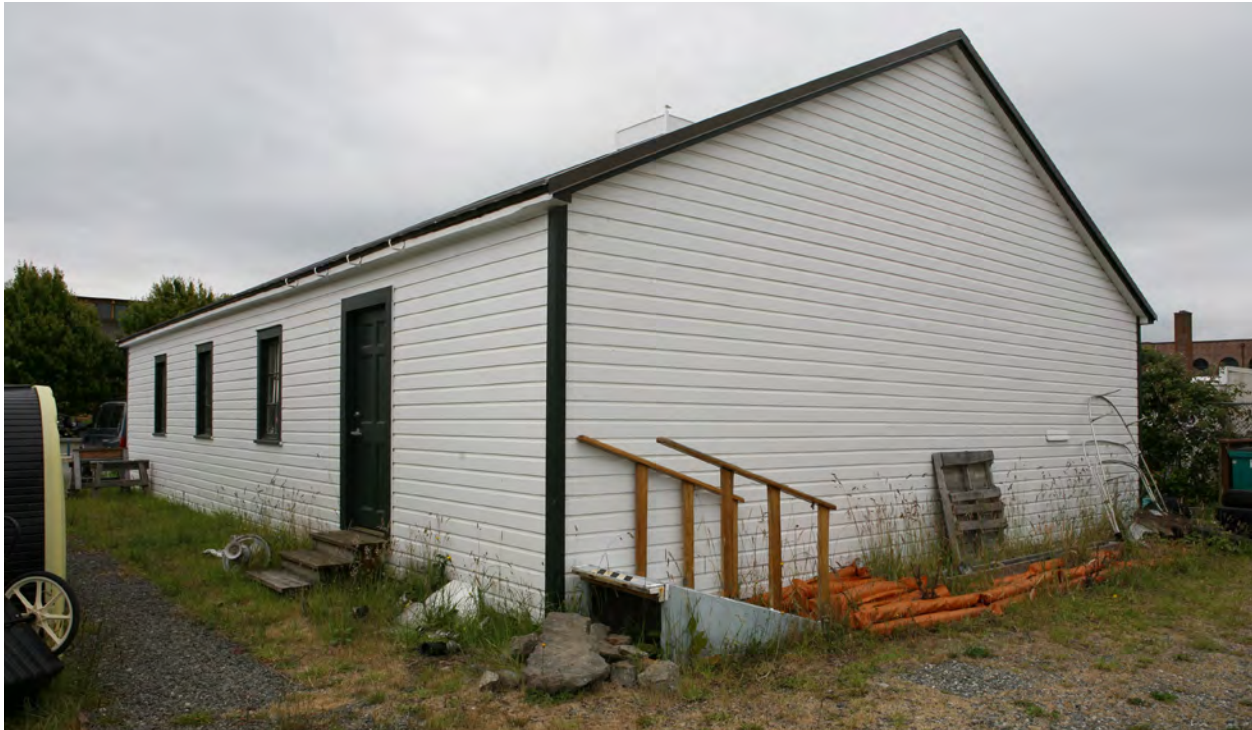
Top: SW corner, July 2020. Bottom: NE corner, July 2020.

Built in 1941-42 for the US Navy, this building reportedly served as storage/warehouse space. Today, it is occupied by the Schooner Martha Foundation for their workshop and office. The single-story, wood platform frame building has a rectangular plan on a concrete perimeter foundation. Wood drop siding clads the exterior. The gable roof structure is formed by a combination of alternating trusses and roof joists. Each individual joist is followed by a “Double Howe” truss. Roof sheathing is tongue and groove, clad with recently installed standing seam metal roofing.

The windows appear to be original wood framed, 6 lite, single sashes. However, at least one window has been relocated – in the south facade, to accommodate the installation of a broad sliding door. Windows are set vertically (east facade) and horizontally (west facade); they appear to be fixed in place. The south sliding barn door replaced the original double doors offset to the SE corner. There are no openings in the north end wall.

Current condition and needs: The building appears to generally be in good condition. There are no evident settlement problems. There is no crawl space from which to inspect foundation. From comparing current and historic photos, some original window and door openings have been altered. The exterior siding and the roofing are in good condition. A detailed window survey was not part of the scope but no major damage/deterioration was noted.

The roof structure is the largest possible concern. Most if not all the trusses have been compromised by the removal of webs on one side or both. Possibly this was done to accommodate storage on the trusses. In addition, at least two trusses were removed from the front (south) portion of the building. This may not be a problem, since the span is not great and weight of the roofing is not onerous. **However, the removal of structure and the storage weight on the bottom cords of the trusses is concerning. A structural engineer’s evaluation is recommended.**
