PORT OF PORT TOWNSEND

Point Hudson Marina Entrance Breakwater Feasibility Assessment

April 25, 2014

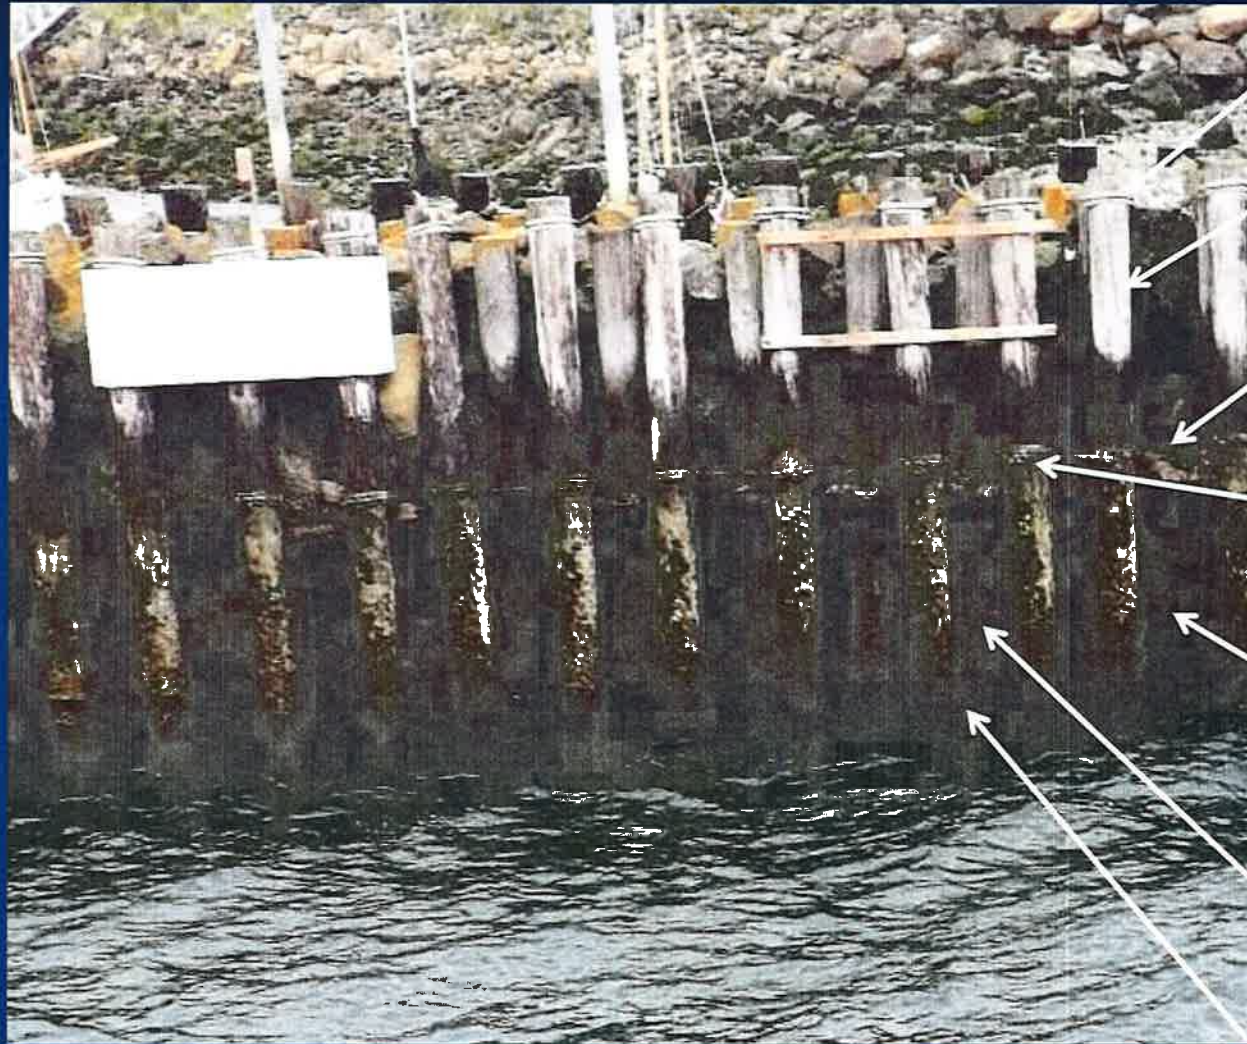
Breakwater Condition – Breakwater Components

Note: >75% Inner Piles (1935) Observed to be Highly Deteriorated, Not Contributing to Structural Stability. Assessment Focused on Outer Piles.

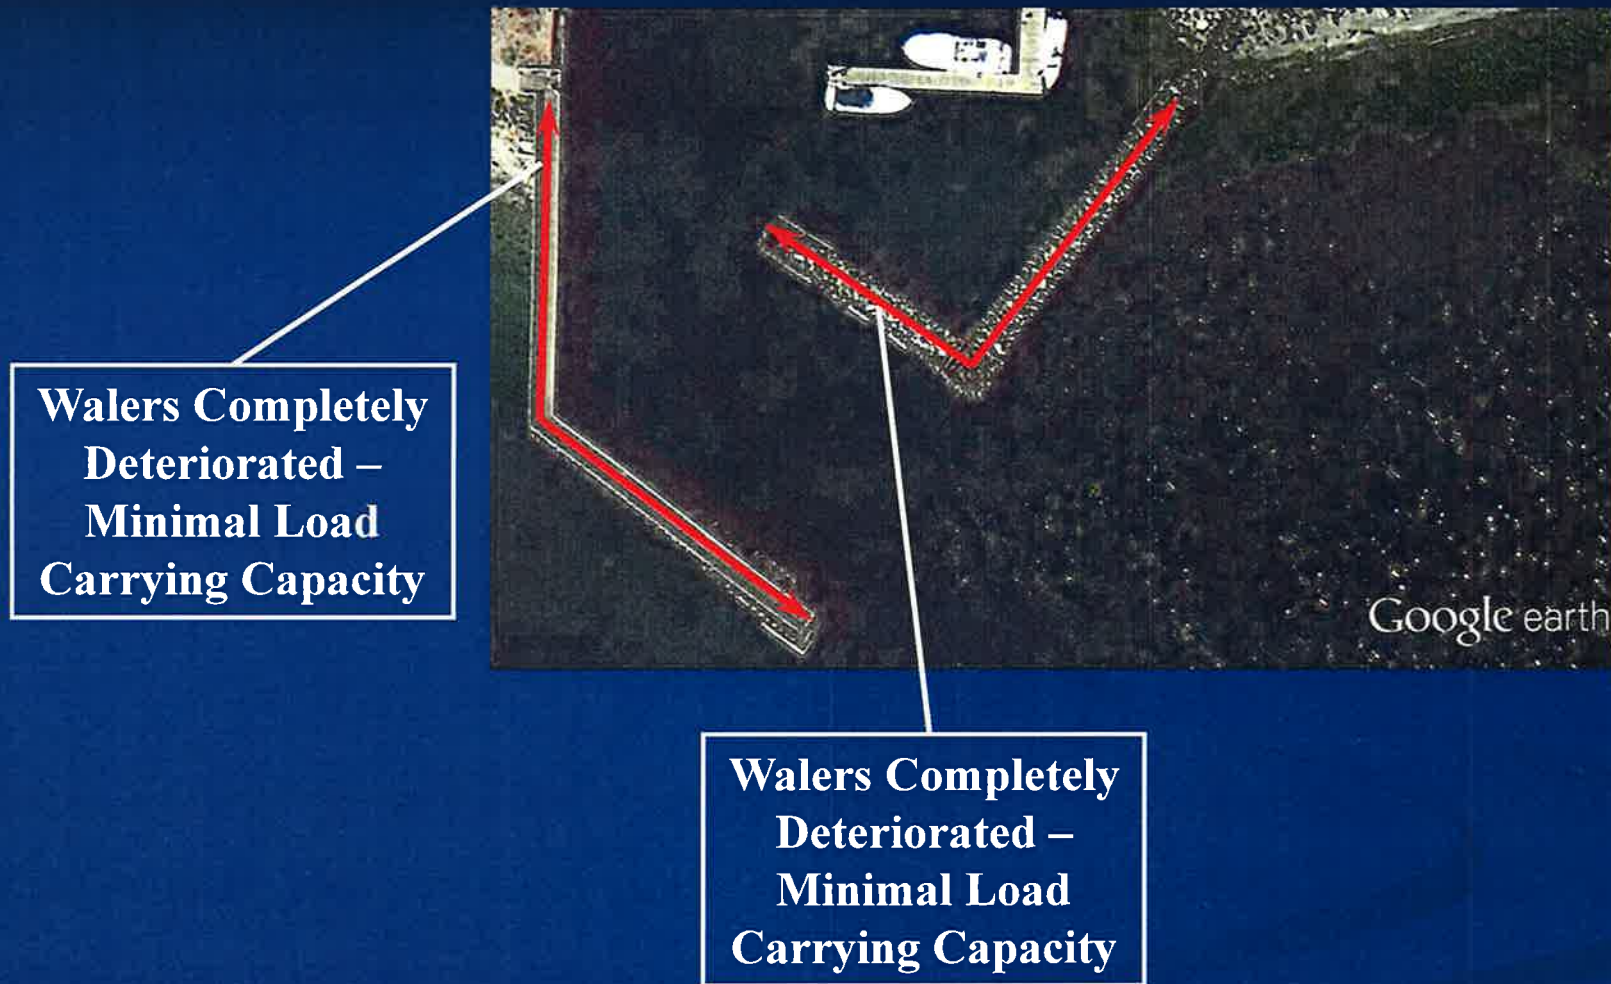
Current Condition – Upper & Lower Walers

- Highly Deteriorated – Minimal Capacity
- Minimal Contribution to Structure Stability – Decreased System Capacity
- Loss of Stone Confinement
- Walers Beyond Useful Service Life

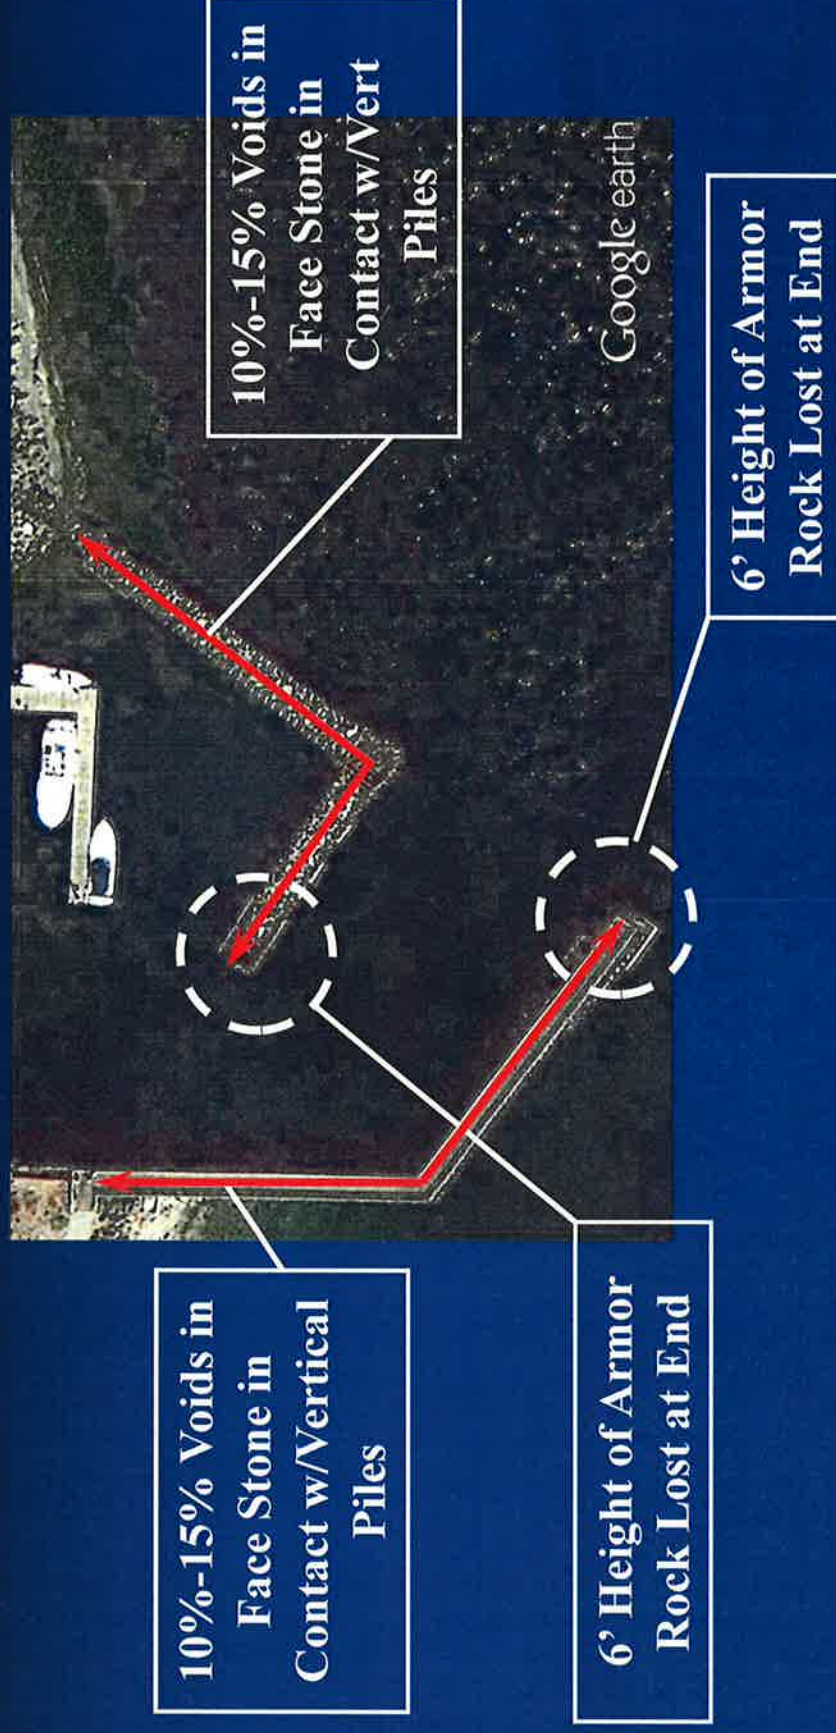
Current Condition – Armor Rock

- Appears to be Matts Matts Sourced Marine Basalt – Low Quality Stone
- Highly Fractured
- >50% of Stone in Deteriorated to Highly Deteriorated State

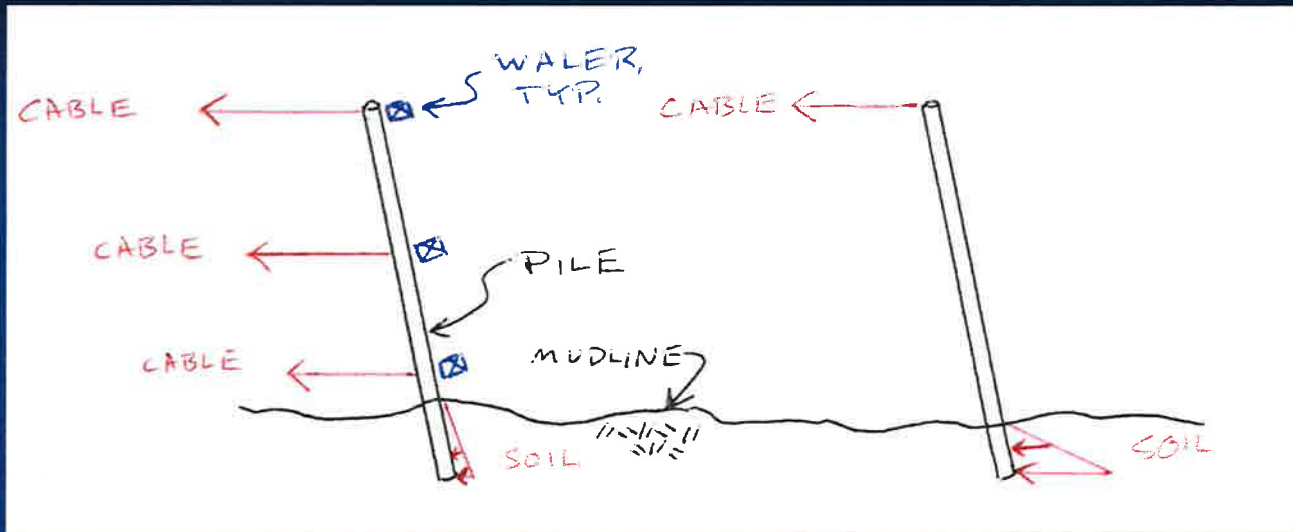
Analysis – Overall Structural System

- Only Top Cable
Remaining
- Top Cable is
Deteriorated –
Reduced Capacity
- Stability Heavily
Reliant on Pile
Capacity and Soil
Capacity

- System Capacity Significantly Reduced due to Deterioration. System Degradation Leading to Increased Pile Loading
- Outer Pile Load Demand Increased Significantly due to
 - Failed Walers (2 Rows)
 - Failed Thru-Rods (2 Rows)
- Outer Piles are Deteriorated Relative to New Condition – Resulting in Reduced Capacity
- Conclusion: Replacement/Rehabilitation Recommended

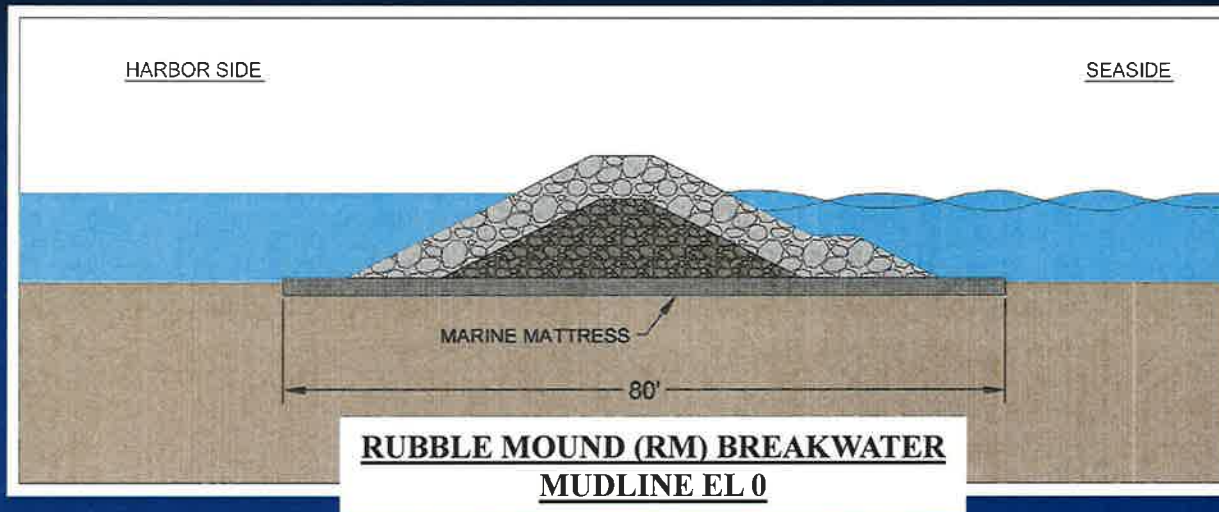
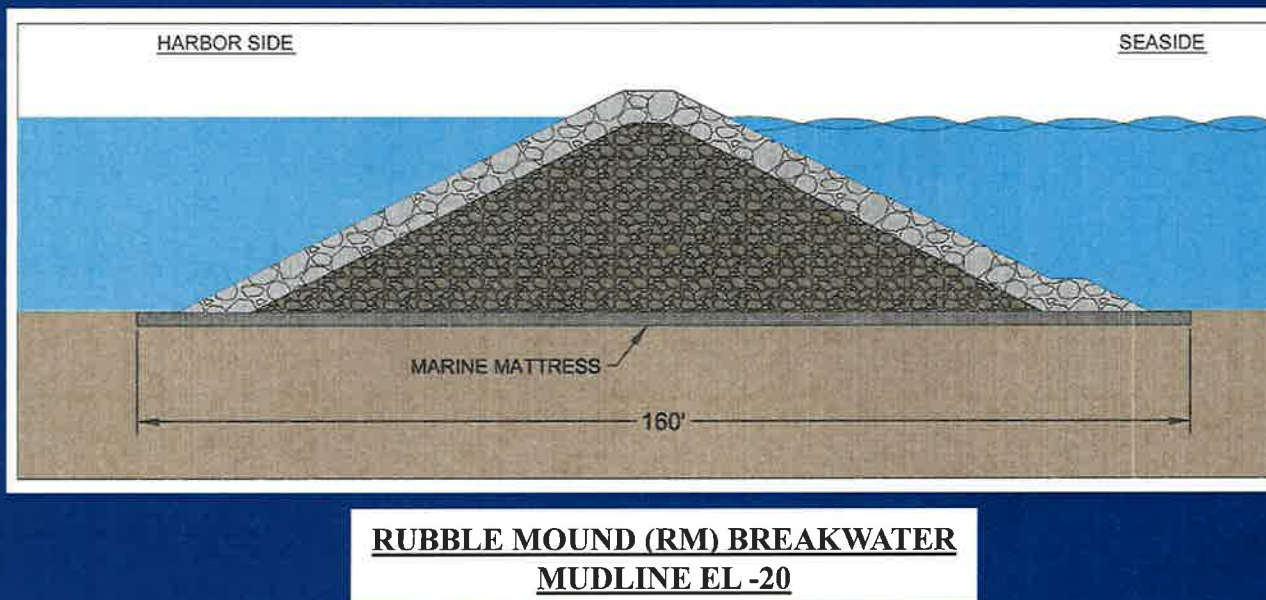
Footprint too large
~ Not Feasible for
seaward
breakwater leg
