Point Hudson

Breakwater Improvement Project

Selected Alternative Feb 12th, 2020

Introduction & Assessment

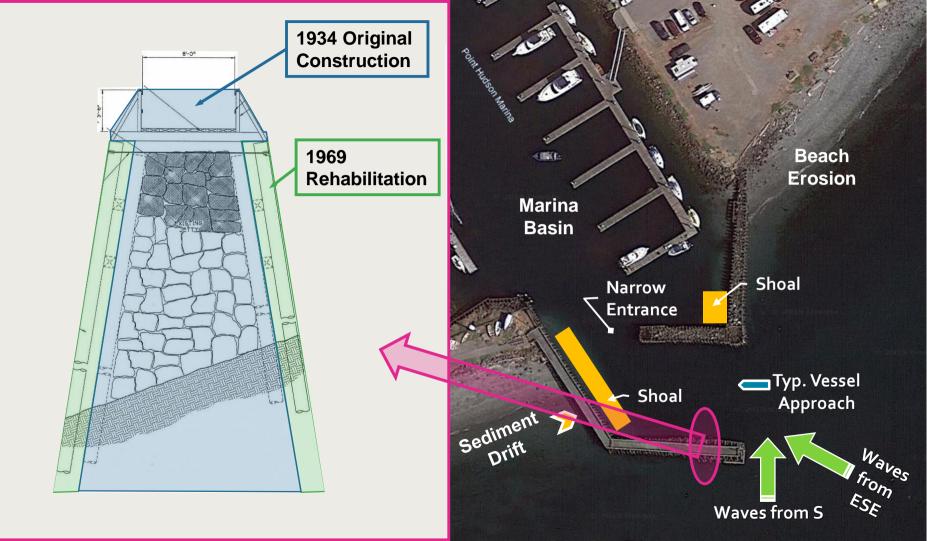
Existing Condition

Timber piles, walers, cable tiebacks, and armor rock are at or beyond useful life. Stability of the overall structural system is compromised.

- The most advanced structural deterioration was observed at the end of the south breakwater.
- Voids in the riprap reduce the system's wave protection capability.
