## GEOMORPHIC ASSESSMENT OF CHIMACUM CREEK

North Olympic Salmon Coalition  
205 W Patison St. b,  
Port Hadlock, WA 98339  
360.379.8051

1900 N. Northlake Way, Suite 211  
Seattle, WA 98103

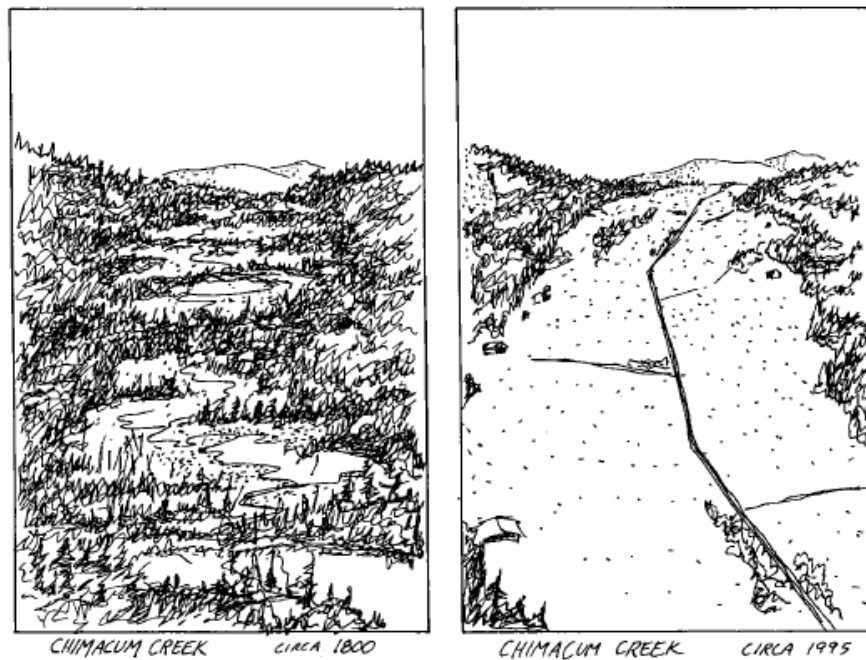
Historically, the Chimacum Creek valley was a vegetated, low gradient alluvial valley with substantial wetlands (Figure 1, from Bahls & Rubin (1996)). Government Land Office (GLO) surveys were conducted between 1858-1974 and notes and maps indicate extensive riparian forests, swamps, wet prairies and beaver ponds, and the morphology of the creek and valley were likely strongly controlled by beaver-created floodplain water bodies (Bahls & Rubin, 1996). Over 2000 acres of the valley consisted of wetlands, including almost 600 acres that were perennial water bodies suitable for both summer and winter fish rearing (Table 1 and Map 2; Bahls & Rubin (1996)). In the early 1900s the floodplain forest was removed and the land was

**Figure 1.** Illustration of the Chimacum Creek watershed looking upstream along the main stem showing (left) historic conditions (circa 1800) which included riparian forest, beaver ponds, and channel complexity and (right) current conditions (circa 1995) after riparian forest removal and channel straightening and ditching. From (Bahls & Rubin, 1996), based on GLO survey data.

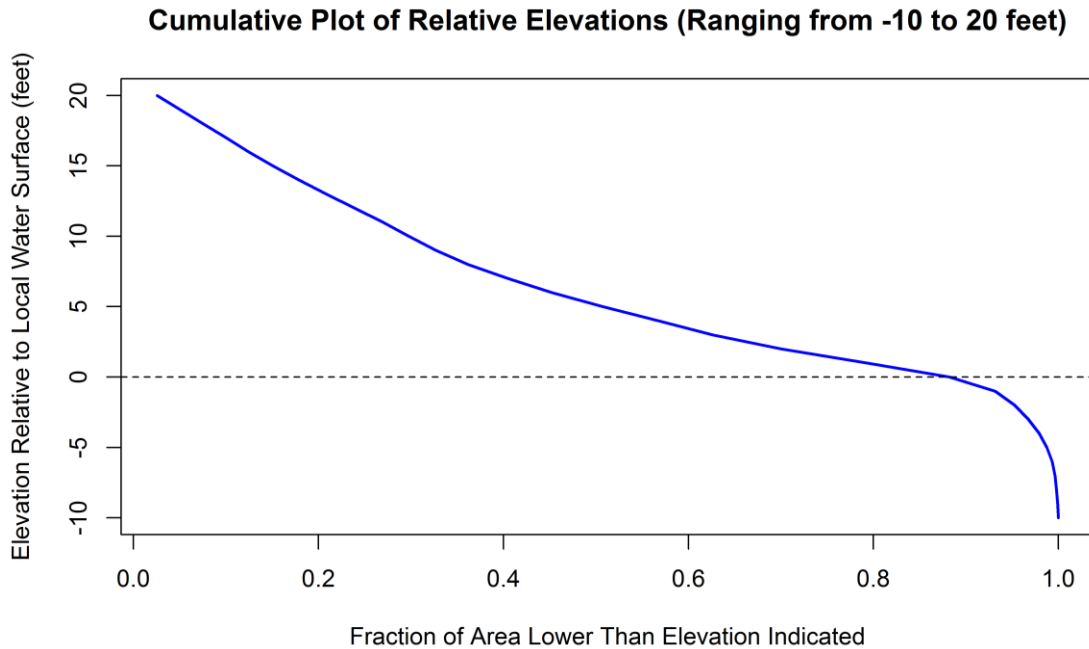
The geomorphic features of the Chimacum Creek valley are consistent with its historic form as an alluvial valley with abundant wetlands (Mapbook 2). In particular, there are many continuous lowland areas surrounding what is now the channel (Figure 5). Most of these low areas identified in the REM maps also coincide with GLO survey wetland data presented in (Bahls & Rubin, 1996). We identified several locations where the channel is incised relative to its floodplain (Figure 6) and where the current channel is higher than nearby remnant meanders (Figure 7). Note that the topographic and REM analyses are limited by the spatial resolution and accuracy of the lidar data, and additional ground surveys are recommended (see Recommendations section).

**Figure 5.** Hypsometric Curve showing cumulative elevation relative to water surface, for values that range from -10 feet below water surface to 20 feet above the local water surface in the Chimacum Creek watershed; note the substantial portion of valley area located below the local water surface (i.e. under the dashed line at 0 feet elevation).

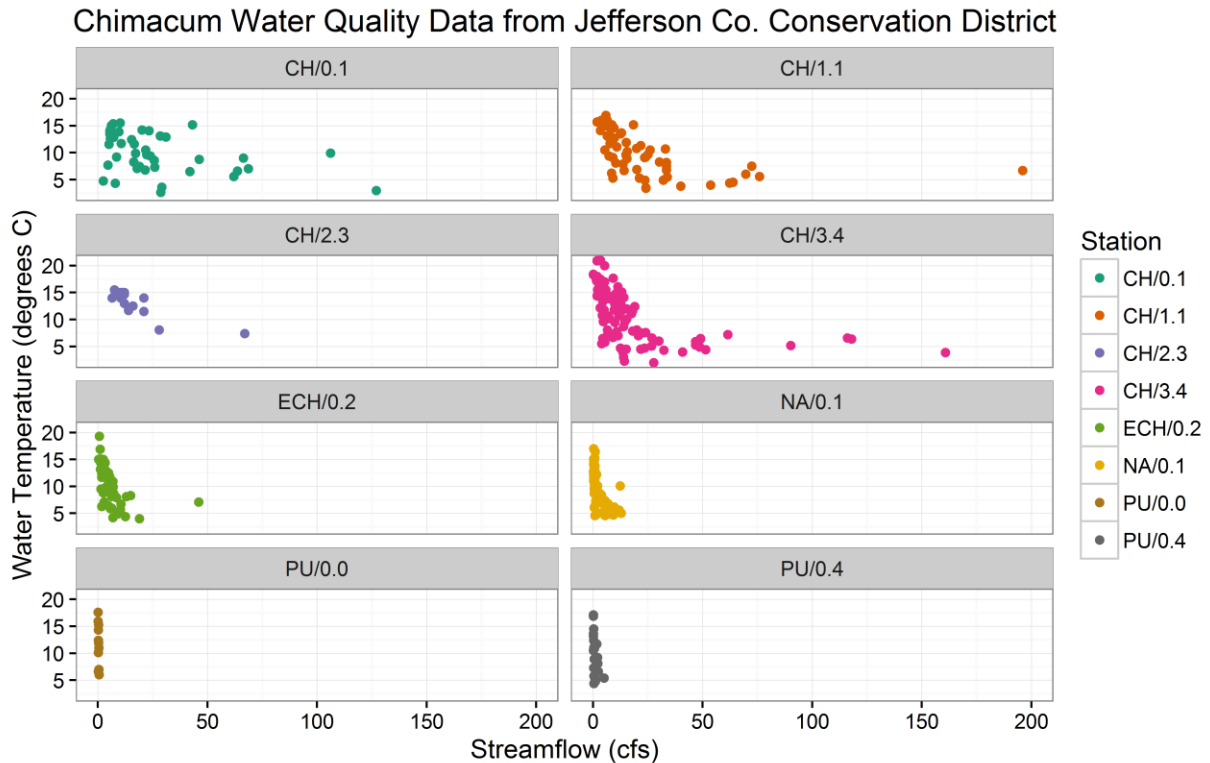
Temperature exceedances are also associated with the flow regime in Chimacum Creek. Observational data collected by Jefferson County Conservation District suggest that water temperature is generally higher at lower streamflow values (Figure 8). The typical timing of low flows during the summer is coincident with warmer air temperatures, and, during low flows there is less cold water advected into the system and less total mass to heat. Shallow inundation of adjacent fields and subsequent warming and/or fertilizer contamination is also a possible contributing factor to water quality impairment. However, since inundation is more likely to occur during the cool, cloudy winter months, and since DO exceedances are correlated with temperature exceedances, this is likely a lesser contributor. Further assessment of contributing inflows during the low flow season are recommended (see Recommendations section).

**Figure 8.** Water temperature as a function of observed streamflow for water quality sampling stations with flow data (Station names indicate the stream and the river mile, such that CH/0.1 is located on the main stem of Chimacum Creek at RM 0.1; CH = main stem Chimacum Creek, ECH = East Chimacum Creek, NA = Naylor's Creek, PU = Putaansuu Creek). Data courtesy of Jefferson County Conservation District (Gately et al., 2015).
