PORT OF PORT TOWNSEND

Point Hudson Marina Entrance Breakwater Feasibility Assessment

May 28, 2014

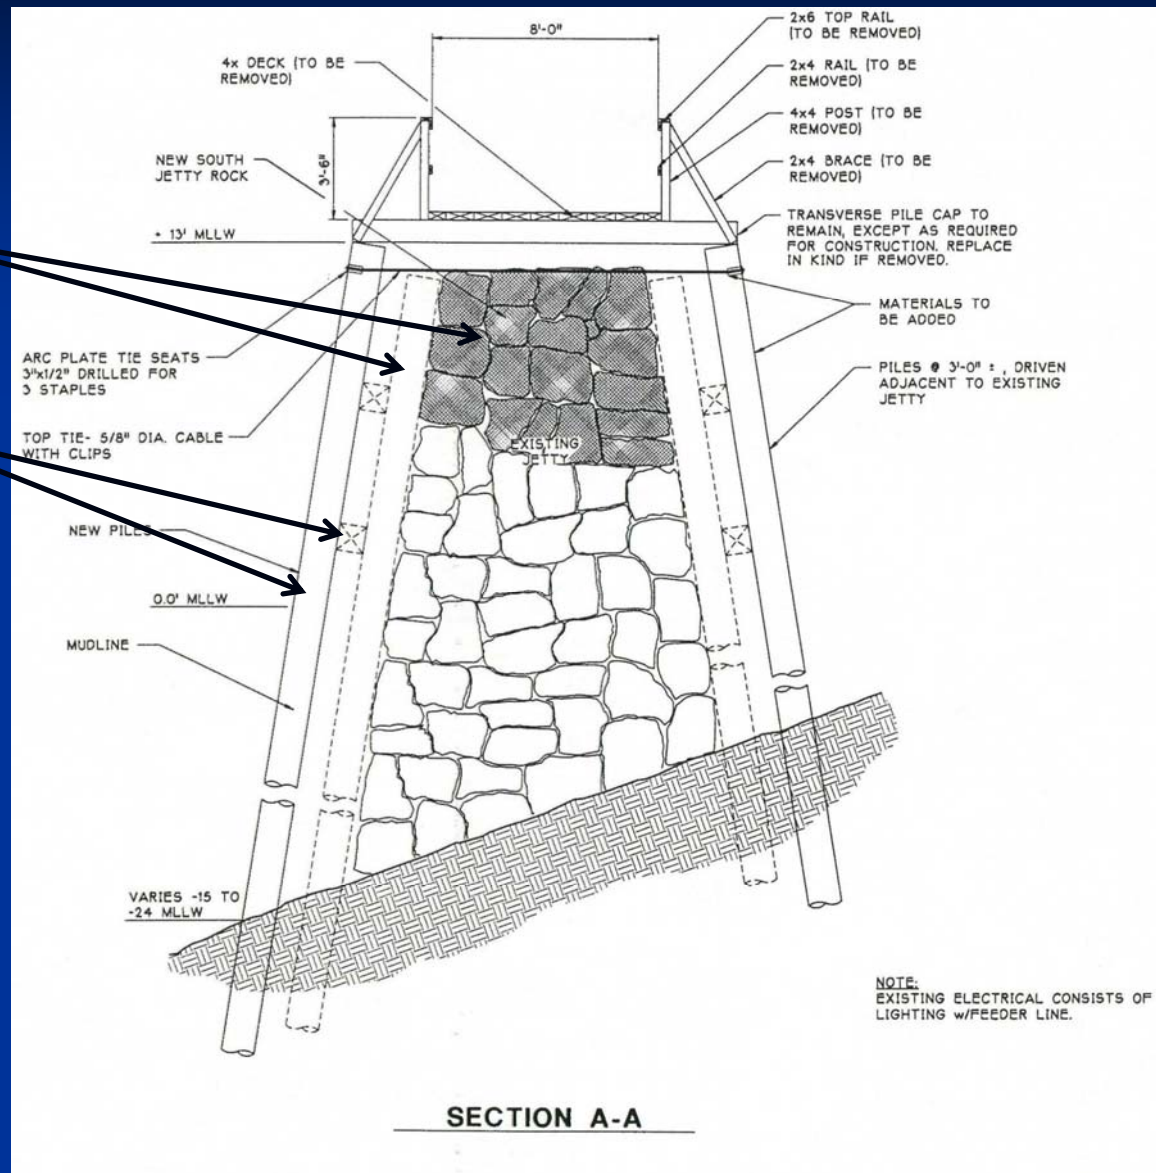
Breakwater History - Facility

- Original 1934 Construction by Military
 - Creosote Treated Timber Piling
 - Creosote Treated Timber Walers (2 to 3 Rows)
 - Armor Rock
 - Steel Cable Tiebacks
- Major Rehabilitation in 1969
 - Conversion from Pier/Breakwater to Breakwater
 - New Outer Piles
 - New Center Cables Tied to Existing Piles
- Retrofit in 1996 - End 60' of S. Breakwater, Bend & End 12' of N. Breakwater
 - New ACZA Treated Timber Piling
 - Steel Cable Wrapped Around New Piling
 - Supplemental Armor Rock

1934

1969

Rehabilitation

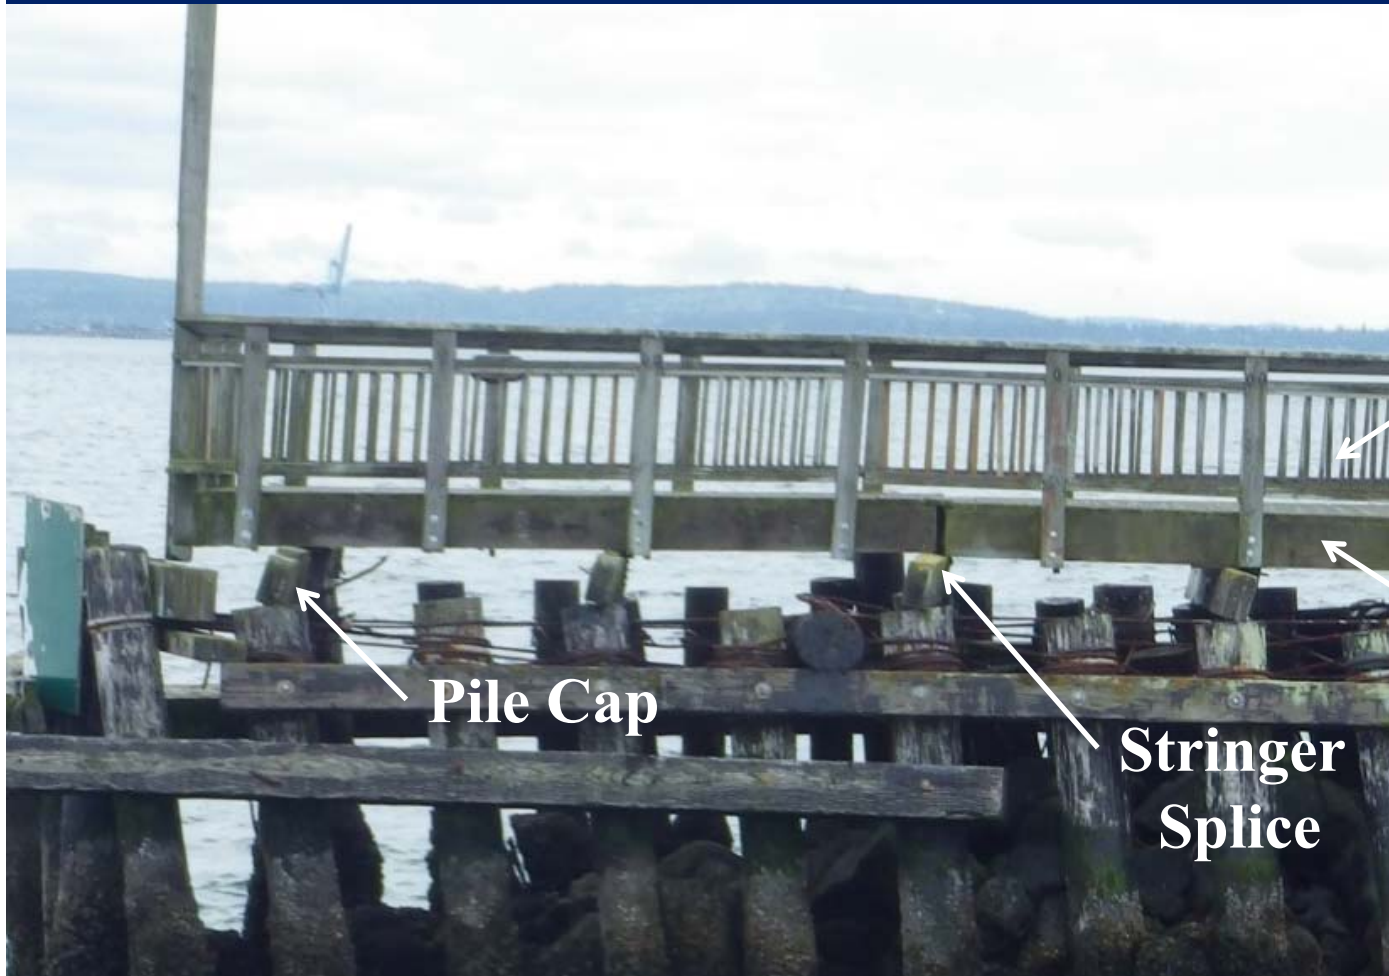
Breakwater Condition – Walkway Components

Walkway

Stringer

Pile Cap

**Stringer
Splice**

- Breakwater End Under Walkway Failing – Maintenance Staff Needs to Closely Monitor Condition.
- Further Failure/Shifting May be Grounds For Closure of Approx. 60' End Portion.
- Port Maintenance to Monitor Pile Caps, Stringer Splices for any Change in Condition.

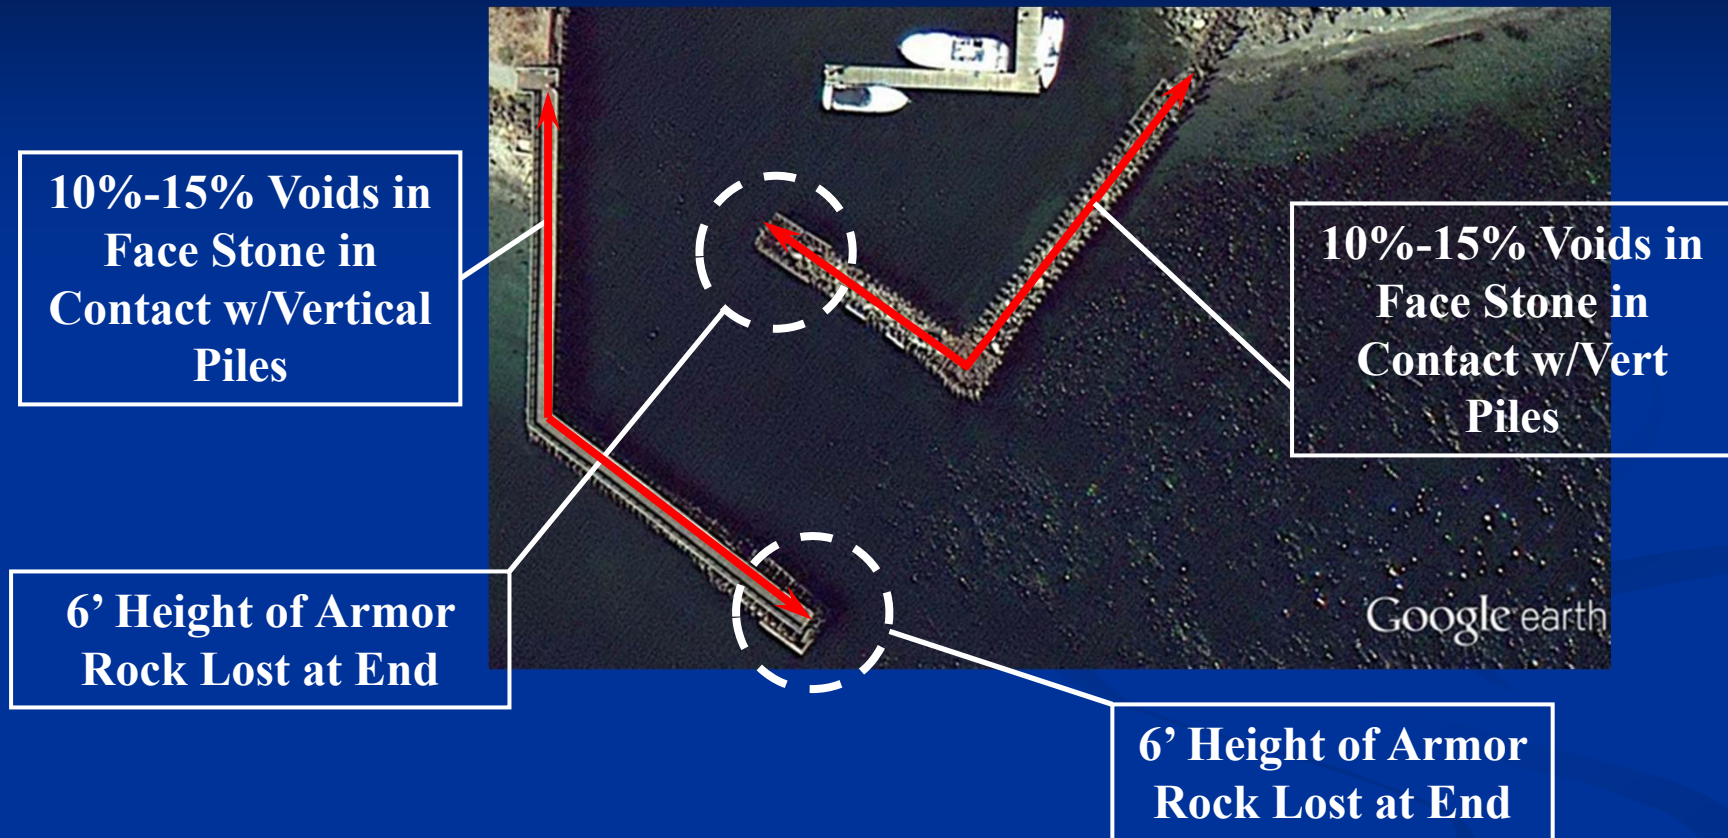
Current Condition – Armor Rock

- Appears to be Matts Matts Sourced Marine Basalt – Low Quality Stone
- Highly Fractured
- >50% of Stone in Deteriorated to Highly Deteriorated State

- Armor Rock Spalls to 12" x 12" x 8" Pieces, Which are Being Pulled From Between Piles by Wave Action
- Loss of Waler Results in Decreased Confinement of Armor Rock

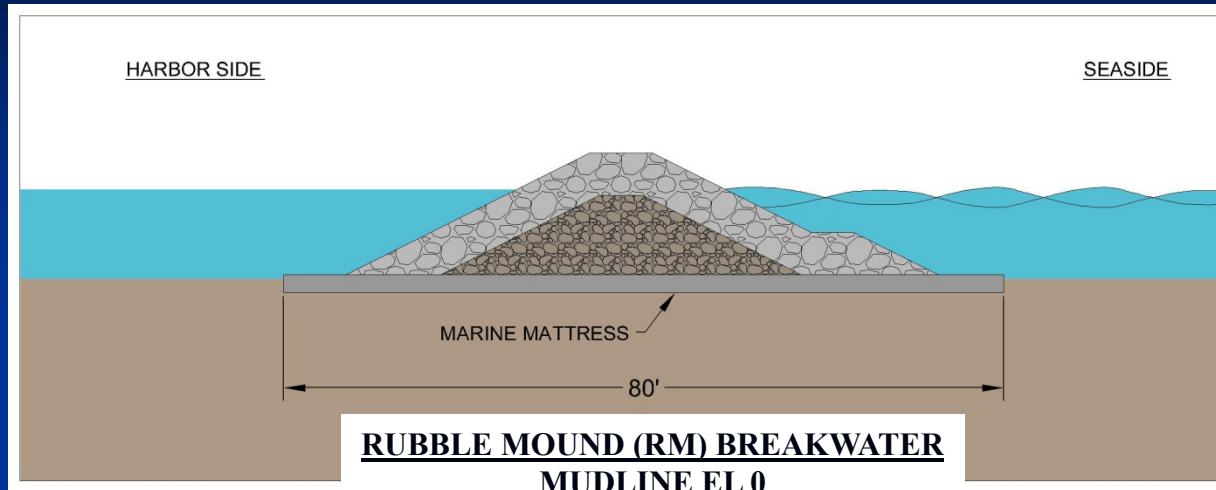
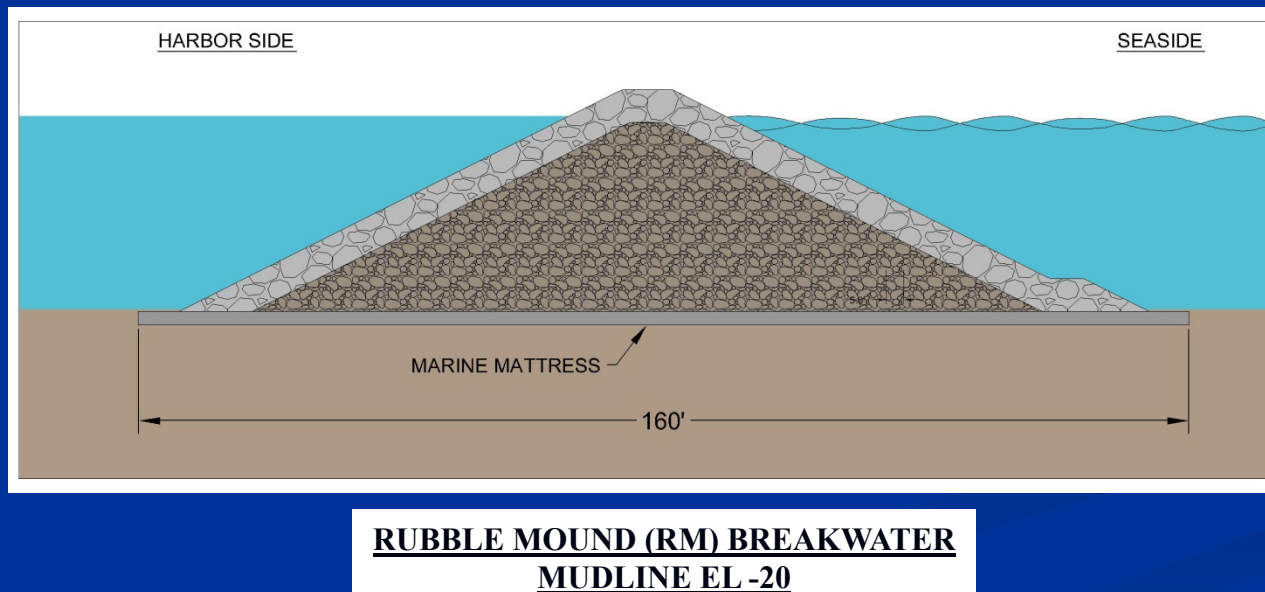
Protecting the Marina - Options

Footprint too large
~ Not Feasible for
seaward
breakwater leg
