PORT OF PORT TOWNSEND

Point Hudson Marina Breakwater Improvement Project

Work Status Update

June 8th 2016

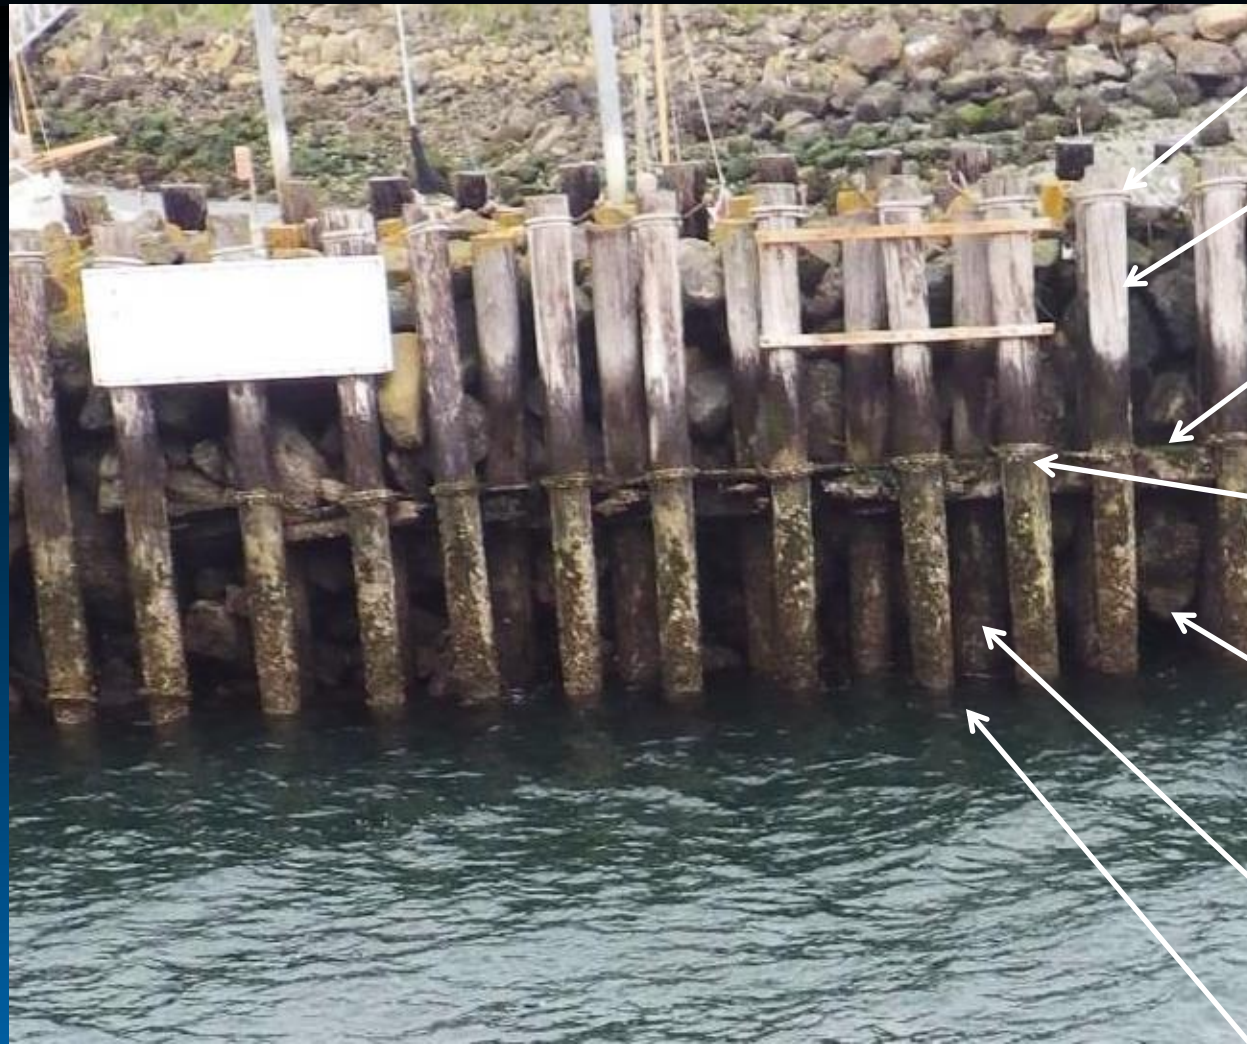
Top Cable (1969)

Outer Pile (1969)

**Upper Waler
(1934)**

**Center Cable
(1969)**

**Armor Rock
(1934)**

Inner Pile (1934)

**Lower Waler
(1934) (Not
Visible)**

Note: >75% Inner Piles (1935) Observed to be Highly Deteriorated, Not Contributing to Structural Stability. Assessment Focused on Outer Piles.

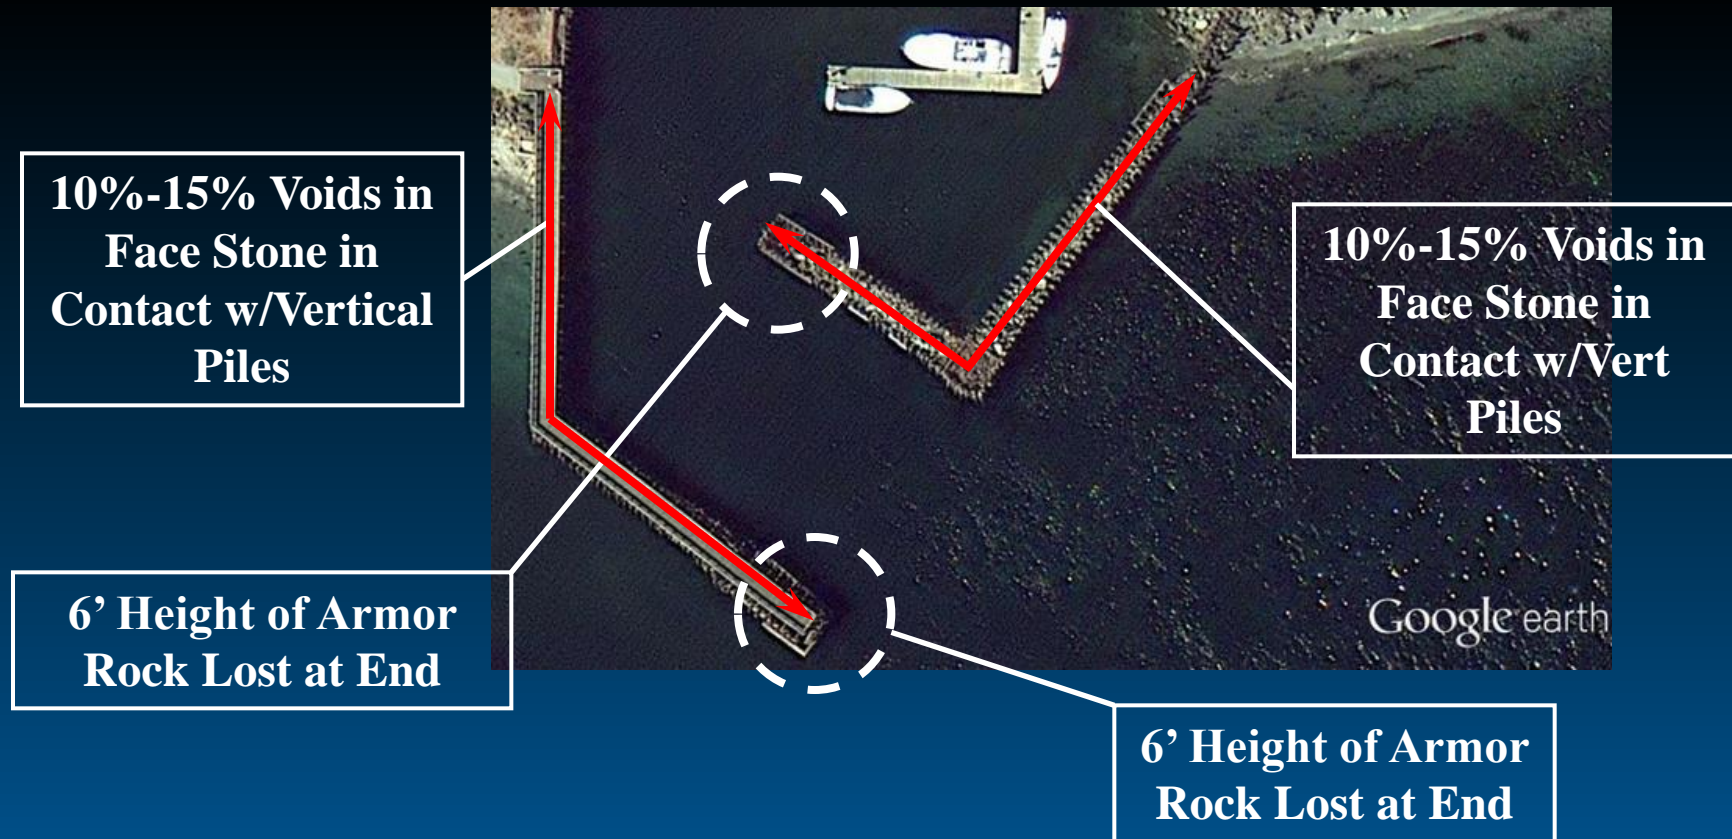
Breakwater Condition – Armor Rock

- Appears to be Matts Matts Sourced Marine Basalt – Low Quality Stone
- Highly Fractured
- >50% of Stone in Deteriorated to Highly Deteriorated State; beyond its useful service life

- Armor Rock Spalls to 12" x 12" x 8" Pieces, Which are Being Pulled From Between Piles by Wave Action
- Loss of Waler Results in Decreased Confinement of Armor Rock
- Large rock loss at vulnerable breakwater ends

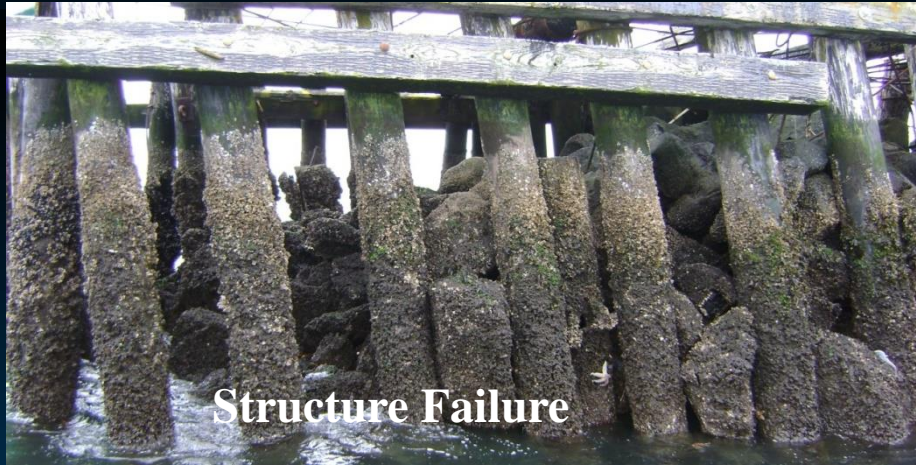
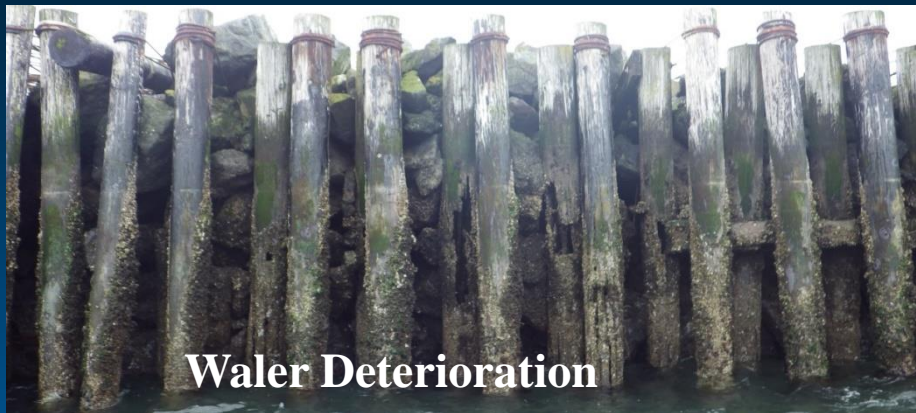
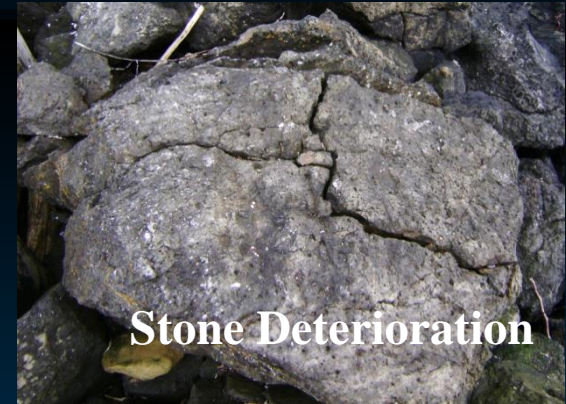
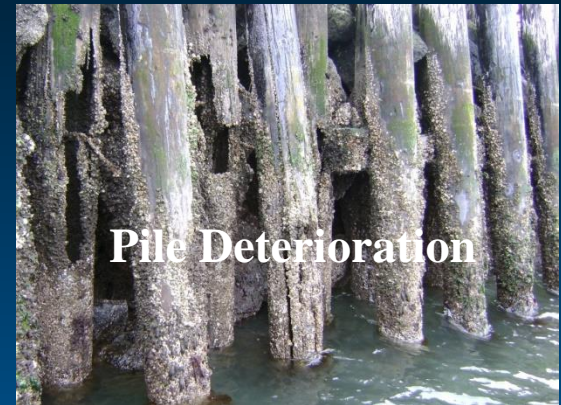
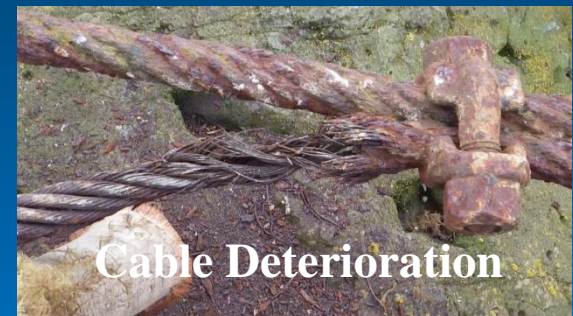
Breakwater Condition

- Walers: *Highly Deteriorated, No Longer Functional*
- Steel Cable Tiebacks: *Deteriorated to Highly Deteriorated, Some Already Failed, At End of Useful Life.*
- Armor Rock: *At Age of Increasing Deterioration Rate, Beyond Useful Service Life*
- Piles: Near End of Useful Life, Abrasion Damage, Marine Borer Attack Damage, Decaying
- Overall Structural System: Substantially Less Stable than Original Construction, Higher Stresses
- S. Breakwater End: Walkway Stringer Nearly Unseated, Entire 60' End Portion Failed, Leaning Seaward
- Walkway: End 60' Near End of Useful Life, Needs Monitoring. Remainder in Good/Moderate Condition

- Full Replacement recommended
- Phasing of Replacement is possible with some localized re-habilitation
- South Breakwater is 1st Priority

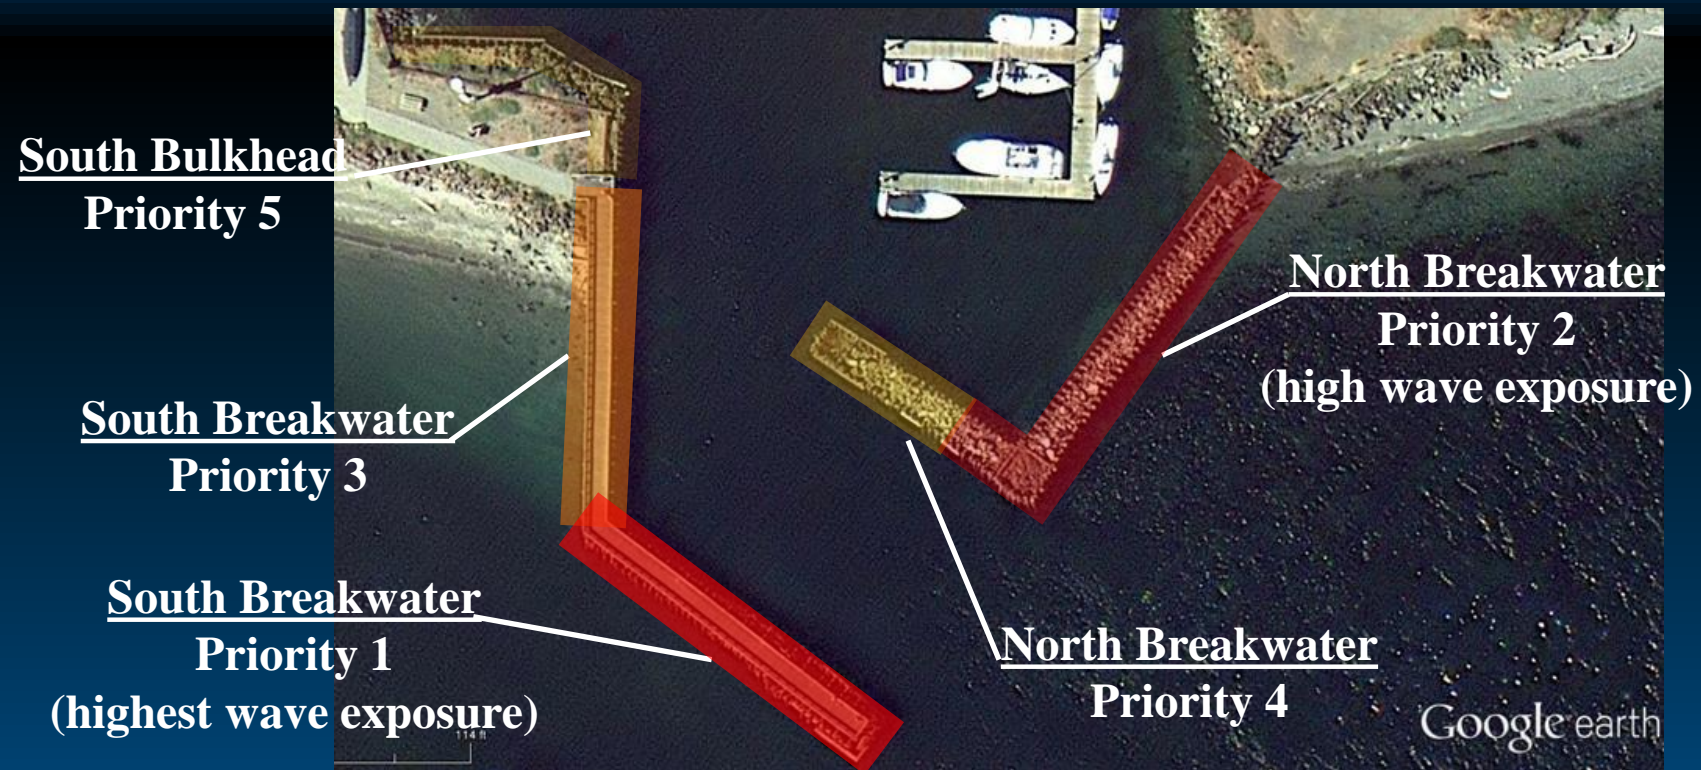
Breakwater Component - Improvement Priority

- South breakwater in worse condition than North breakwater.
- South breakwater is more critical in wave protection than the North breakwater.
- Overall South breakwater priority (1,3) should be replaced over the North breakwater
- If North breakwater is not replaced, it should be rehabilitated
