**Revised Level Three Response Engineering Report
Boat Haven Boatyard
2790 Washington Street
Port Townsend, Washington**

**Port of Port Townsend
P.O. Box 1180
Port Townsend, Washington**

**LANDAU
ASSOCIATES**
130 2nd Avenue South
Edmonds, WA 98020
(425) 778-0907

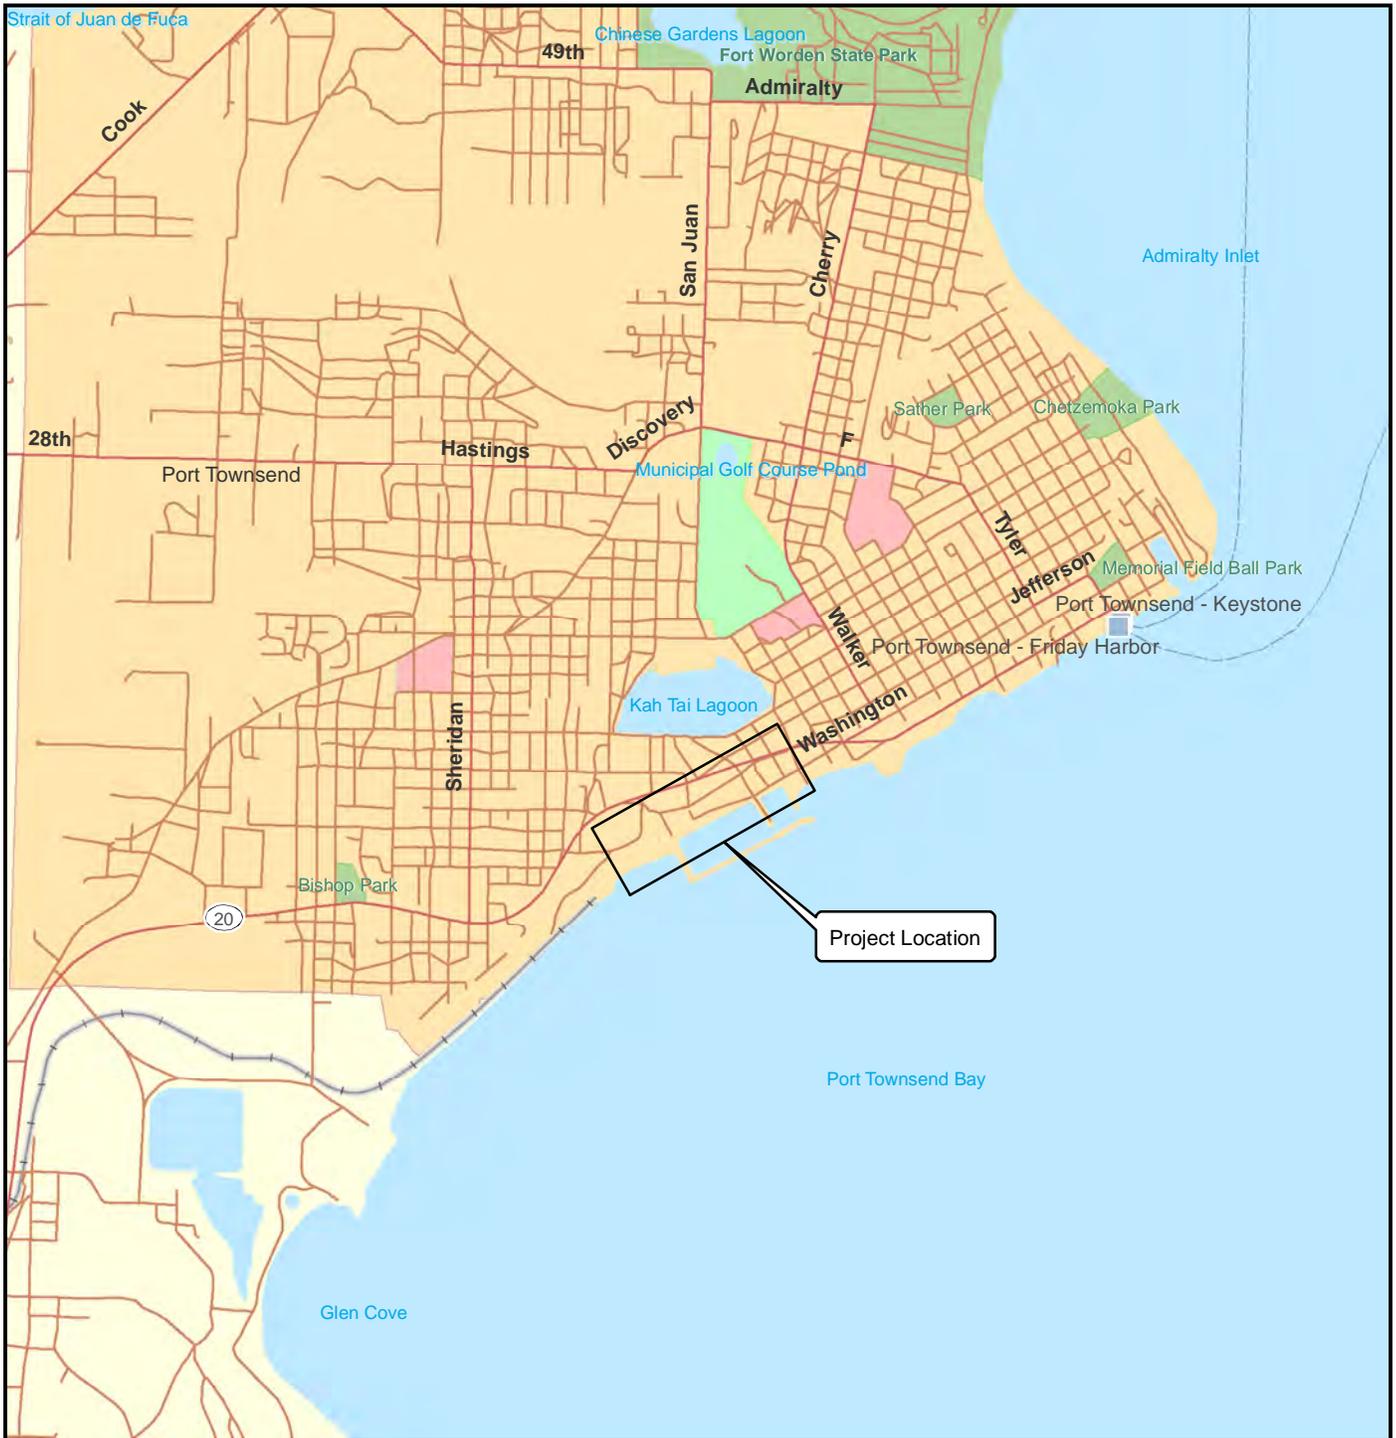
Figure
1

Vicinity Map

This document presents an Engineering Report as part of the Level Three Response for the Port of Port Townsend (Port) in accordance with the conditions of the Boatyard General Permit (Boatyard Permit) issued by the Washington State Department of Ecology (Ecology). The Port Townsend Boat Haven Boatyard (Boatyard) is located at 2790 Washington Street in Port Townsend, Washington. A vicinity map is provided on Figure 1. An overview of the Port's facility and the storm drain system is shown on Figure 2.

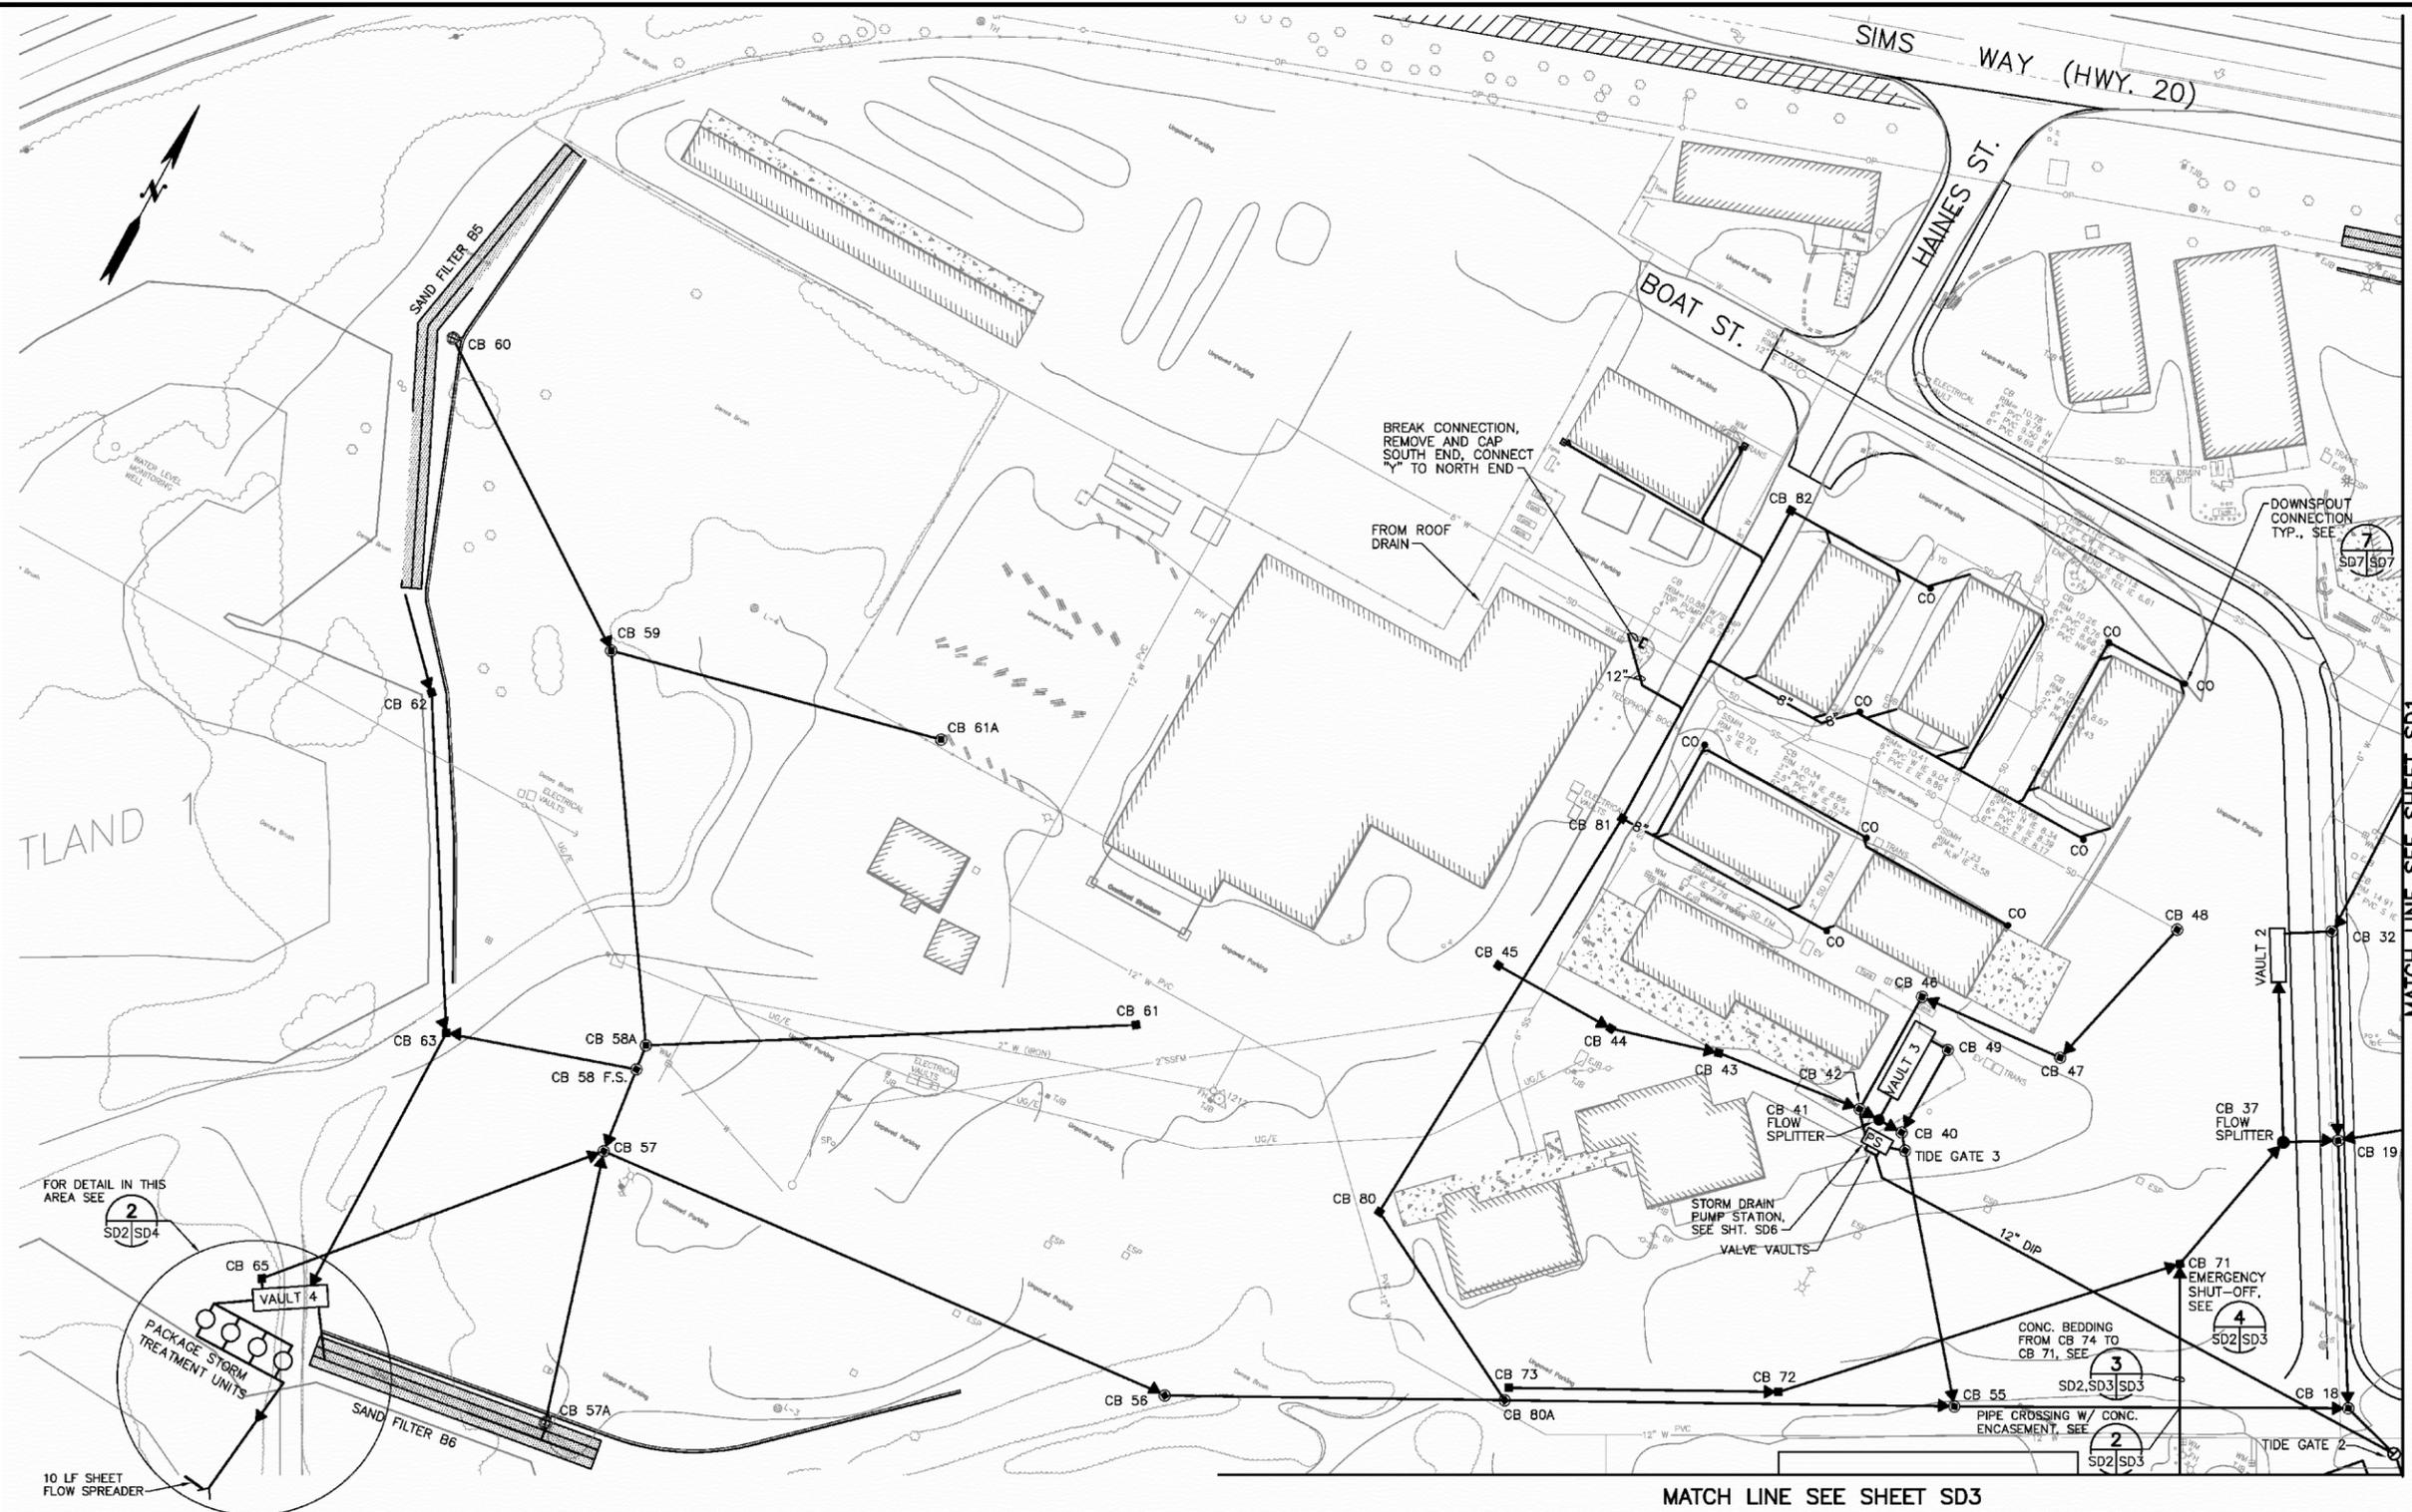
Figure 4

FOR DETAIL IN THIS AREA SEE 2 SD2/SD4

Tide Gate 2, as shown on Figure 4, is located to prevent the backflow of marine water from Outfall A into the storm drain system during high tides. Until recently, it was believed that this tide gate did not provide full backflow prevention, as some marine water was detected in the upstream storm drain system, specifically at Vault 1. The performance of the Aquip unit at that location was likely negatively affected from treatment of marine water, which may partially explain that system's poorer than expected removal of metals. An investigation revealed that a City of Port Townsend stormwater outfall at the eastern edge of the Boatyard did not have a backflow prevention device, and during high tides marine water was briefly ponding in an area near the northeastern corner of the Boatyard, and from there the marine water entered the Boatyard storm drain system through catch basin CB 29C. At the Port's request, the City installed a backflow prevention device at the aforementioned outfall in March 2013.

There are four existing perimeter sand filters at the Boatyard, one filter in each of the East Sims and West Sims drainage areas as shown on Figure 3, and filters B5 and B6 in the Vault 4 drainage area as shown on Figure 4. These four sand filters provide capacity to filter some of the stormwater runoff from these drainage basins. In 2009, it was determined that the sand filters were very conservatively designed with respect to allowable flow, and the Port enlarged the flow control orifices in the upstream structures to enable higher flow rates to the filters prior to bypass as was described in the Stormwater Treatment

Zinc (283 $\mu\text{g/L}$) and copper (173 $\mu\text{g/L}$) concentrations from the pipe entering CB81 (shown on Figure 4) from the north indicate that roof runoff is a likely source of zinc and copper in stormwater at concentrations above the benchmarks. There are multiple buildings with roofs that drain to CB81, and

Results from CB46 (part of the Vault 3 drainage basin, as shown on Figure 4) indicated elevated concentrations of zinc (861 µg/L) and copper (1,510 µg/L). The potential source has been attributed to a nearby tenant where a large amount of exposed metal and metal shavings was observed in the vicinity of CB46. The Port has communicated the importance of appropriate housekeeping procedures to the tenant, and the Port plans to perform additional sampling at this location in the future to verify the elimination of the pollutant source.

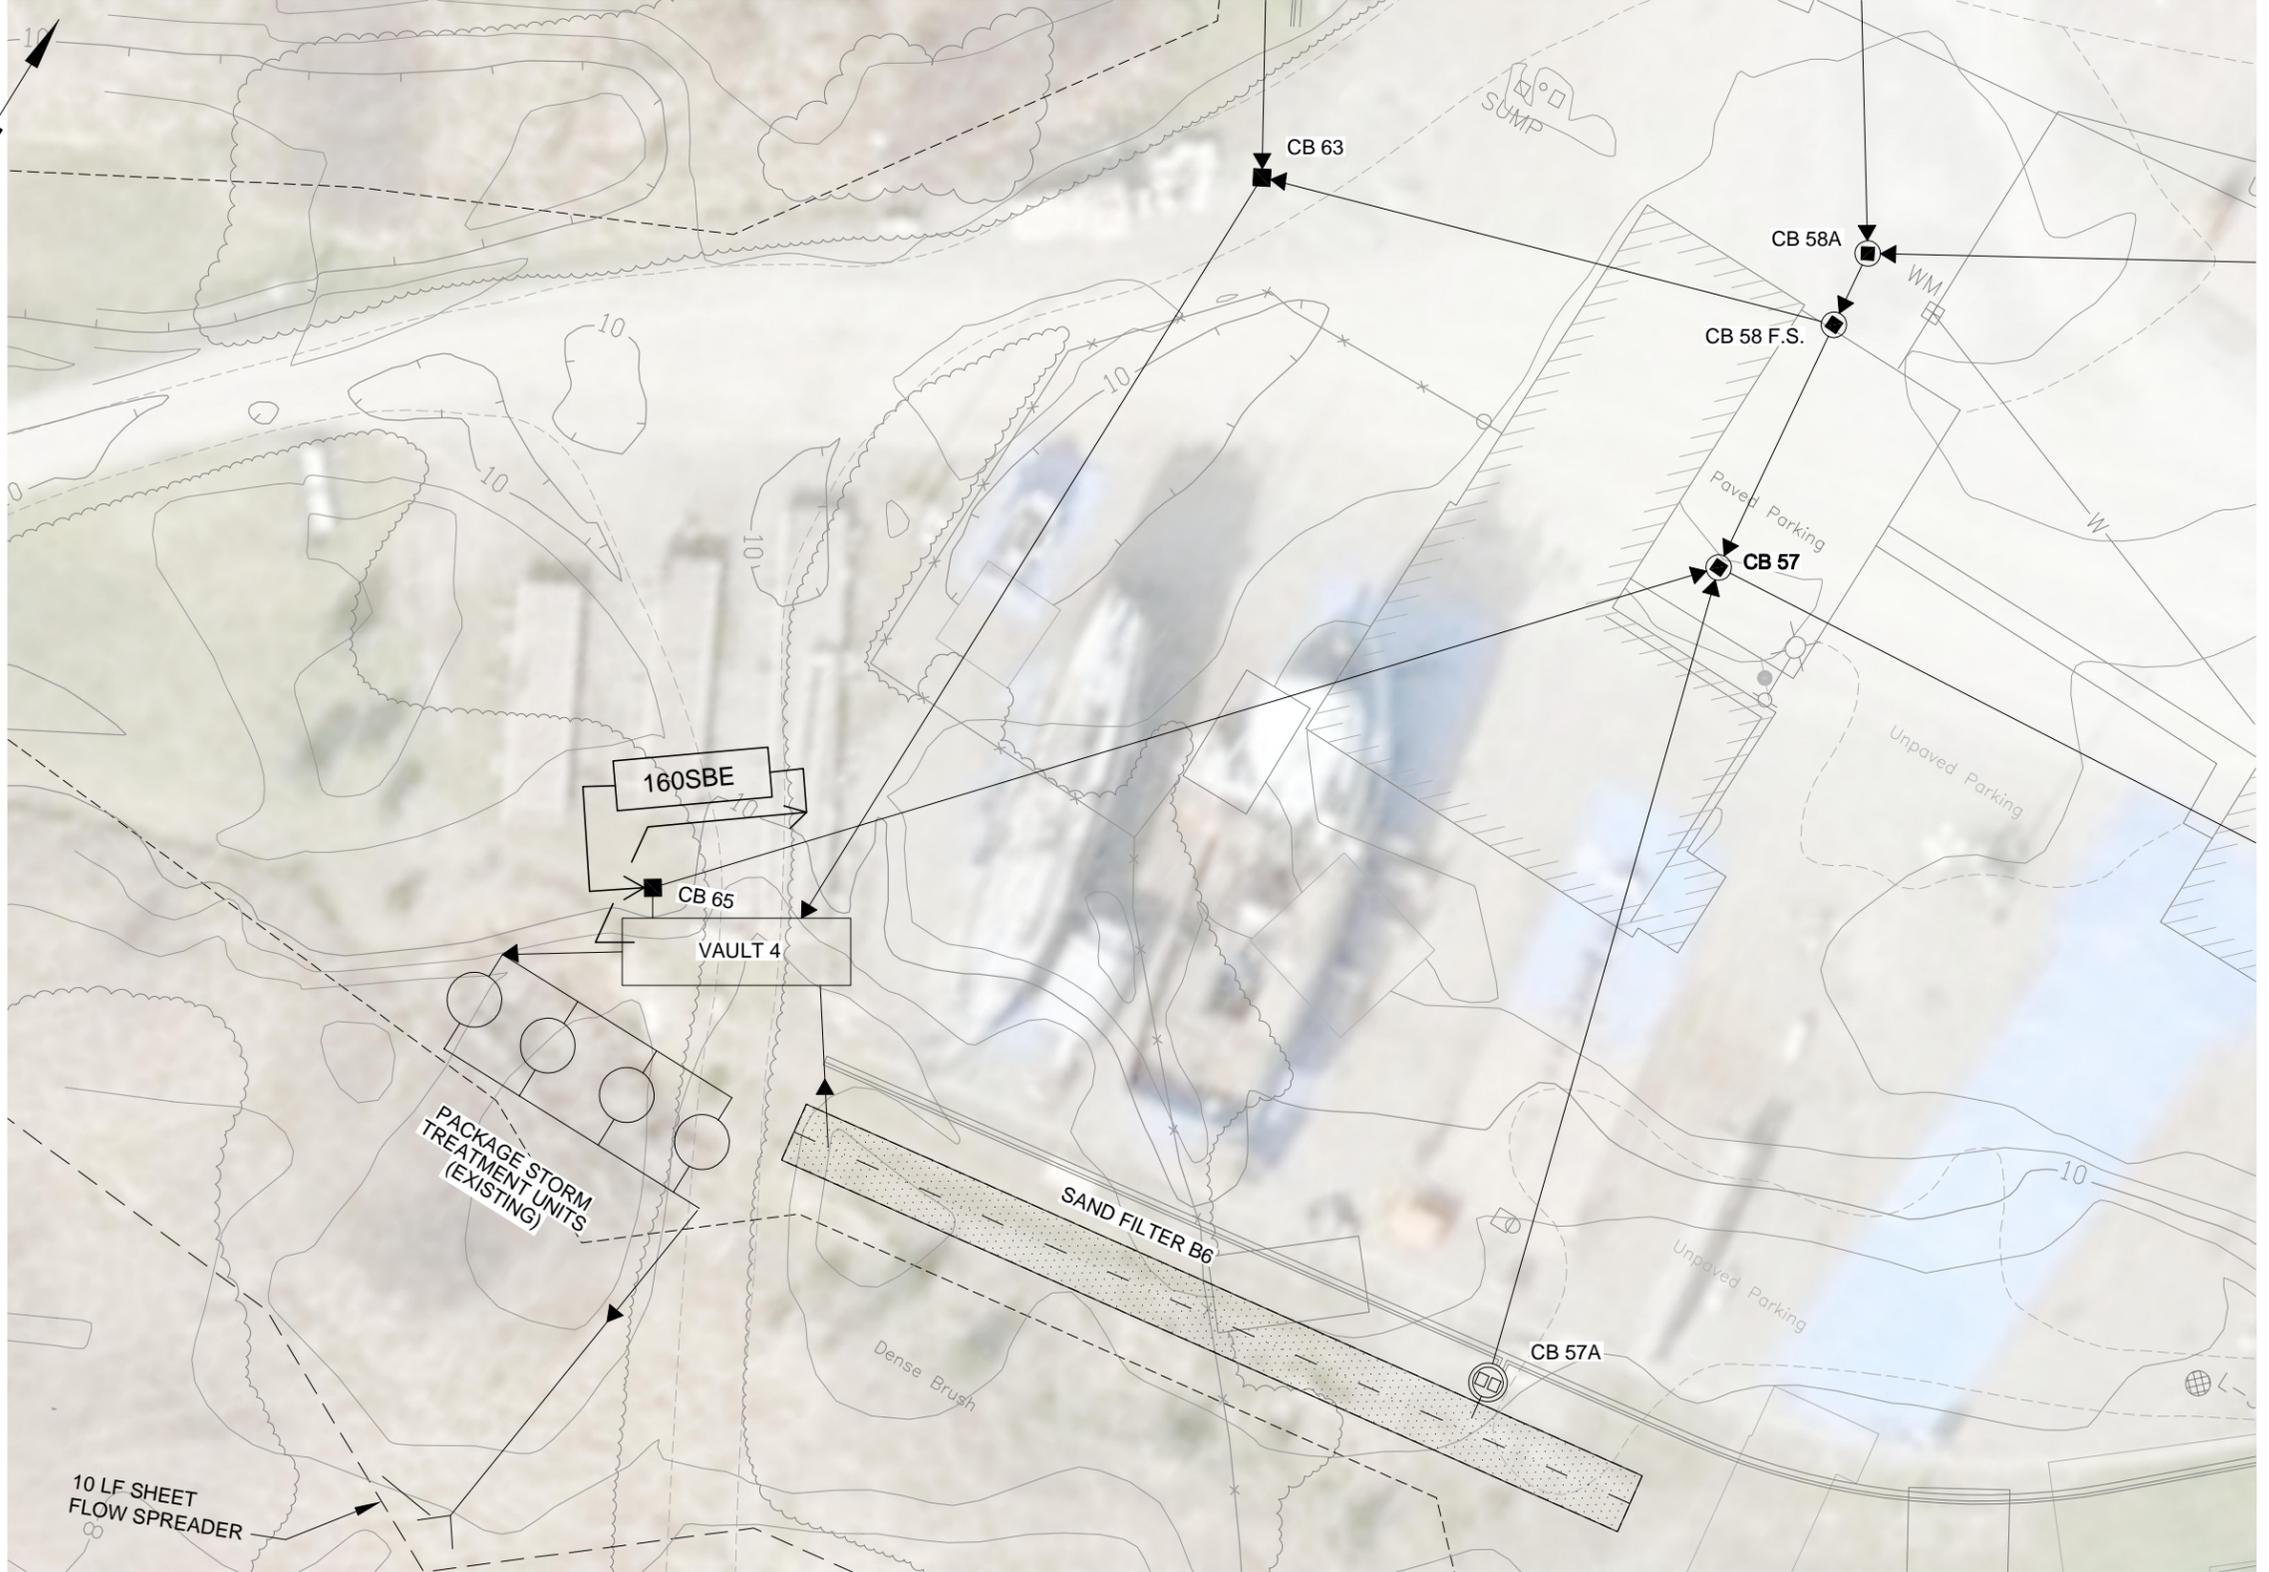
Port Townsend Boatyard Port Townsend, Washington	Vault 4 and West End Treatment System	Figure 6
---	---	--------------------

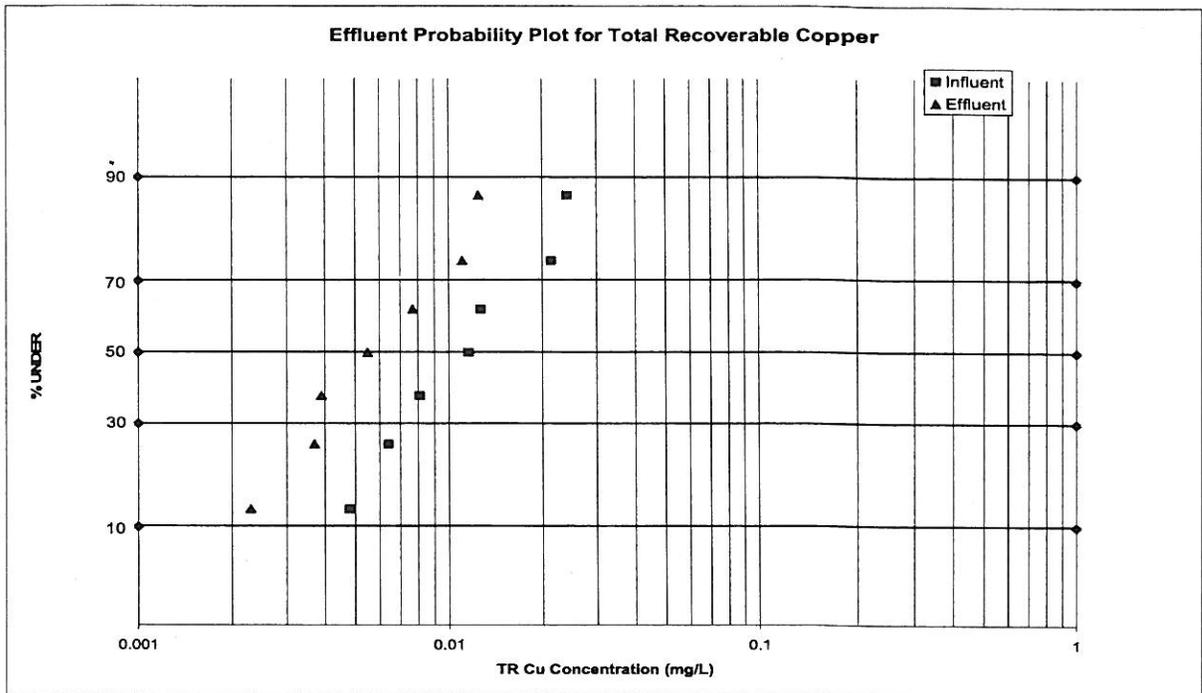
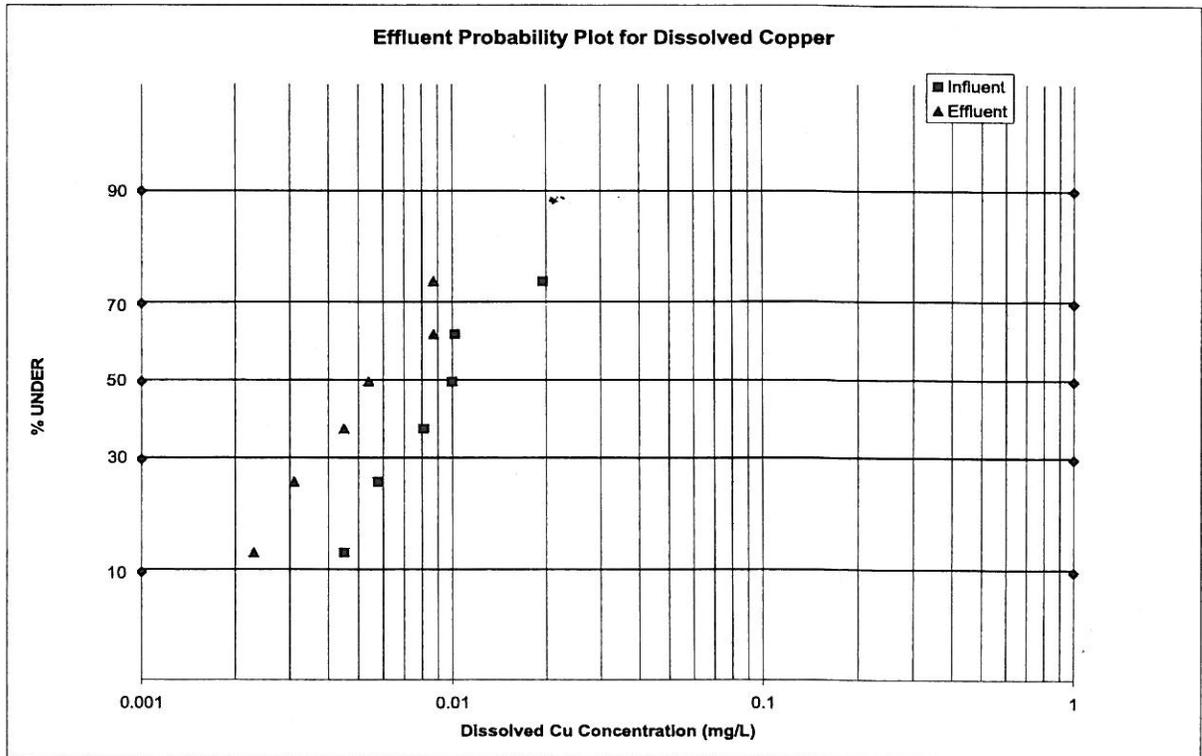
Figure 1: Effluent Probability Plots for Total Recoverable and Dissolved Copper

Figures 1 and 2 are the effluent probability plots for both T_R and dissolved copper and zinc. For copper, the distance between inlet and outlet concentrations over a range of concentrations does not change much, meaning that performance ability was relatively constant over the range of influent concentrations. For zinc however, influent and effluent values get much closer together at the lower end of the

concentrations range observed in this study, meaning that performance was greater when inlet concentrations were high.

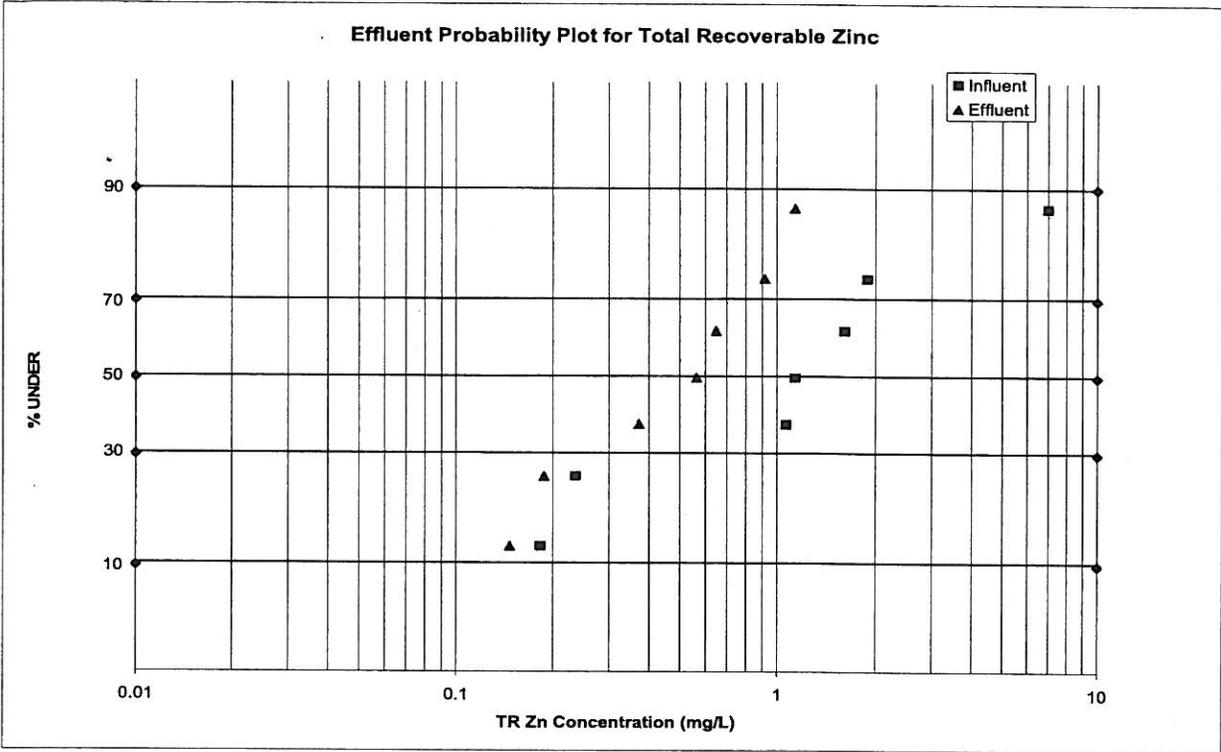
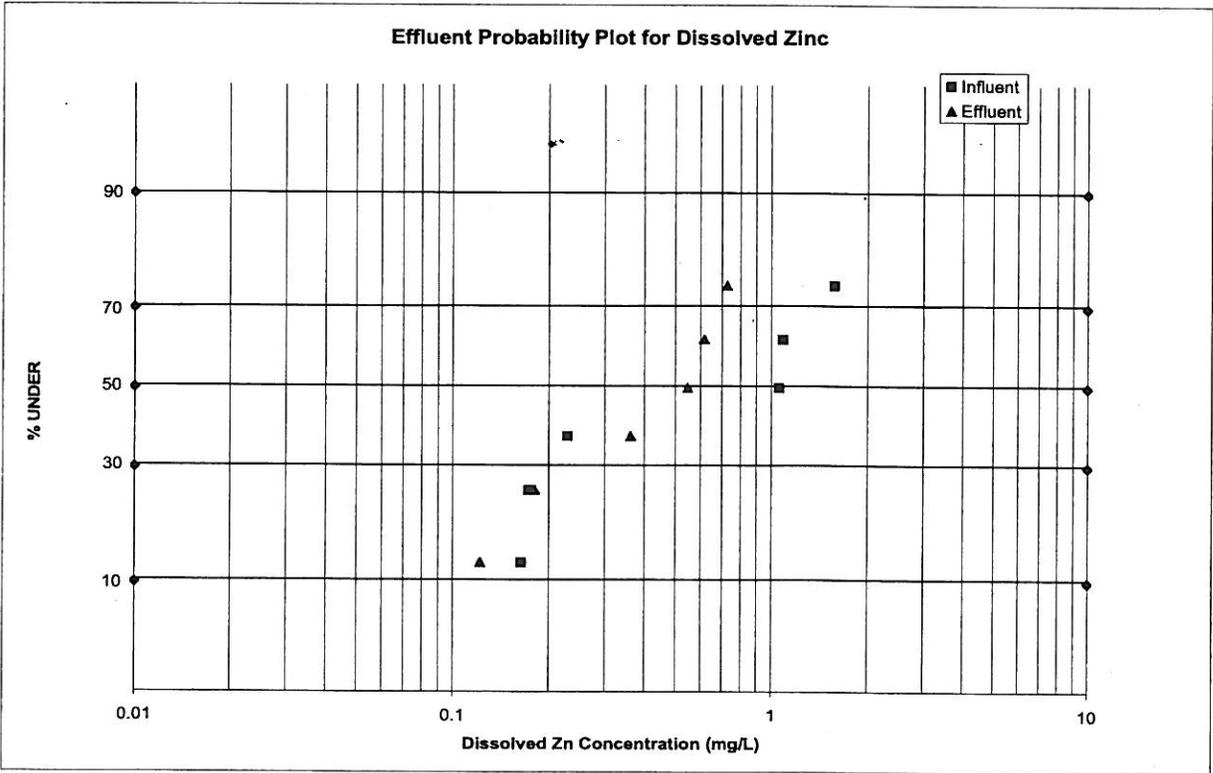
Figure 2: Effluent Probability Plots for Total Recoverable and Dissolved Zinc.

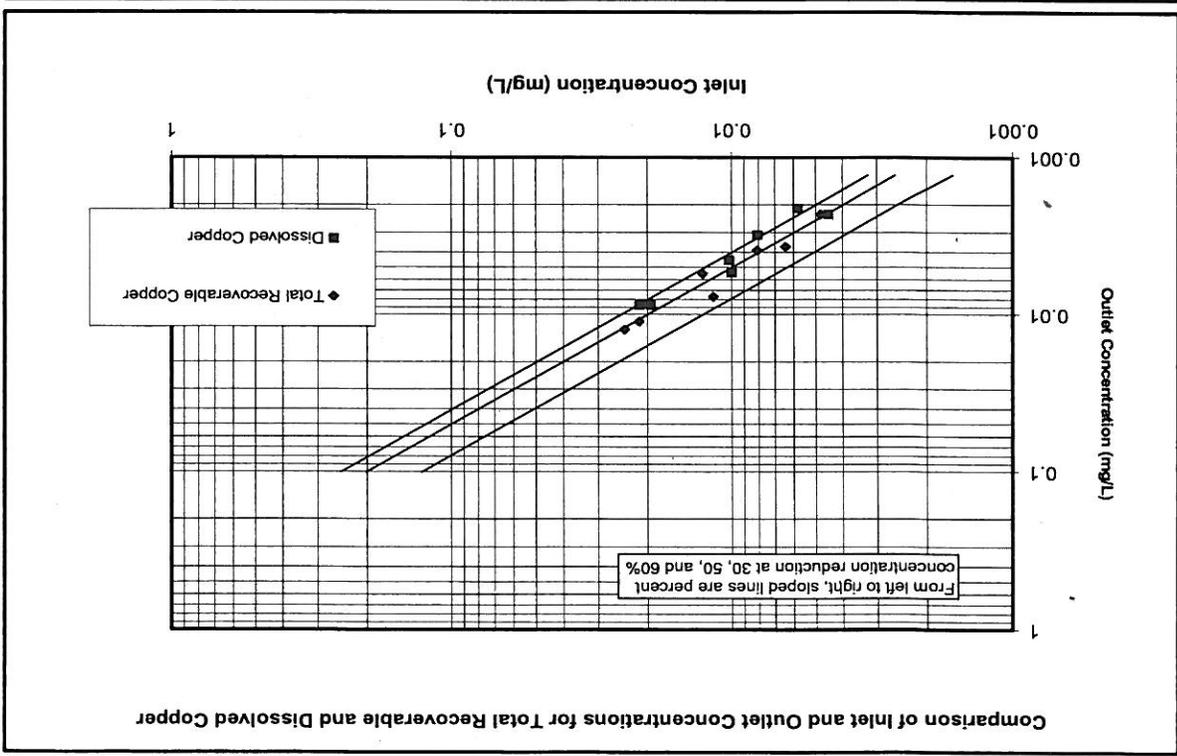
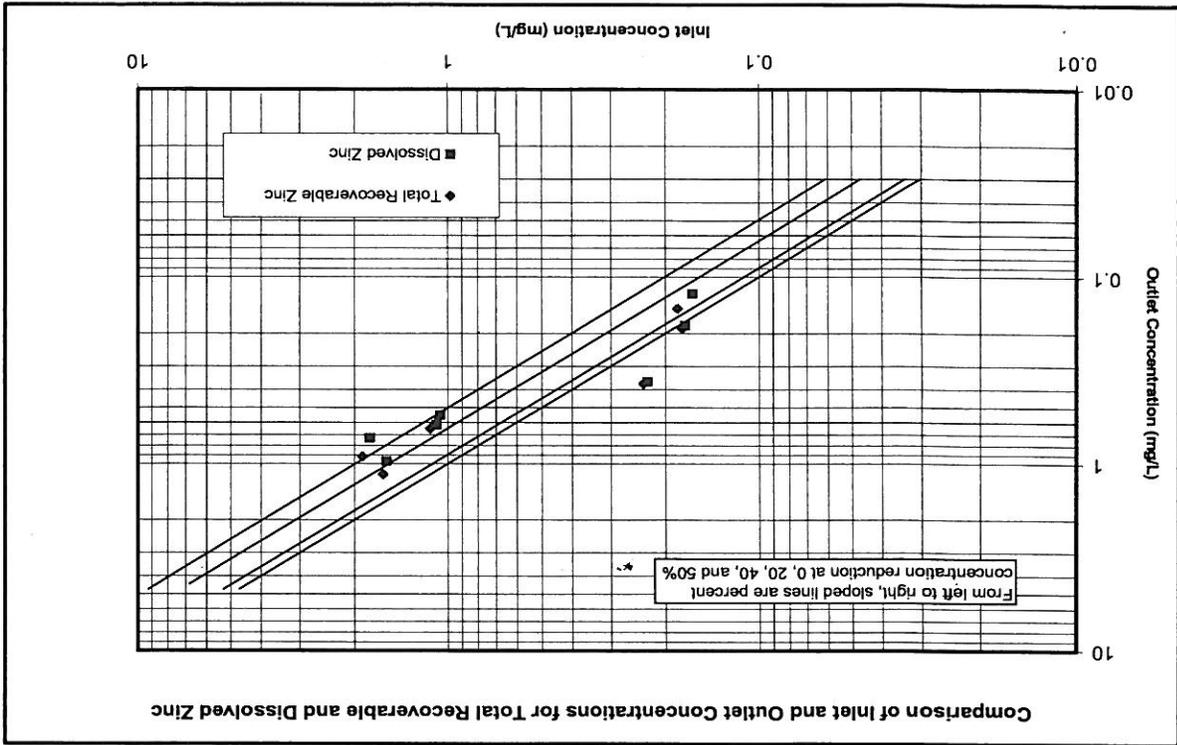
Figure 3: Comparisons of Influent and Effluent Total Recoverable and Dissolved Copper and Zinc Concentrations

Figure 3 shows a comparison between inlet and outlet concentration data for both copper and zinc. Flow reduction lines indicate the percentage of copper or zinc that was removed by filtering through oystershell media in this study. Reduction of copper ranged from 34-64 percent over the entire range of concentrations observed in this study. For zinc however, it was necessary to evaluate the high and low ends of the concentration range separately. At the high end of the range (influent concentration > 1 mg/L), reduction of total and dissolved zinc ranged from approximately 30 to 59 percent. At the low end of the range (inlet concentration < 0.3 mg/L), reduction ranged from -58 to 26 percent. For the last two storm events, zinc was exported (outlet concentration greater than inlet concentration.) Zinc exportation during the last two monitored storm events are likely due to the unusually high loading associated with uncoated galvalume roofing. Tables 4 and 5 represent the metals concentration data and summarize the percent removal data for individual storms.
