Point Hudson

Breakwater Improvement Project

Alternatives Assessment November 22nd, 2019

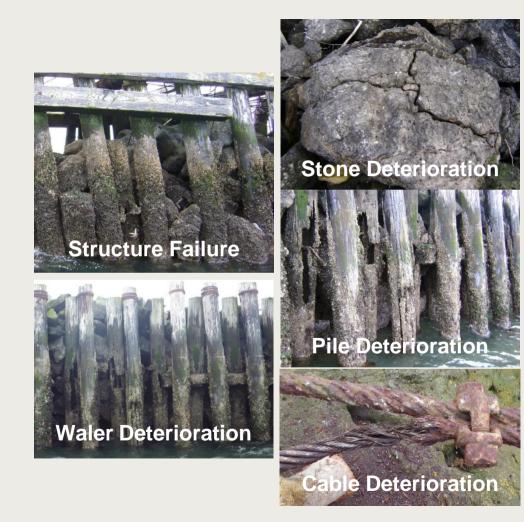
Existing Condition

Timber piles, walers, cable tiebacks, and armor rock are at or beyond useful life. Stability of the overall structural system is compromised.

The most advanced structural deterioration was observed at the end of the south breakwater.

Voids in the riprap reduce the system's wave protection capability.

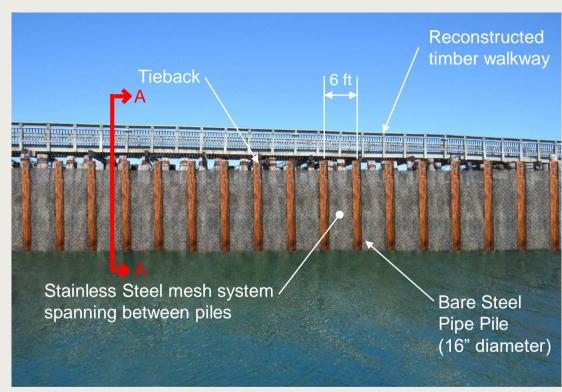
Section A-A

Selected Concept

Exterior Bare Steel Piles, Mesh Lagging System, and New Rock

• Based on the objectives, this design concept was selected as the best alternative. Layout options include encapsulation or reconstruction but both options would look similar from the outside.

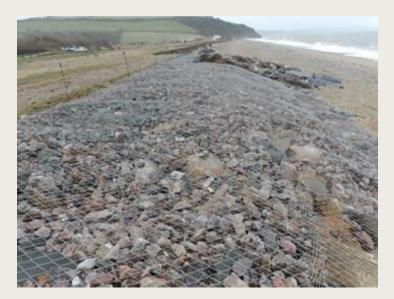
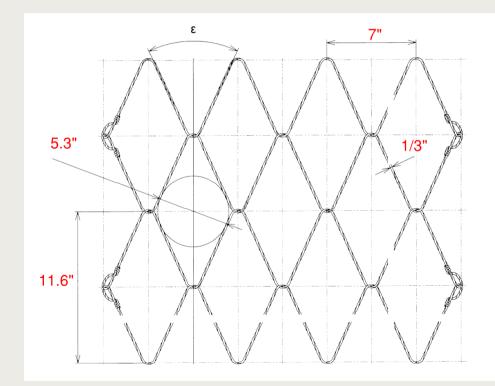
Mesh Lagging System

- Mesh would retain rock between piles for encapsulation options.
- May or may not be used for the reconstruction options.
- Mesh would be marine grade stainless steel to reduce maintenance and increase design life.

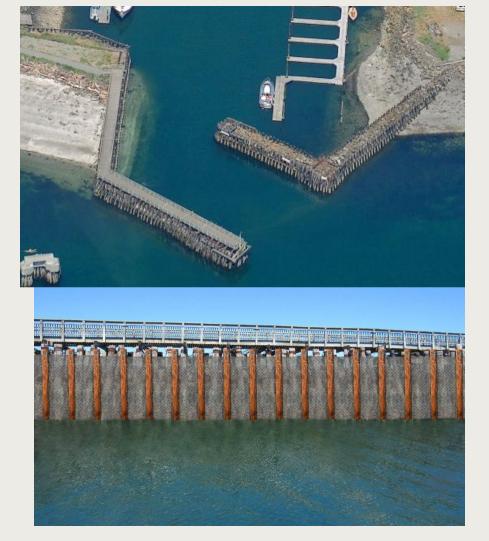
Alternative 1 Full Length Encapsulation

NEW THREADED BAR -FUTURE TIMBER NALKWAY PULL PERIODIC INTERIOR NEW STEEL WALER, TYP. EXISTING CREOSOTE PILE T.O. PILE EL +16.0' 15 NEW ARMOR ROCK (2'-4' SIZE TBD), TYP. 10 MHHW EL 8.25' ~ 5 NEW ARMOR ROCK, TYP. MLLW EL 0.0' (MLLW) 0 t -5 NEW ARMOR ROCK ELEVATION, (9"-18" SIZE TBD), TYP. -10 -15 NEW 16*Ø PIPE PILE, TYP. -20 EXISTING CREOSOT -25 TIMBER PILES, TYP. SCALE IN FEET -30 0 10 20 30 50 60 70

- Entire length of the existing south breakwater leg is encapsulated with new piles, rock, and lagging.
- Large expansion of footprint.
- Offsite mitigation needed for expansion of area and remaining creosote.
- Narrows navigation channel width.

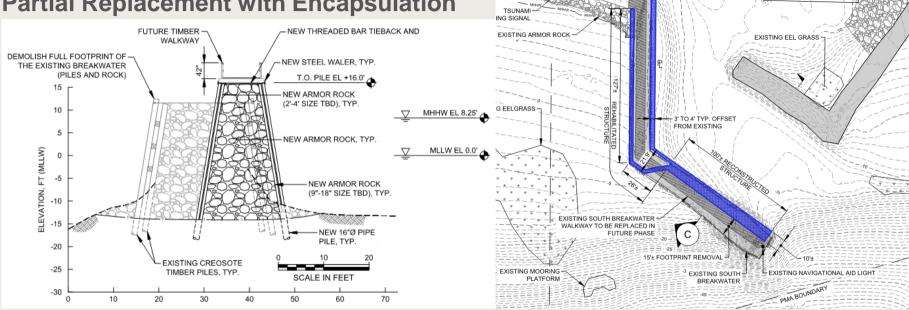
Alternative 2

Partial Replacement with Encapsulation

EXISTING BULKHEAD (TO BE REPLACED

WOOD GUARDRAIL

- Partial length of the existing south breakwater leg removed and reconstructed and • the remaining is encapsulated with new piles, rock, and lagging.
- Overall structure footprint is maintained, some creosote remains. •
- Potentially self mitigating for area.
- Narrows navigation channel width. •

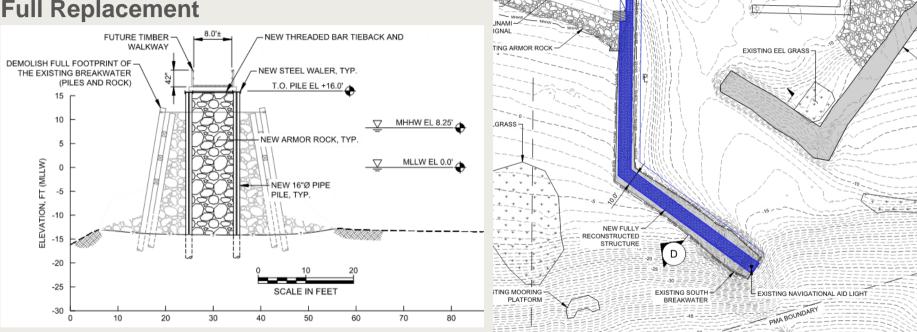
Alternative 3

Full Replacement

EXISTING BULKHEAD TO BE DEDI ACED

WOOD GUARDRAIL

- Entire length of the existing south breakwater leg is removed and reconstructed with • new piles, rock, and lagging.
- Reduction in footprint, removal of creosote, reduction in environmental impacts. •
- Self mitigating for area and creosote. •
- Widens navigation channel.

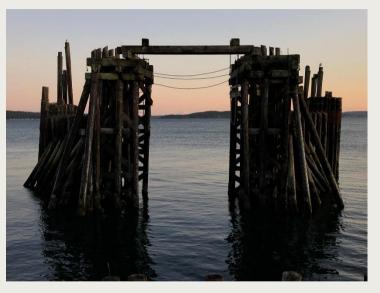
- <u>Mitigation.</u> Complete removal of Quincy Street Dock needed as offsite mitigation for full length encapsulation option (Alternative 1).
- Partial removal may be needed for Alternative 2.
