Point Hudson

Breakwater Improvement Project

Selected Alternative
Feb 12th, 2020

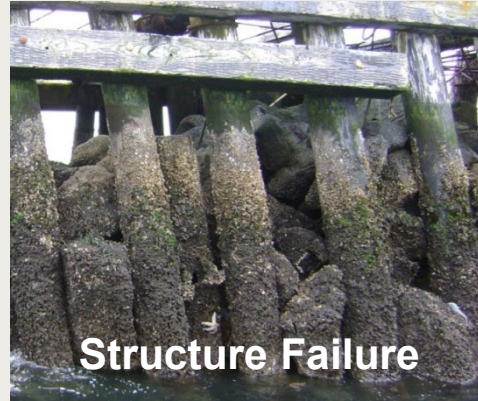
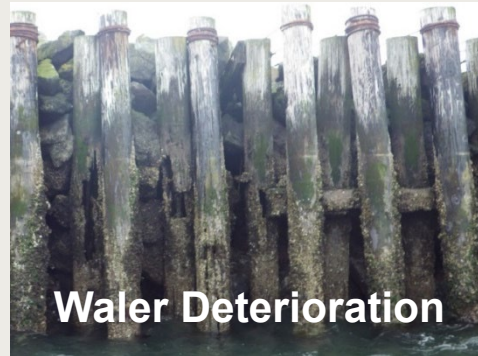
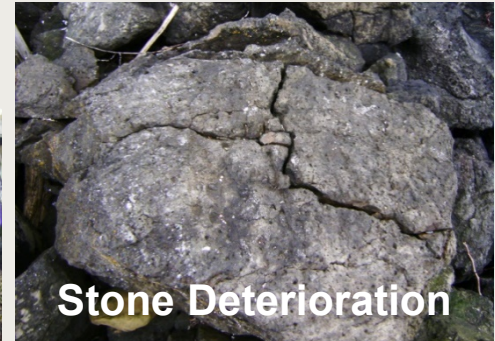
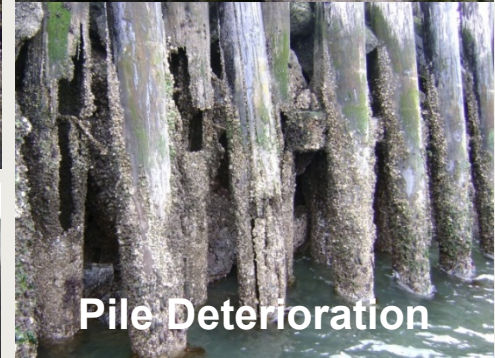
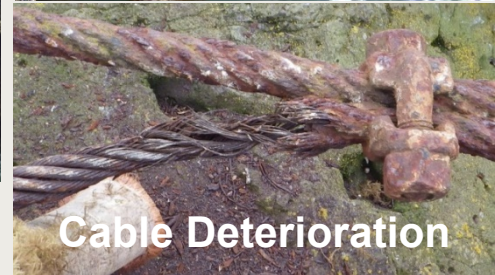
Existing Condition

Timber piles, walers, cable tiebacks, and armor rock are at or beyond useful life. Stability of the overall structural system is compromised.

- The most advanced structural deterioration was observed at the end of the south breakwater.
- Voids in the riprap reduce the system's wave protection capability.

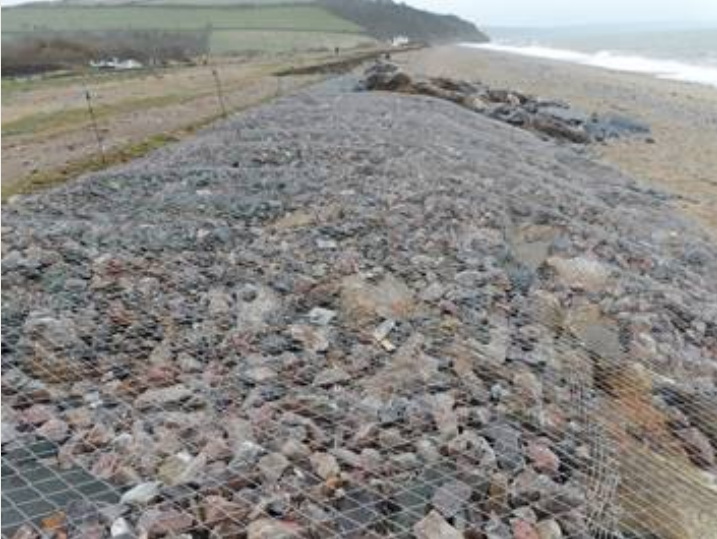
Mesh Lagging System for Encapsulation – Alternative 1 and 2

- Mesh would help retain rock between new piles.
- Mesh would be marine grade stainless steel.
- Would not be used for the reconstruction option.
