A/B Dock design informed by citizens advisory committee

Expanded article from page 1 of the Summer 2008
Port of Port Townsend newsletter, *The Conversation*

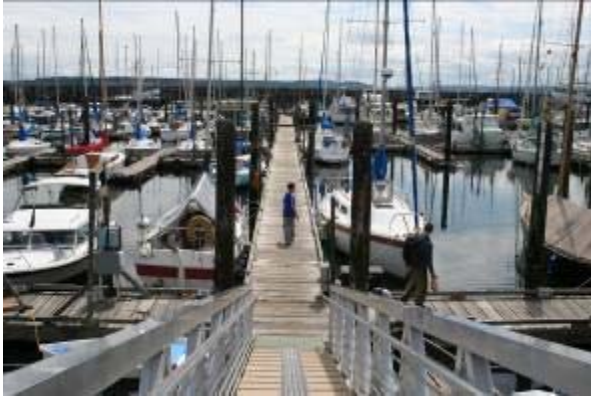
An overview of A/B Dock

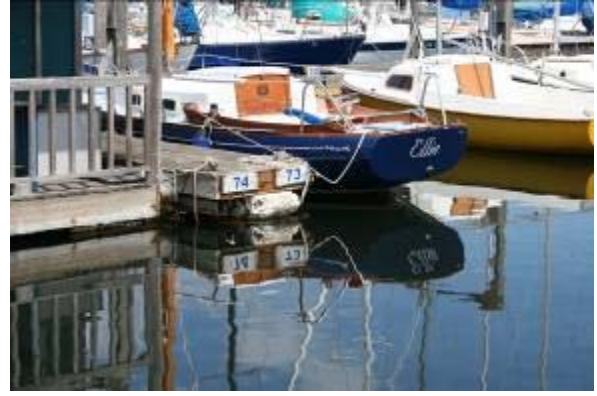
Degrading styrofoam flotation

Rotten piles, sagging flotation, crumbling bull rails. Look closely and the deficiencies of the 40-plus-year-old A/B Dock at the Port of Port Townsend Boat Haven become clear.

- Replacing degrading styrofoam flotation with solid concrete or foam-filled plastic floats.
- Replacing the creosote-treated wood piles with steel piles.
- Using modular instead of ribbon dock assembly, so the pieces can be taken apart and re-used.
- Widening the main walkways and laterals.
- Steps to ease congestion at the fuel dock.
- Consolidating some small slips, which are not all full, into bigger slips that are more in demand.

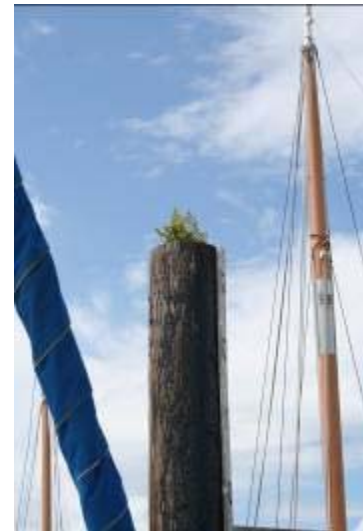
Rotten pilings grow vegetation

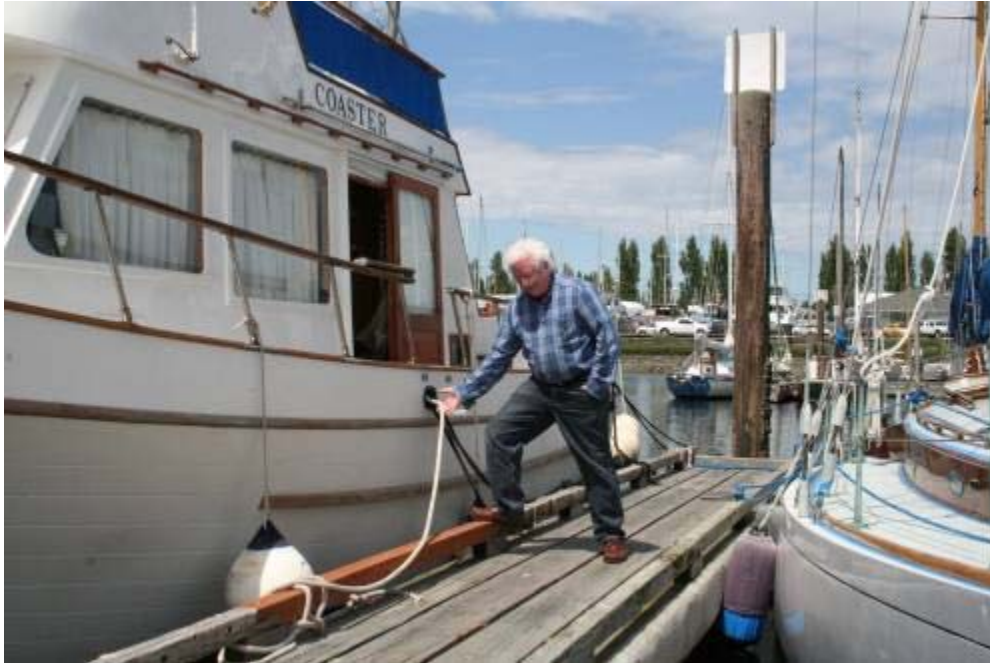
Moorage tenant Stephen Lewis has already experienced a dock failure at his A/B Dock slip. In May of 2007 he was backing his 39-foot trawler on a spring line tied to the bull rail when—crack! “I found myself tied to a piece of driftwood in the middle of the water,” Lewis recounts. The port responded quickly to replace the rotting section of bull rail within a day, he says, but more than a year later Lewis is still in the habit of securing a few extra dock lines—just in case.

Moorage tenant Stephen Lewis shows the section of bull rail that failed (and was replaced) at his A/B Dock slip
