Chimacum Cr.—Short Farm

1951 Aerial Photo

Chimacum Cr., Short Farm

2019 aerial photo

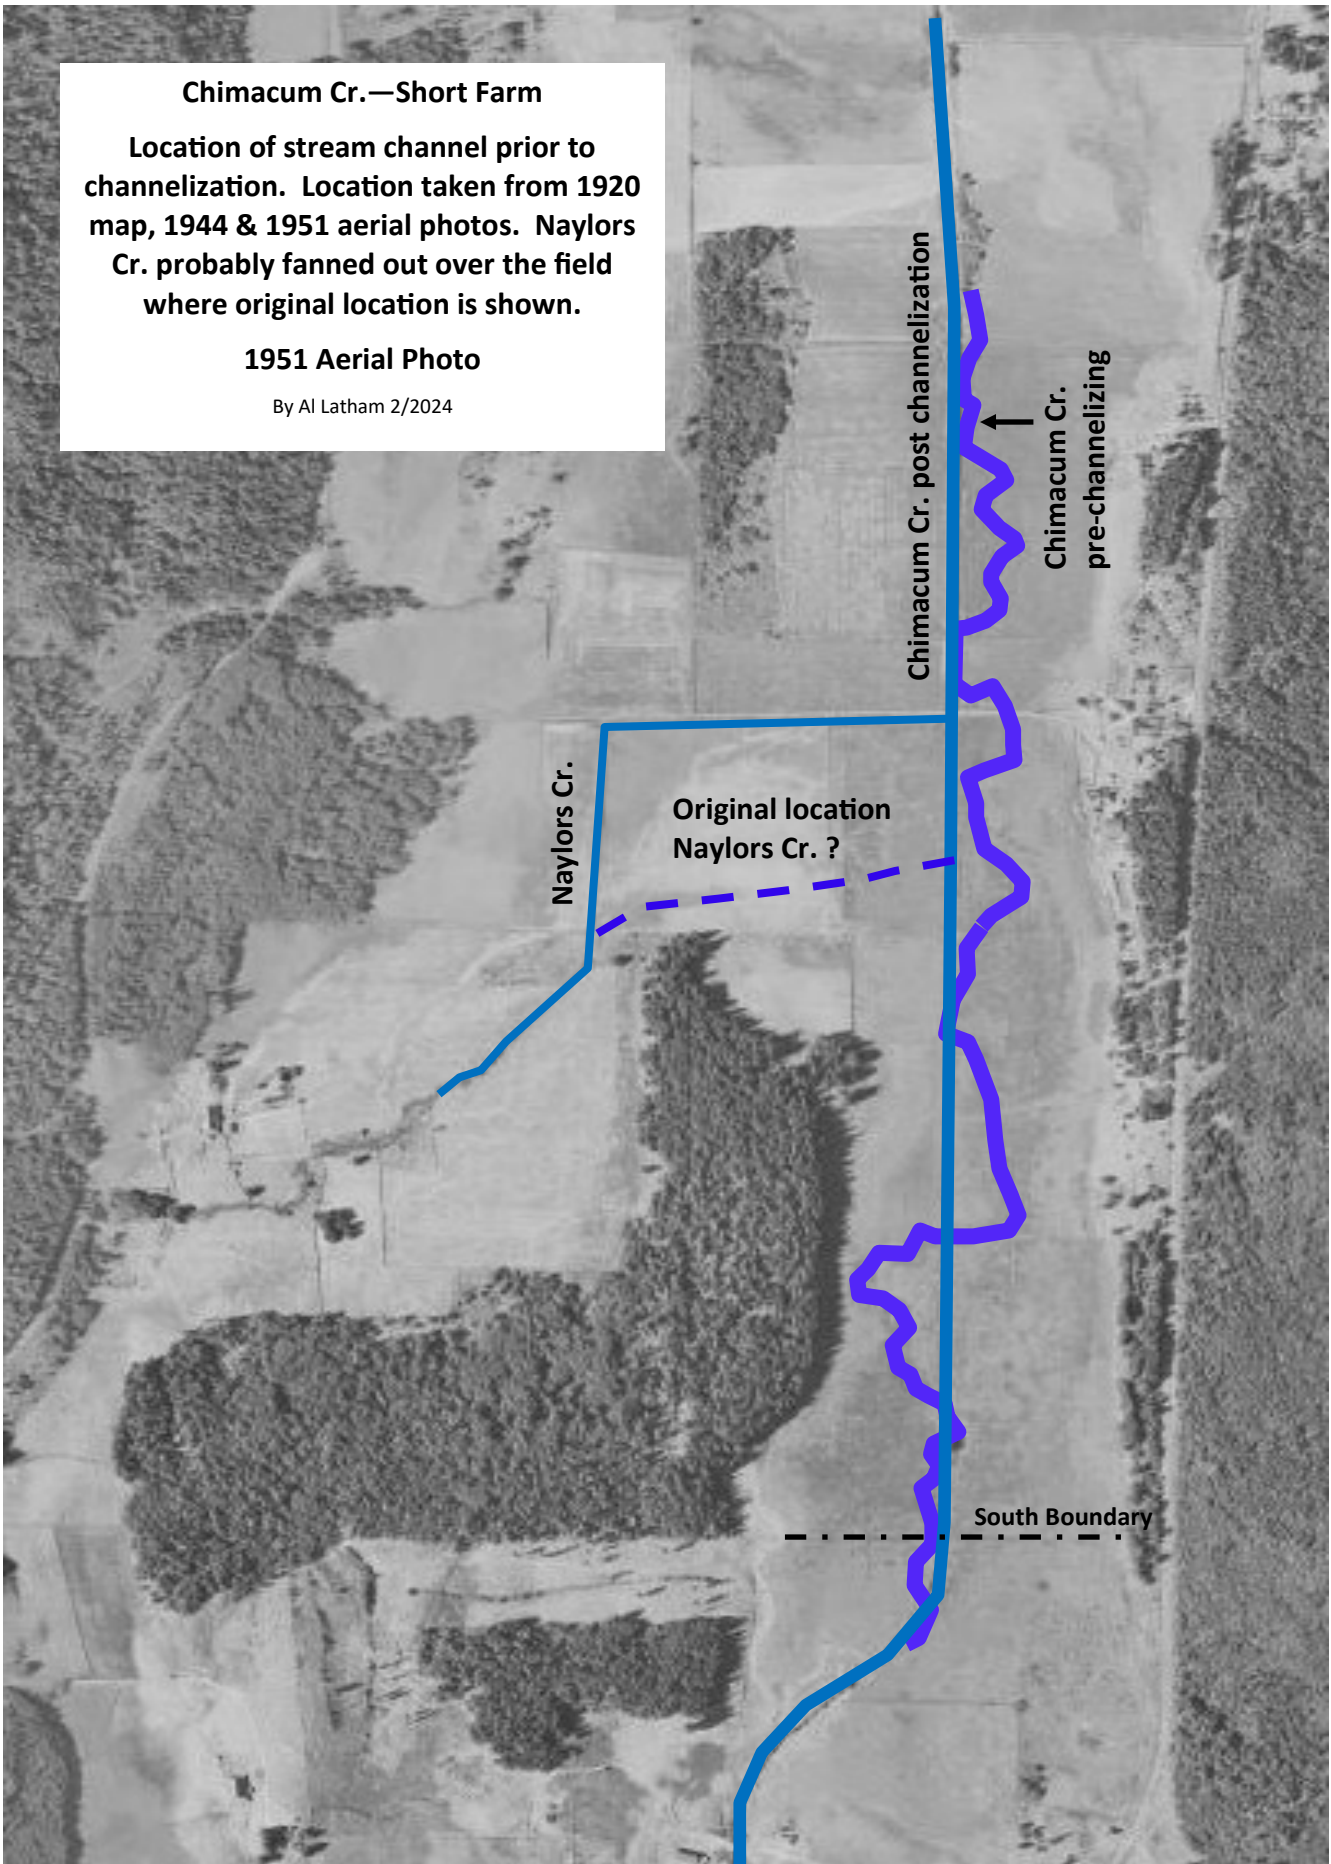
Location of stream channel prior to channelization. Location taken from 1920 map, 1944 & 1951 aerial photos. Naylor's Cr. probably fanned out over the field where original location is shown.

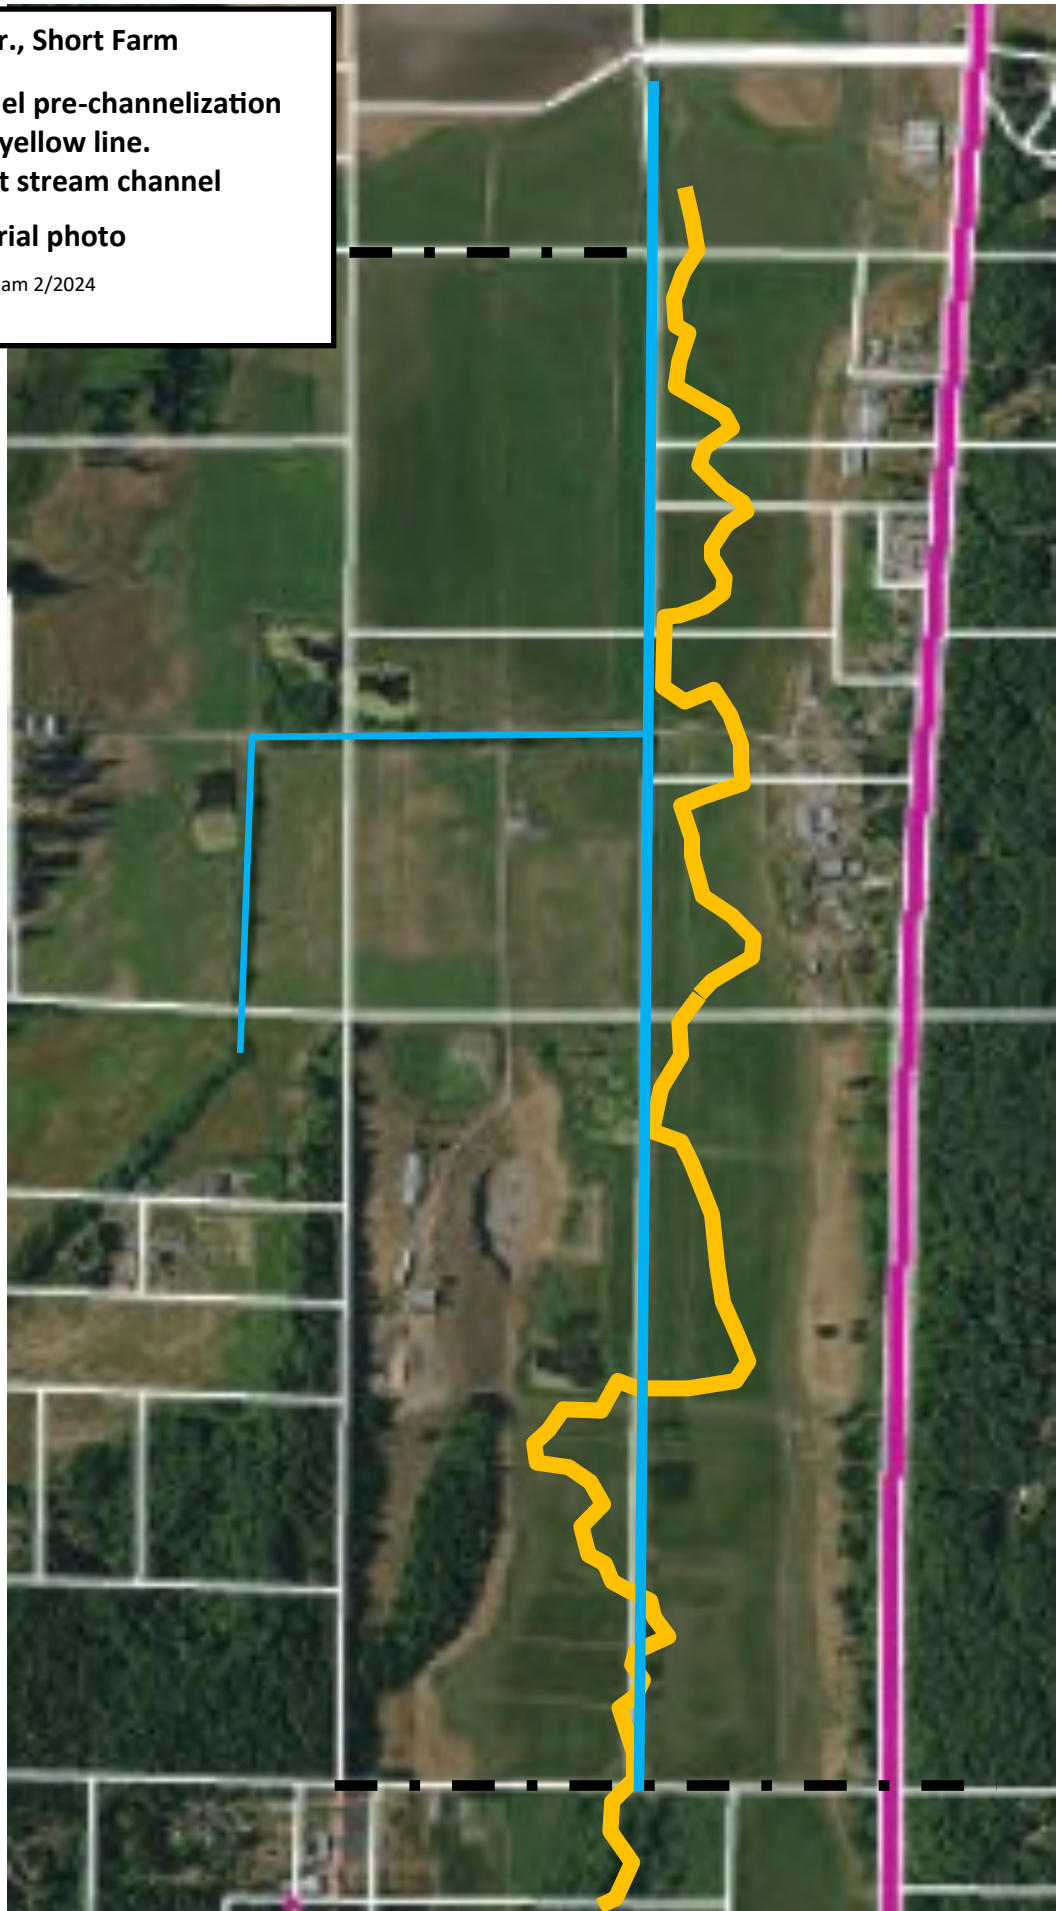
**Chimacum Cr. channel pre-channelization
location = yellow line.
Blue line current stream channel**
