# Point Hudson Condition Assessment Port Townsend, WA

**TITLE PAGE / TABLE OF CONTENTS**  
**PAGE T-1**

WASHINGTON ENGINEERING  
4040 WHEATON WAY, SUITE 202  
BREMERTON, WASHINGTON 98310  
360-405-1420

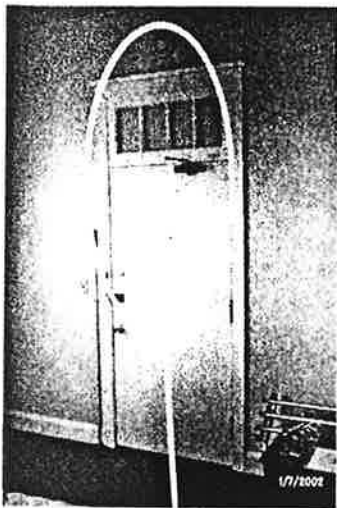
2.3

Typical room entrance door showing [in-swinging but closed] transom, door closer, locking hardware, surface mounted heating controls and fire alarm.

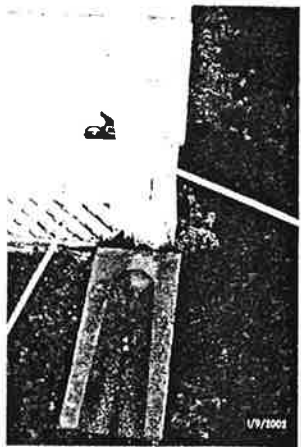
6.7

- Corner of building settling.
- Trapezoidal door opening.

Indication that the floor of this area of the building is out of level.

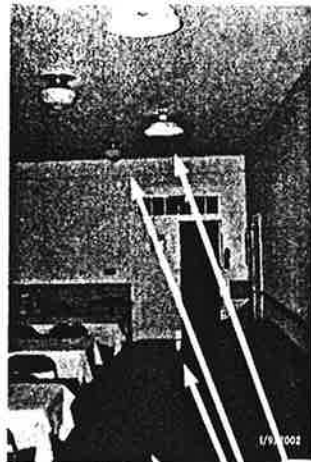
11.1

- Lighting added to supplement original lighting levels
- Original lighting fixture
- Slide bolt on egress door.
- 'Hardwood' floors.

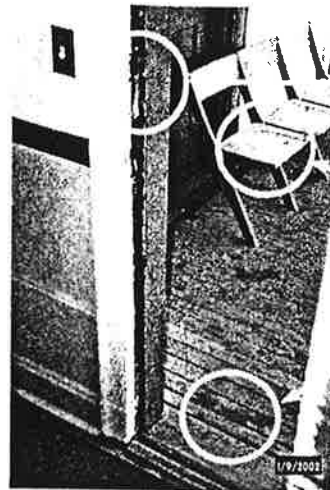
11.2

- Beat-up hardware and weather-stripping.
- 'Depressed' furniture conflicting with door
- Handicapped access
- Porch deck showing signs of weathering and wear [needing maintenance].

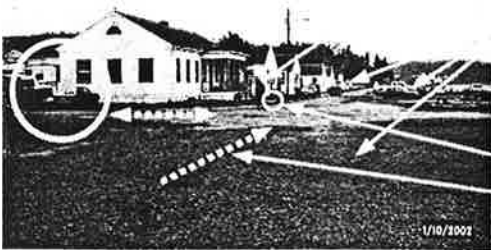
16.5

- Parking
- Original windows typically showing indications of deterioration on sides of building exposed to the South-west.
- Decommissioned entrance exhibiting signs of deterioration.
- Aluminum windows.
- Decommissioned pedestrian access.
- Pedestrian walking in the street as the street is the only pedestrian option at this location.
- Parking on shoulders, lawns conflicting with pedestrian space allocation.
- End of the sidewalk.
- Primary 'public' access.

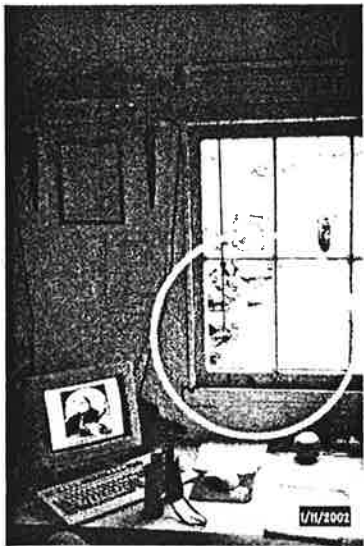
21.1

Single glazed windows

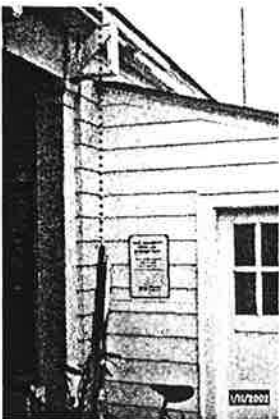
21.2

Addition to building  
Deteriorating planking

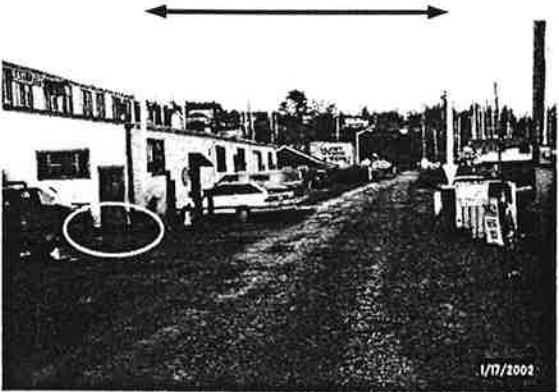
22.3

Space allocated  
for transportation  
interests

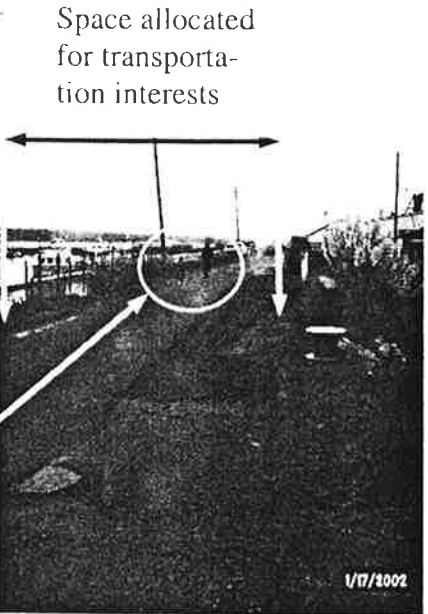
22.4

Pedestrians forced to move out of the way in the face of on-coming traffic.

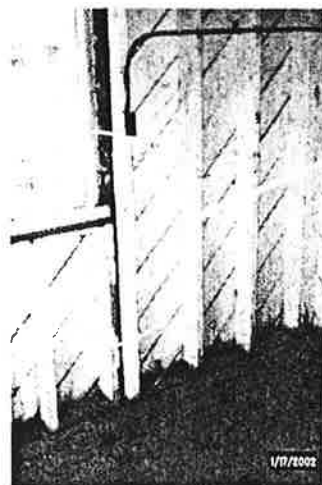
24B.4

Water migration through exterior wall

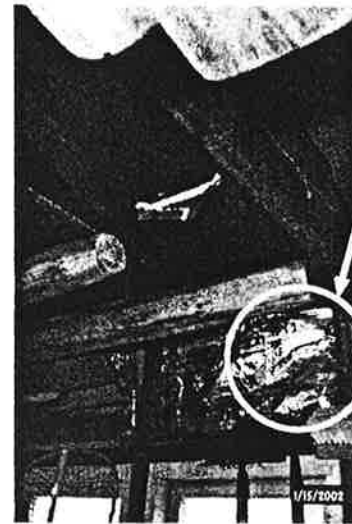
26.1

Exposed insulation  
Non-creosote treated  
framing

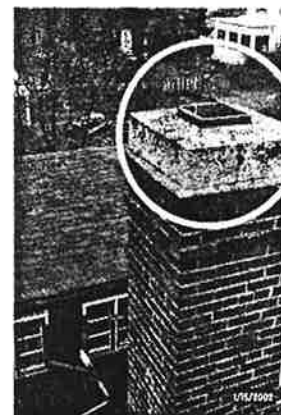
26.5

Ceramic lined double wythe brick  
masonry chimney with a concrete  
weather cap

Asbestos shingle cap repair attempt
